Technical Support

2005 - 2007 Ford 6.0L Throttle Control Diagnostics

Underhood70 V900080	
•	Throttle Control P/N# 3560092

Undernood150 V910006
•	Throttle Control P/N# 3560092

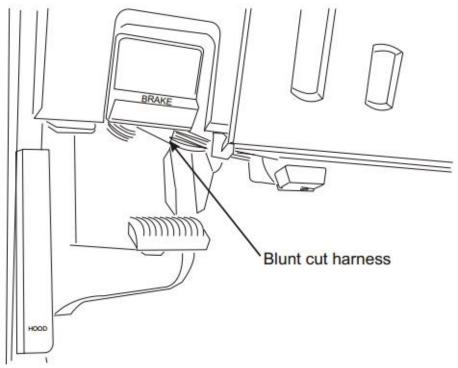
Most Throttle Control issues are due to poor electrical connections and/or poor grounding. VMAC recommends that all electrical connections (with the exception of the clutch connector in the engine bay) be soldered and shrink wrapped. We do not recommend using bullet connectors.

Figure 1 shows the location of the SEIC Blunt Cut Wire Harness where the majority of the Throttle Control connections are made.
