**August 30, 2011  
Phase I Environmental Site  
Assessment:  
25 W. Lake Street  
Former Aldi Store  
Oak Park, IL**

Park District of Oak Park  
218 Madison Street  
Oak Park, Illinois

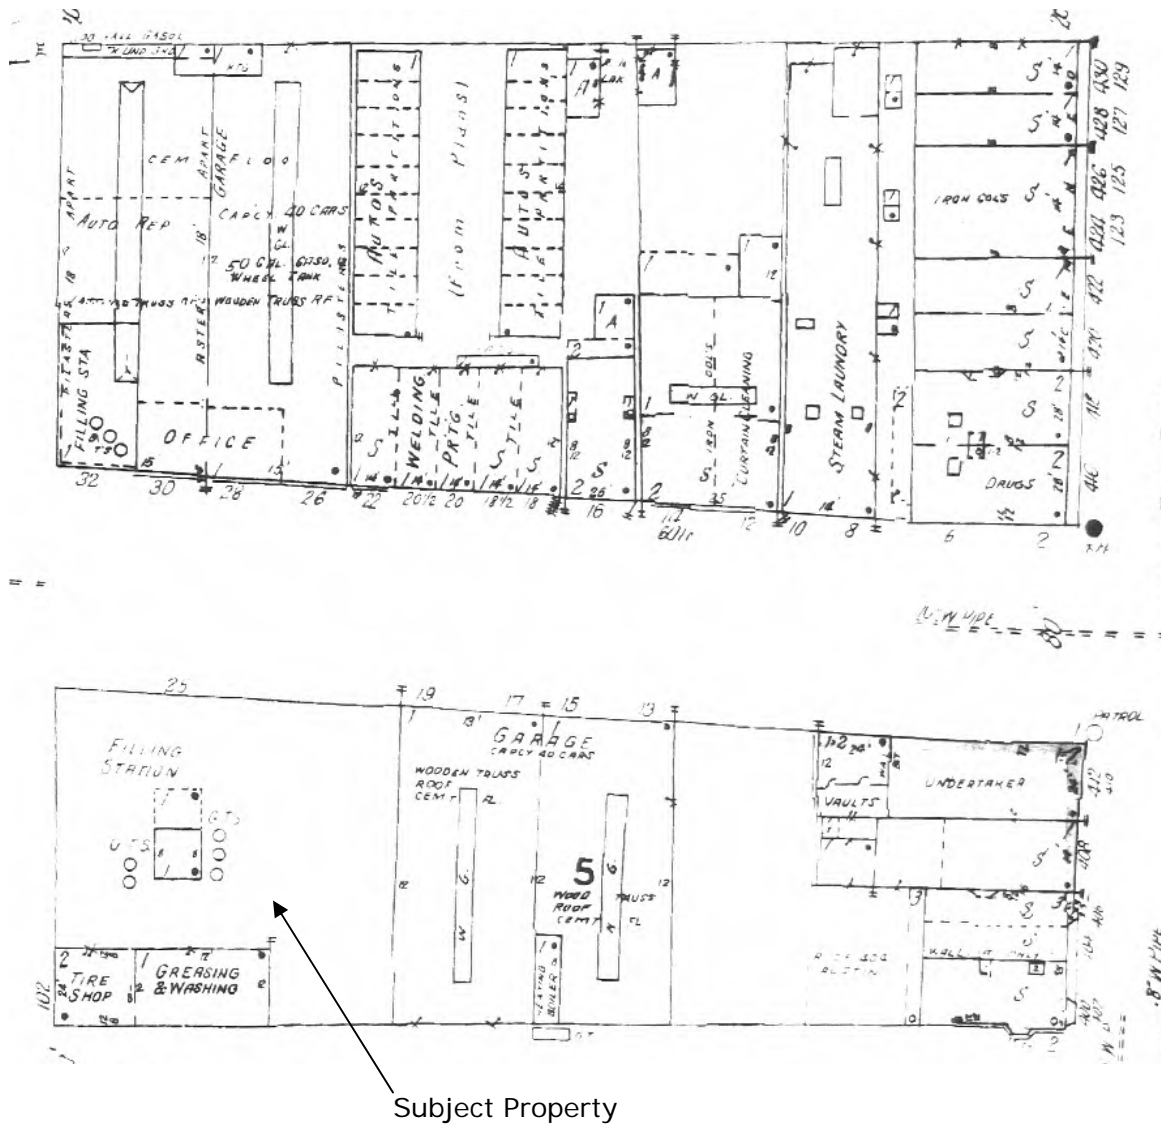
Figure 2-4. 1947 Sanborn

1947: A filling station and 5 USTs are shown present (see **Figure 2-4**). In addition, the Subject Property contains a greasing and washing building and a tire shop. A filling station with 3 USTs and an auto repair building are located immediately opposite the Property (north side of Lake, east of Humphrey). The property immediately east of 25 Lake is identified as 13 – 19 Lake Street and is shown as a garage having a capacity of 40 cars. The garage building is equipped with a boiler (possible fuel oil UST). It appears that the current property,

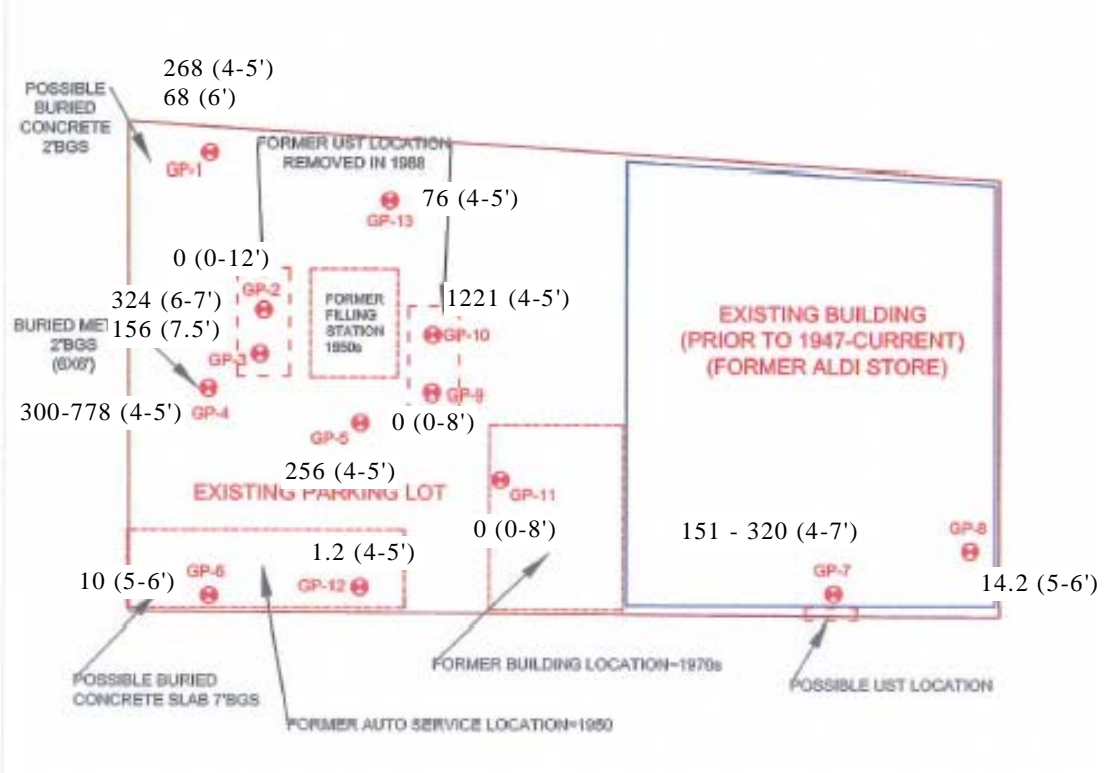
Figure 2-5. Weaver Boos Sampling Locations (PID Readings)

- A limited Phase II Environmental Site Assessment Report, prepared by Weaver Boos Consultants, was obtained from Aldi. Weaver Boos drilled 13 sample locations on site to depths ranging from 8 - 12 ft. Elevated PID readings (indicative of VOC impacts) were found a number of boring locations. Benzene was detected in GP-1 at a concentration that exceeded Tier I TACO screening levels. Weaver Boos recommended that Aldi either remediate soils or install a vapor barrier or other vapor intrusion prevention method, if a new building was to be constructed on

- The Phase II Report also noted the possible presence of an in-ground UST near the trash compacter. Buried debris and a 6 ft x 6 ft metal obstruction located beneath the west side of the parking lot was also reported present.

WB recommended that Aldi either remediate or install a vapor barrier or other vapor intrusion prevention method, if a new building was to be constructed on the site. It was suggested that the site be enrolled into the Illinois voluntary site remediation program (SRP) to obtain a No Further Remediation Letter (NFR Letter).
