Subject
2011 – 2016 Ford 6.2L Throttle Control Diagnostics

Underhood70 V900112
<ul style="list-style-type: none"> Throttle Control P/N# 3560213

Underhood150 V910012
<ul style="list-style-type: none"> Throttle Control P/N# 3560228

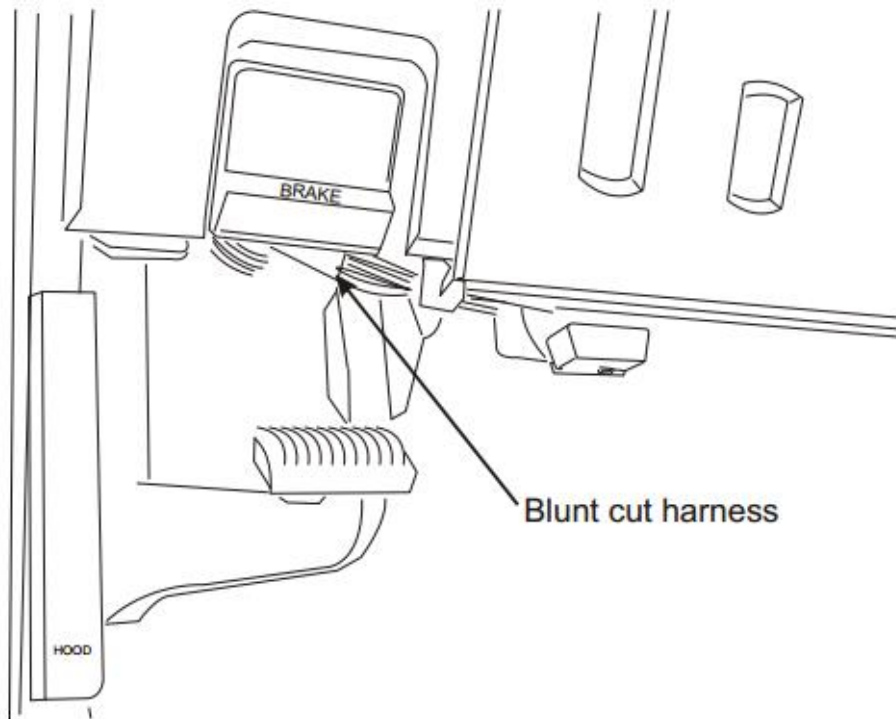
Figure 1 shows the location of the SEIC Blunt Cut Wire Harness where the majority of the Throttle Control connections are made.

Most Throttle Control issues are due to poor electrical connections and/or poor grounding. VMAC recommends that all electrical connections (with the exception of the clutch connector in the engine bay) be soldered and shrink wrapped. We do not recommend using bullet connectors.
