Subject
Multifunction Power System Will Not Increase to Higher Speed

- All Kubota Powered Multifunction Power Systems

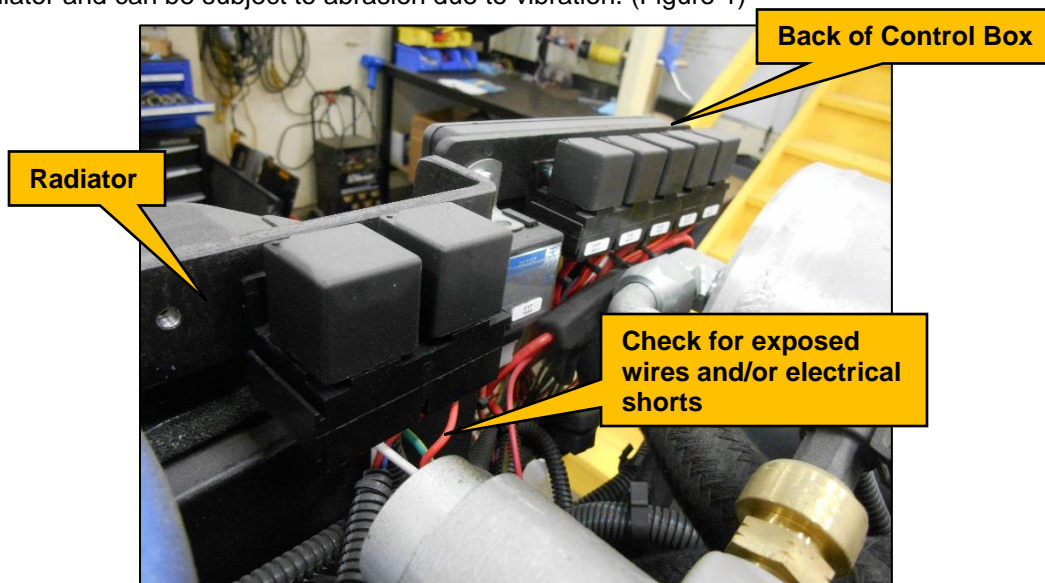
Figure 1

Multifunction Engine will only run at low rpm speed, will not rev up to high rpm speed.

This issue is generally caused by a short in the wiring going to the throttle relay. This relay is located next to the radiator and can be subject to abrasion due to vibration. (Figure 1)
