Blowdown Cap Operation and Troubleshooting

<b>Underhood VR70 and DTM</b>
Blowdown Cap P/N# 9200437

<b>Underhood VR150</b>
Blowdown Cap P/N# 9210028

<b>PREDATAIR</b>
Blowdown Cap P/N# 9400059

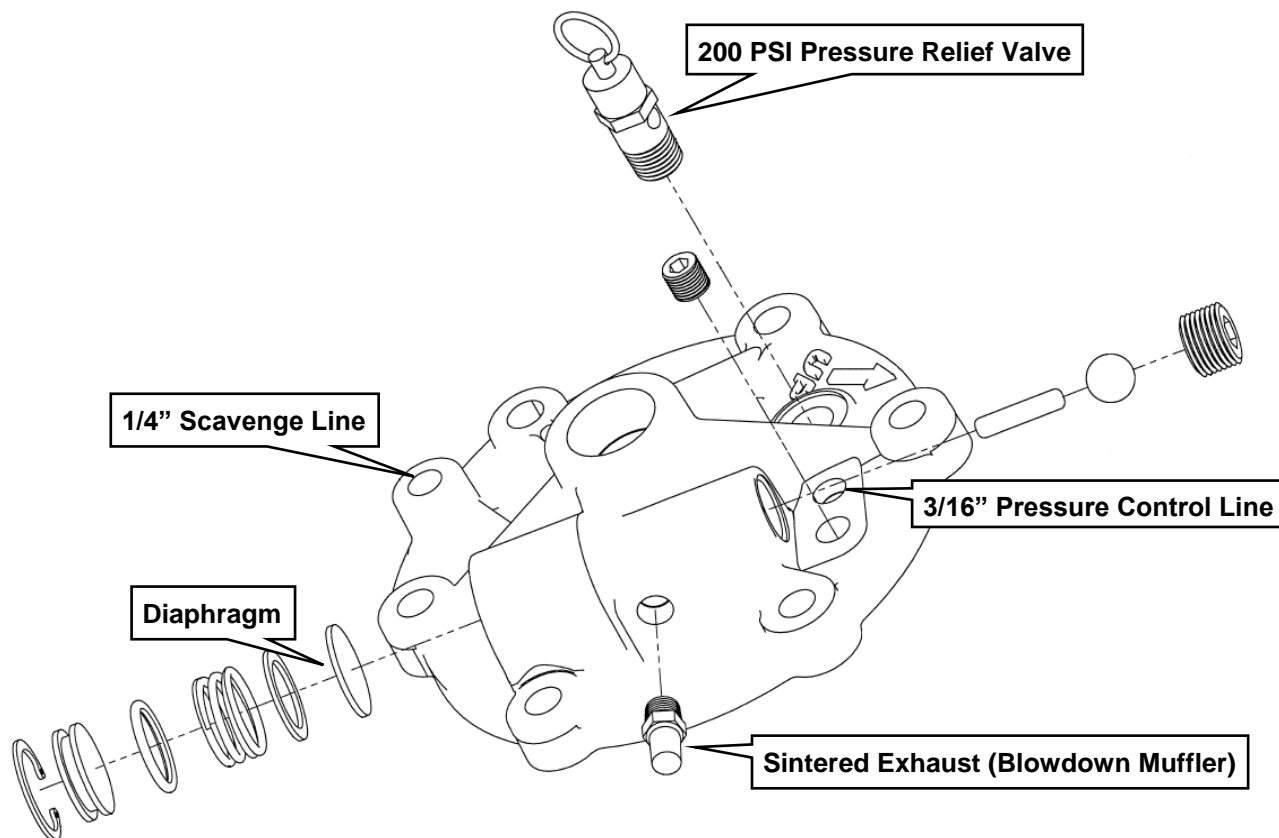
Figure 2

- Determine if venting air is from the Blowdown Muffler or the 200PSI Pressure Relief Valve.
- Check the 1/4" scavenge line for leaks, kinks or obstructions.
- Check 1/4" scavenge fittings for leaks, or obstructions.
- Check the scavenge port in the blowdown cap, ensure it is not obstructed.
- Ensure the scavenge screen is not plugged.

- Plugged muffler: This will prevent the air pressure from venting.
- Ball seized onto seat: Remove cap from tank, and shake the cap. The ball move should move freely inside, like in a paint can.

- Blowdown diaphragm is damaged.
- Tank or cap mounted is upside down (Arrow on discharge cap should be pointing upwards).

- Restricted Blowdown muffler.
- External receiver tank installed without one-way check valve between the AOST and the tank.

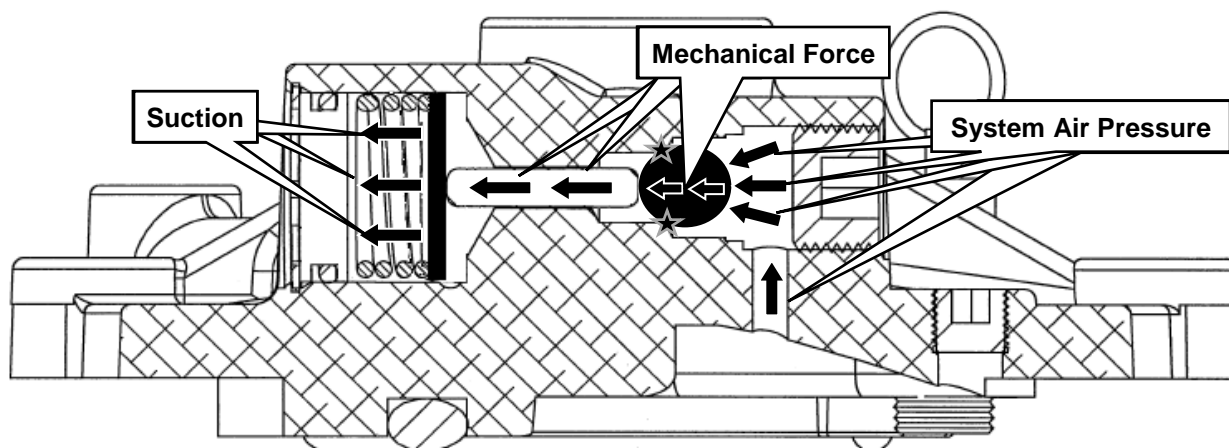
Figure 4

Suction from the 1/4" scavenge line pulls on the diaphragm, against the spring, allowing the blowdown pin to move with the diaphragm. System air pressure forces the blowdown ball against the internal seat which stops any air from flowing through to the blowdown muffler. (Figure 4)

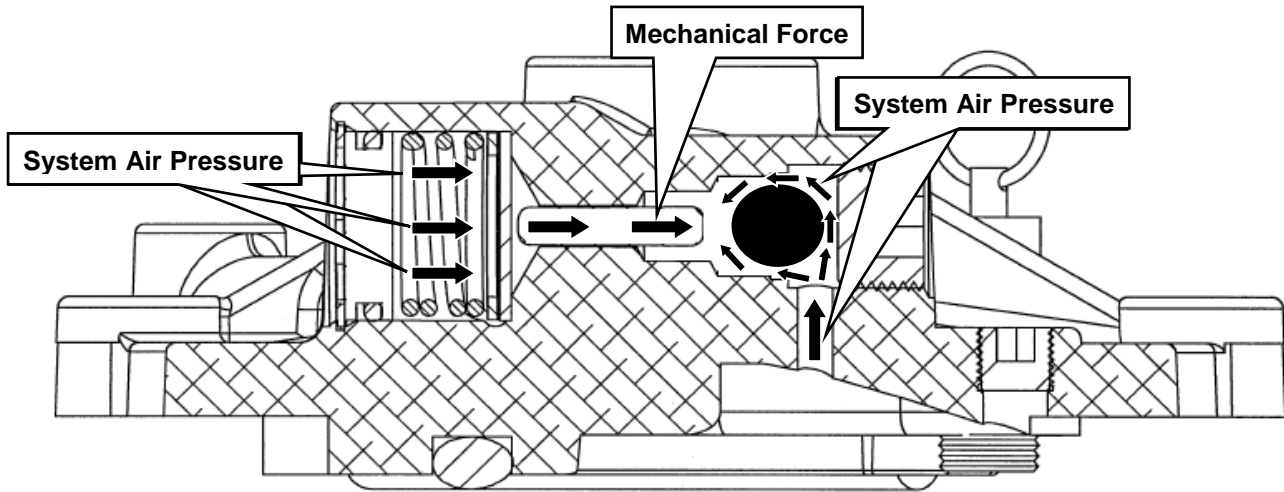
Figure 5

System air pressure is applied to the blowdown diaphragm (suction only occurs when the compressor is turning). While the pressure is dropping in the ball chamber it allows the diaphragm and spring pressure to move the ball off its seat allowing air to bypass the ball seat where it vents out through the muffler. (Figure 5)
