Subject
V900130 Crank Pulley Socket Clearance

- Underhood70 (V900130)

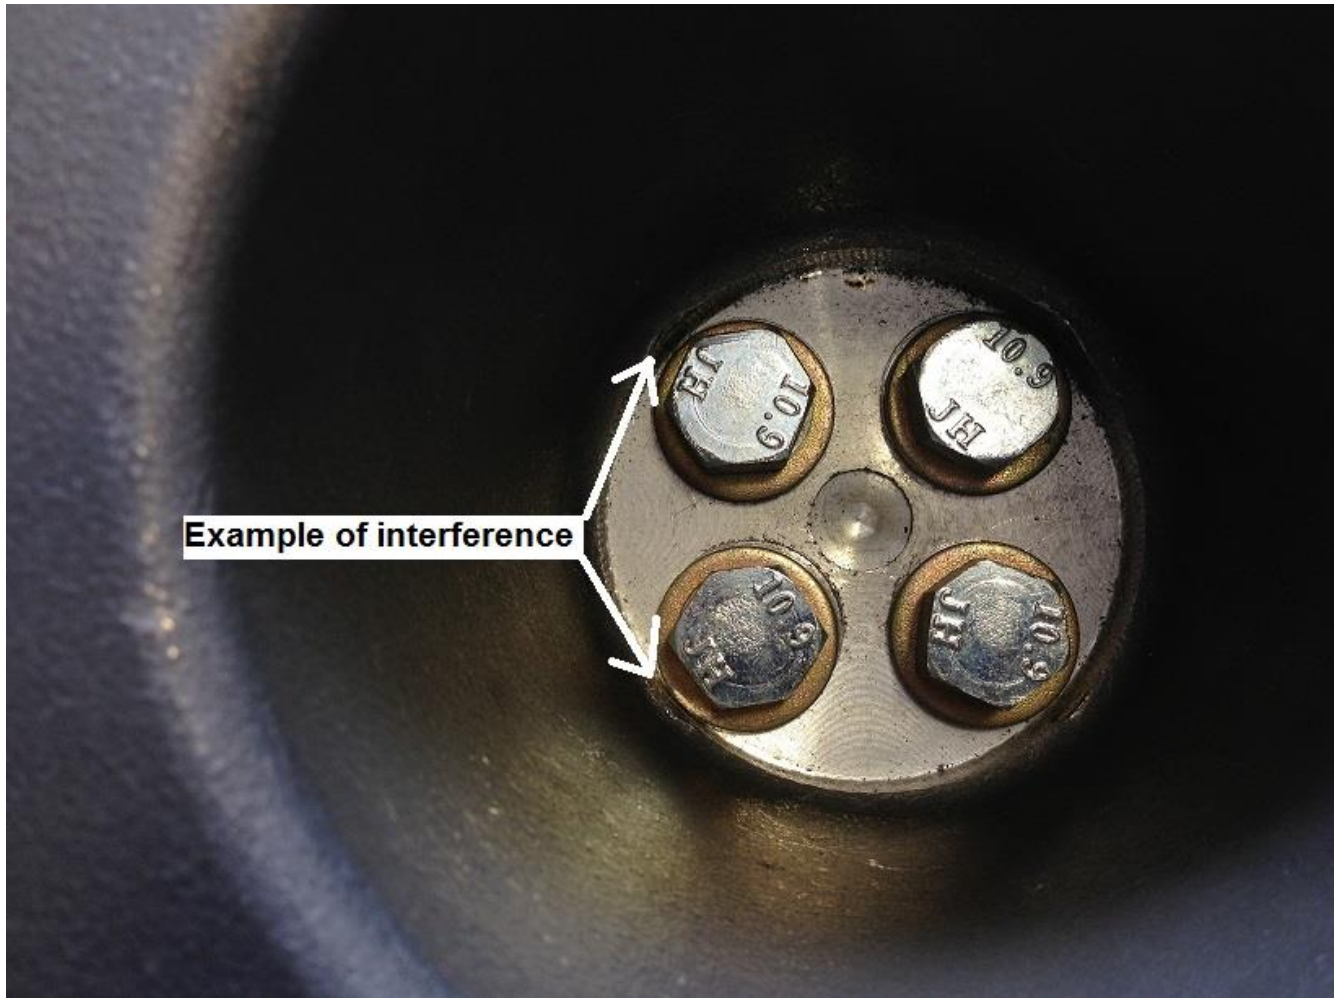
Some customers have had difficulty accessing the crank pulley fasteners with a socket due to the clearance between the fastener and the VMAC Crank Pulley.

VMAC engineers have confirmed that removing 0.100" – 0.150" inch from the inside of the crank surface should allow sufficient clearance for a "thin walled" socket to access the fasteners without causing any detrimental effects.
