Subject
2008-2010 Ford 6.8L V10 Throttle Control Diagnostics Except "G" Kit

Underhood70 V900101
• Throttle Control P/N# 3560094

Underhood150 V910009
• Throttle Control P/N# 3560094

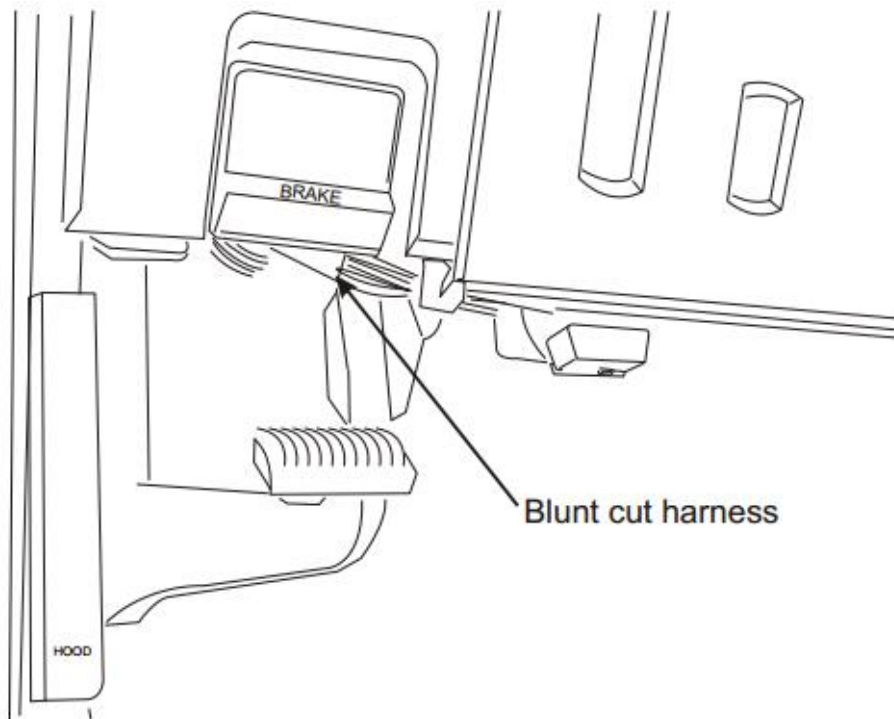
Figure 1 shows the location of the SEIC Blunt Cut Wire Harness where the majority of the Throttle Control connections are made.

Most Throttle Control issues are due to poor electrical connections and/or poor grounding. VMAC recommends that all electrical connections (with the exception of the clutch connector in the engine bay) be soldered and shrink wrapped. We do not recommend using bullet connectors.
