Subject
2005-2007 Ford 6.8L V10 Throttle Control Diagnostics Except "G" Kit

<b>Underhood70 V900081</b>
<ul style="list-style-type: none"> <li>• Throttle Control P/N# 3560094</li> </ul>

Document	Version	Department	Revision Details	Revised by	Tech	Engineering	Implemented
EXT-VRTC-006	A	Tech	Document Release	SP 30 Jul 2015	DB 30 Jul 2015	N/A	30 Jul 2015

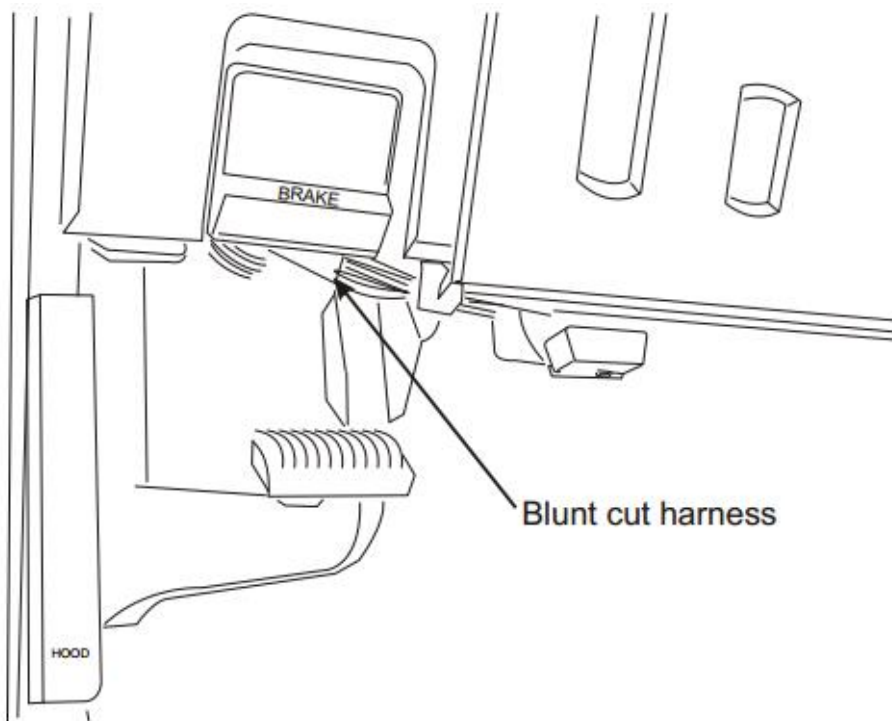
Most Throttle Control issues are due to poor electrical connections and/or poor grounding. VMAC recommends that all electrical connections (with the exception of the clutch connector in the engine bay) be soldered and shrink wrapped. We do not recommend using bullet connectors.

Figure 1 shows the location of the SEIC Blunt Cut Wire Harness where the majority of the Throttle Control connections are made.
