Subject
RAPTAIR-MF Welder/Booster Low/No DC Current

- RAPTAIR-MF (D600005 / 7)
 - Genset Ribbon Cable P/N# 3550856

Document	Version	Department	Revision Details	Revised by	Tech	Engineering	Implemented
EXT-MF-017	A	Tech	Document Release	BDJ 15 Feb 2016	BPC 16 Feb 2016	N/A	16 Feb 2015

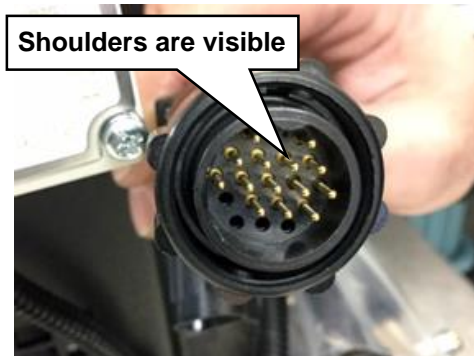
- 1) Disconnect the welder control box from the Multifunction at the connector at the Multifunction.
- 2) Closely inspect the male pins in the connector at the end of Multifunction side of the connection.
- 3) Pins should stand at uniform height from the connector, and the metal shoulder should be visible at the base of each pin. (Figure 1)
- 4) If pins are uneven and/or the shoulders of the pins are not visible, the pins are not seated correctly. (Figure 2)

Figure 1 – Example good plug

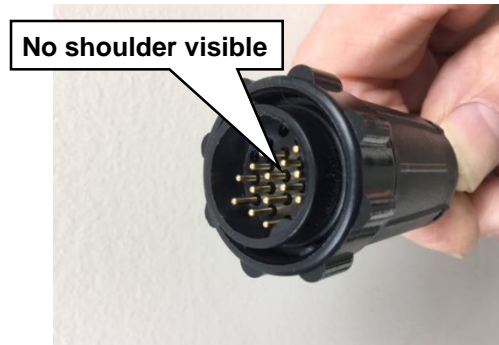
- A small number D600005/D600007 Raptair Multifunctions may have left the factory with an improperly manufactured 14 pin male welder connector.
- The pins in this connector may not have been fully locked into the connector, and could potentially be pushed back into the body of the male connector when connecting to the female.
- This can prevent good connection between the welder control box and the DC side of the booster/welder.
- The connector can be corrected rather than replacing the cable. (Cable replacement requires removal of the generator)

- lack of power to the welder
- Incorrect voltage to the battery booster
- Inoperative battery booster

Figure 2 – Example of poorly seated contacts

1. Using a small flat screwdriver, from the inside of the connector press the pins into the body of the connector, taking care not to damage the wire. The pins will seat with a distinct 'click'.
2. Pins should be uniform height in connector, tips almost flush with rim, all with shoulder showing as in Figure 1.

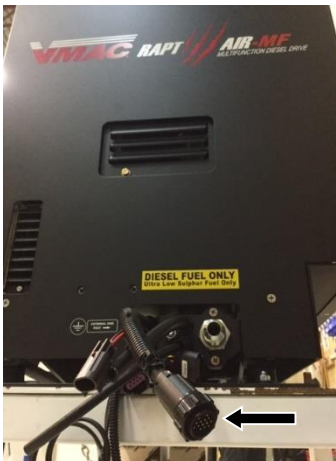
Figure 3 – Plug location

1. Locate and clean the connector. Provide a clean, solid surface to work on. (fig3)
2. Remove the two screws and wire retainer clamp from the base of the connector. (Fig 4)
3. Slide the knurled knob forward while turning it to find its locking point. Once locked you can loosen off the threaded connector cover. (Fig 5)
4. Grasping the cable with one hand, pull the cover back exposing the inside of the connector. (Fig 6-7)

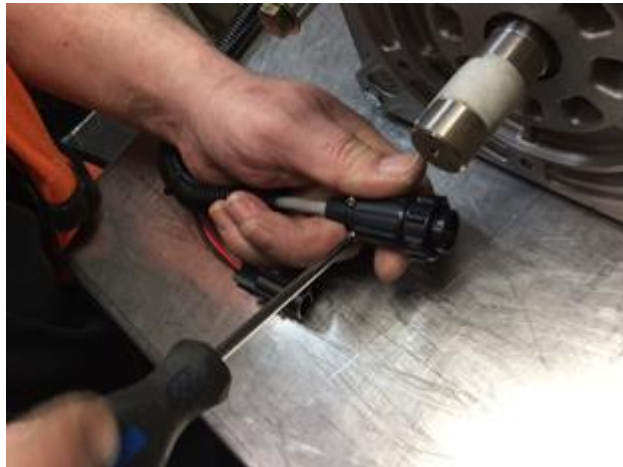
Figure 4 – Plug disassembly
