ShearForce10 ECTRM Installed over cool season grass mix in high flow channel at the base of an overburden cap on September 10, 2019. Objective: Evaluate potential as rock riprap replacement in high flow areas at the mine

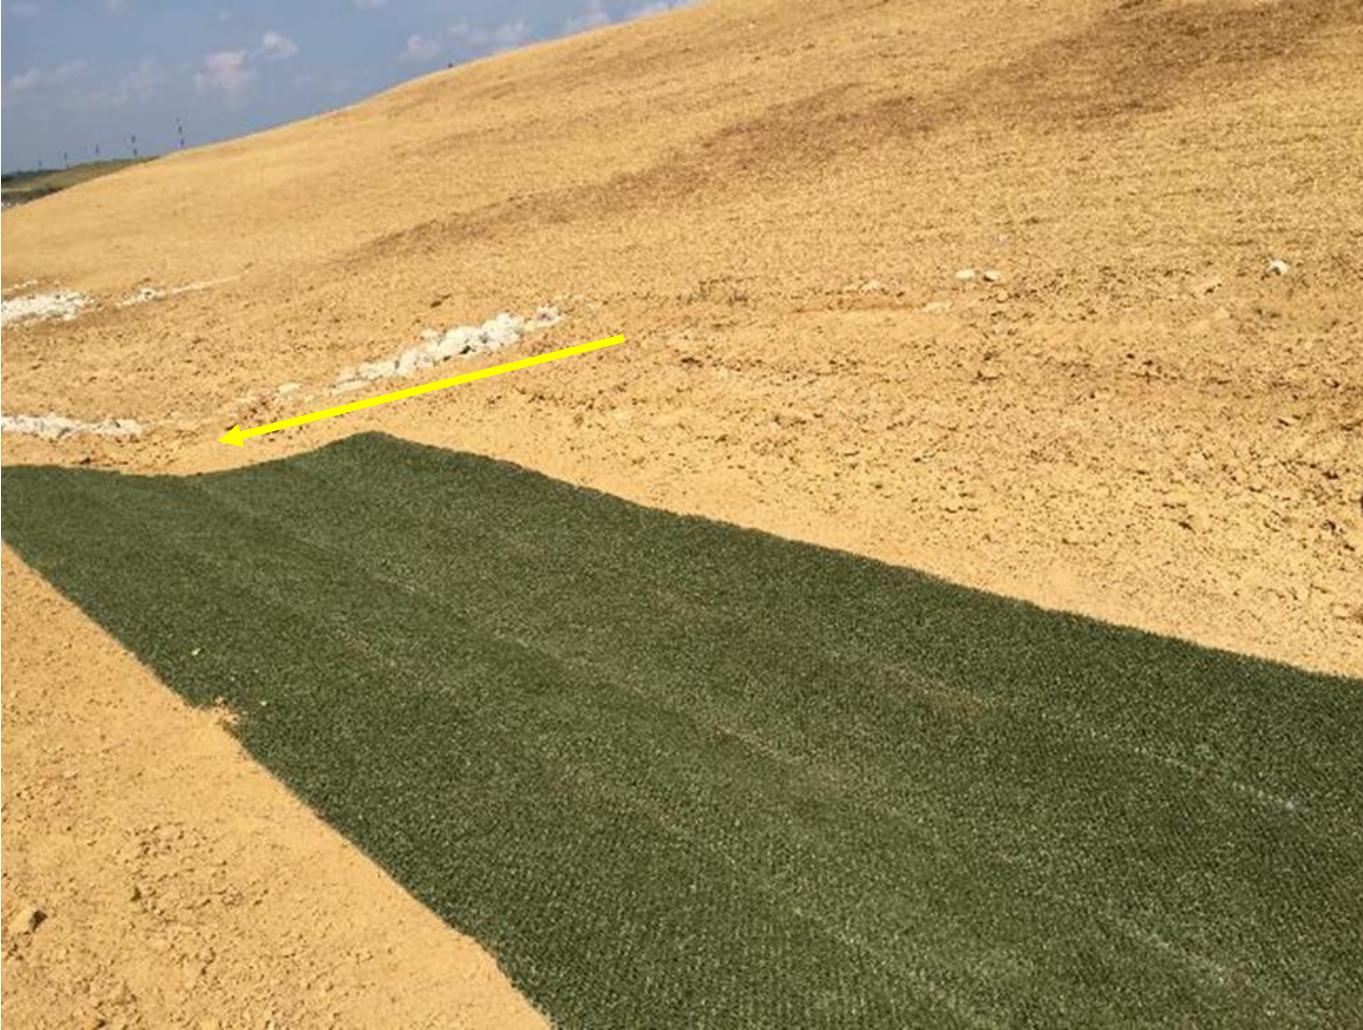
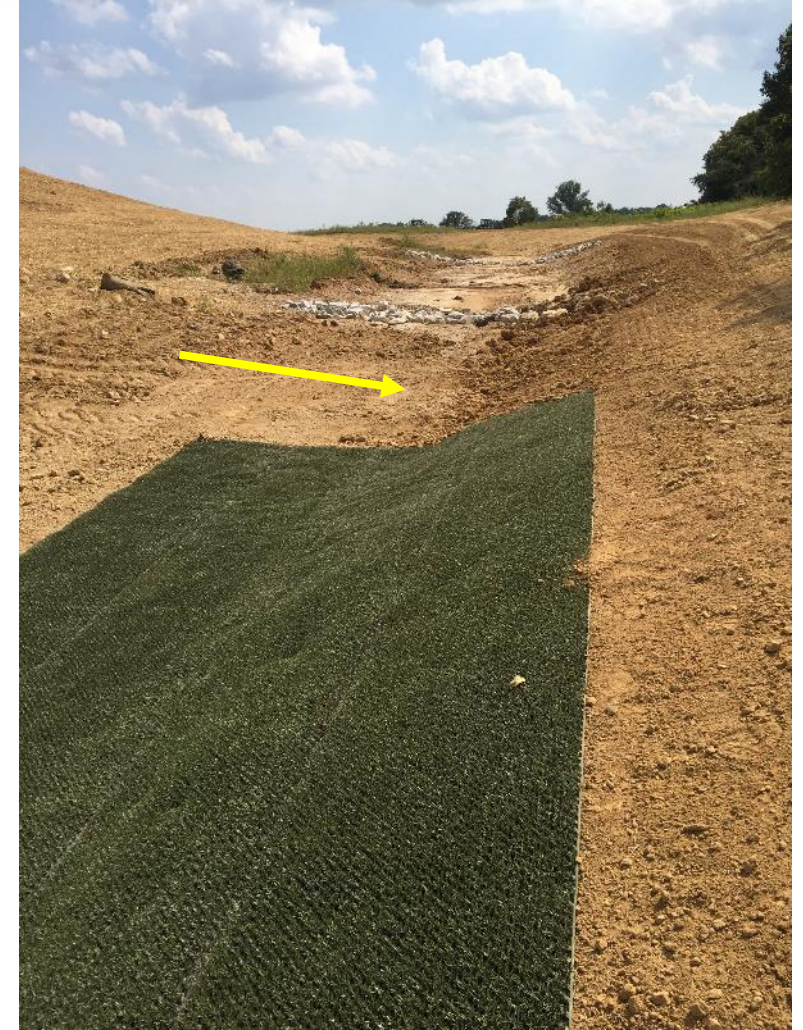
Mats were installed between rock checks using 8 inch sod staples and 6 inch fabric pins on 1.5 ft centers according to published InstaTurf installation guidelines. Note small sections of channel downstream and upstream of mats left unprotected for comparison.

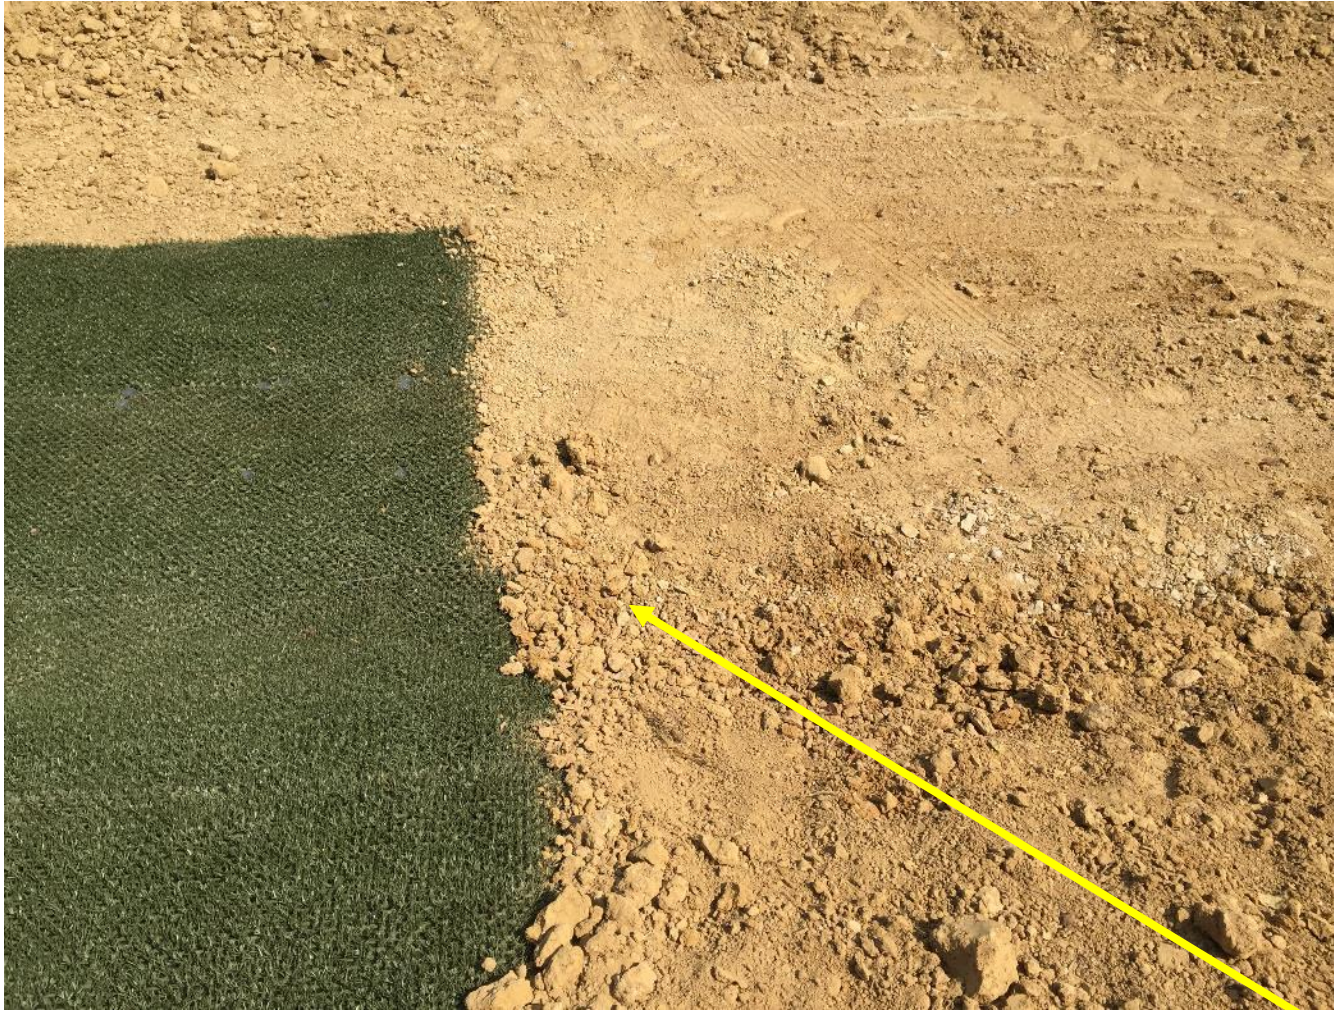
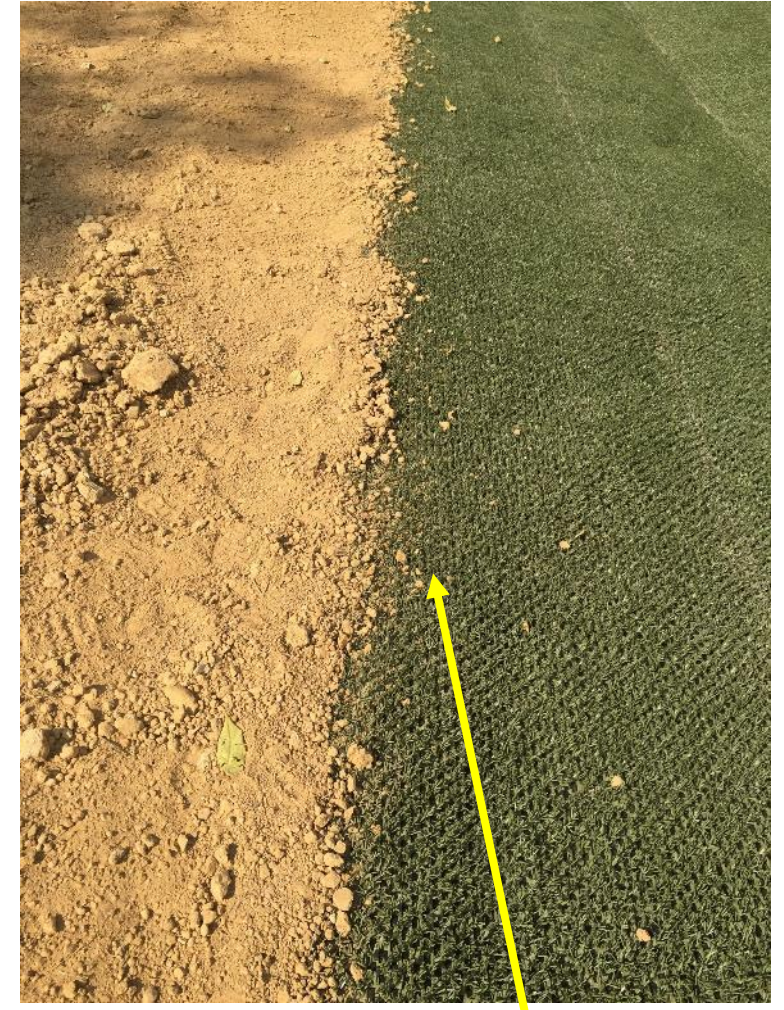
Upslope terminal ends of mats were trenched in approximately 6 inches (left). Mat edges at top of both sideslopes (Right photo) and downstream terminal ends were simply stapled on 9 inch centers with loose soil placed over edges.

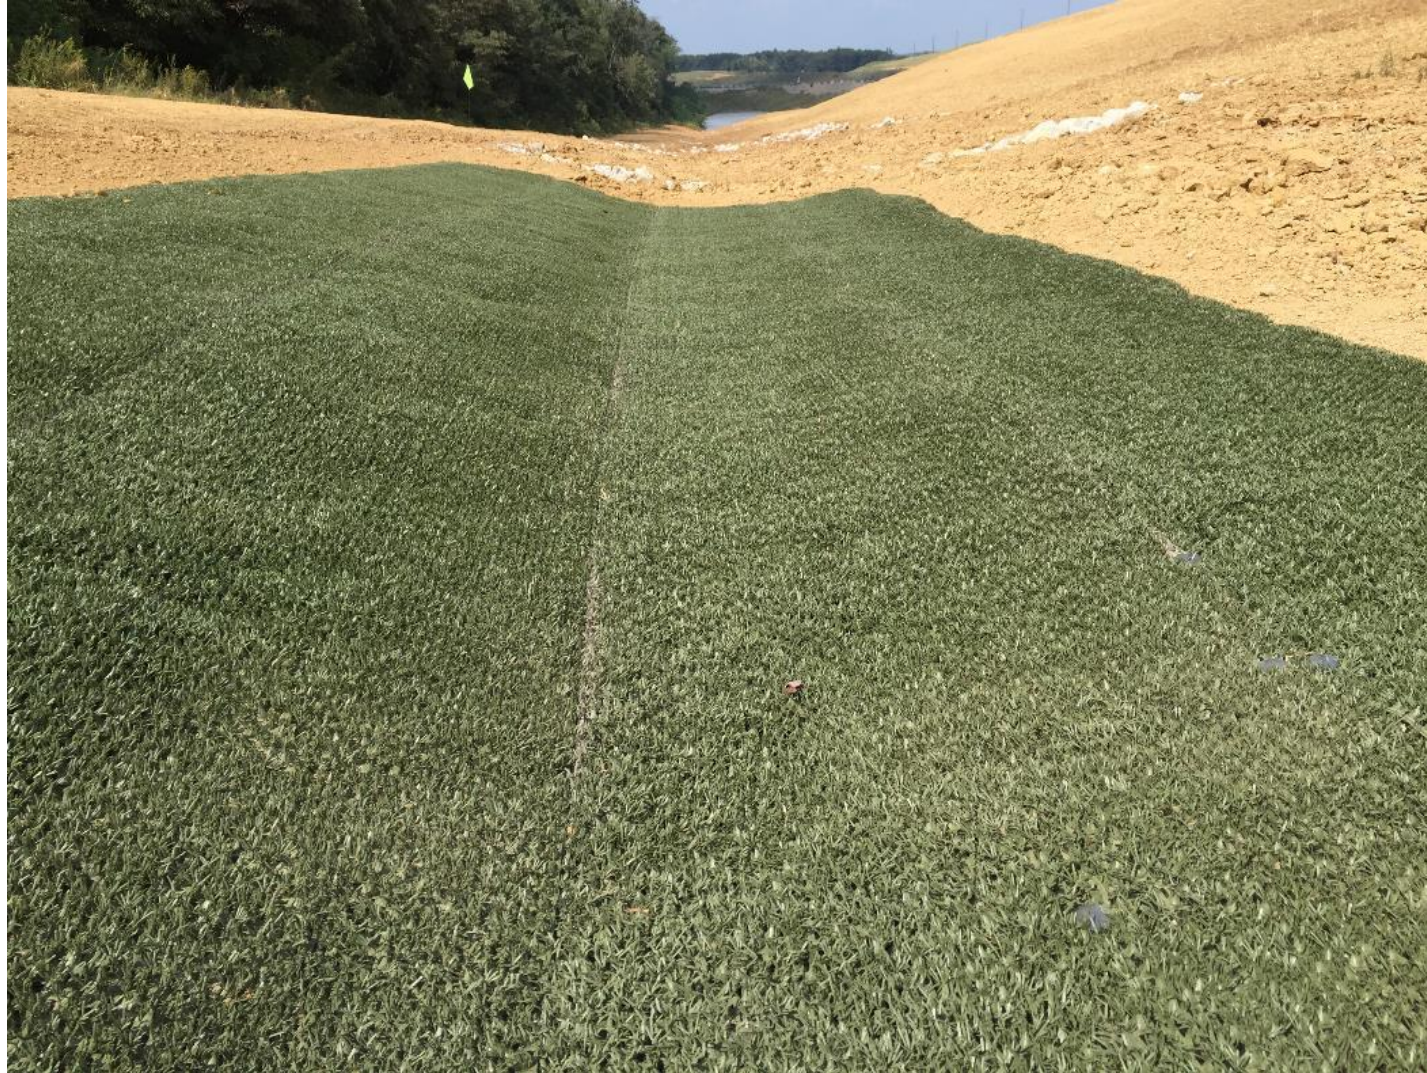
Completed ShearForce10 Installation looking down channel grade

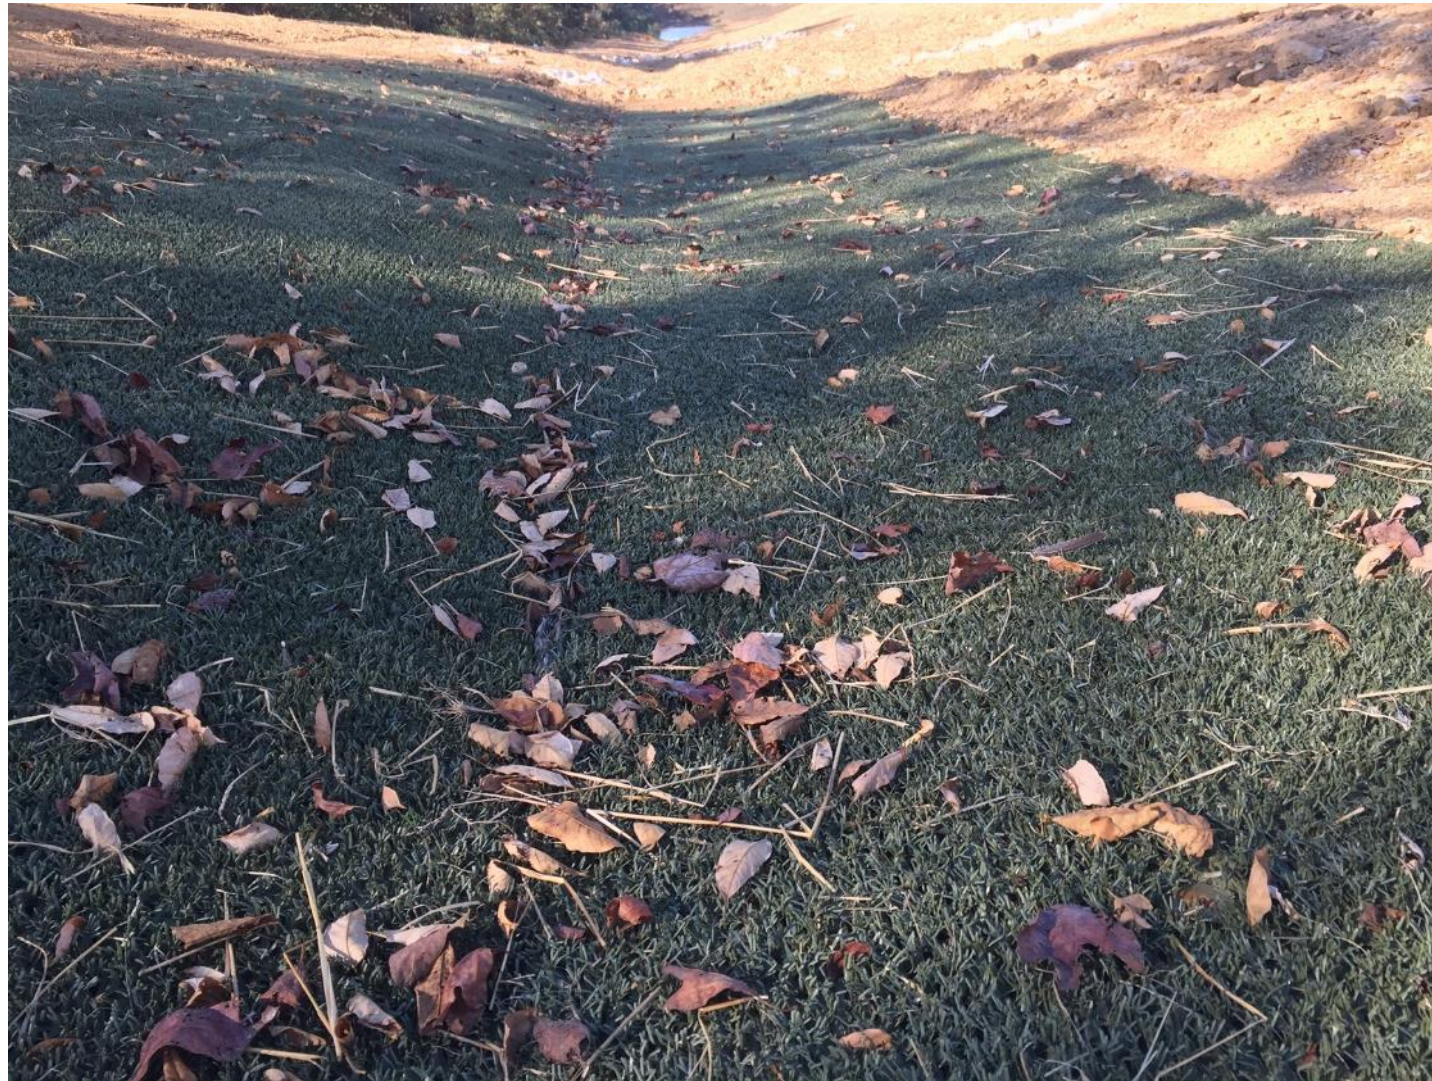
Nearly One Month Later, ShearForce10 Waiting for Rain

Due to the lack of rainfall in September (.6 inch total), very little germination had occurred by Oct 7

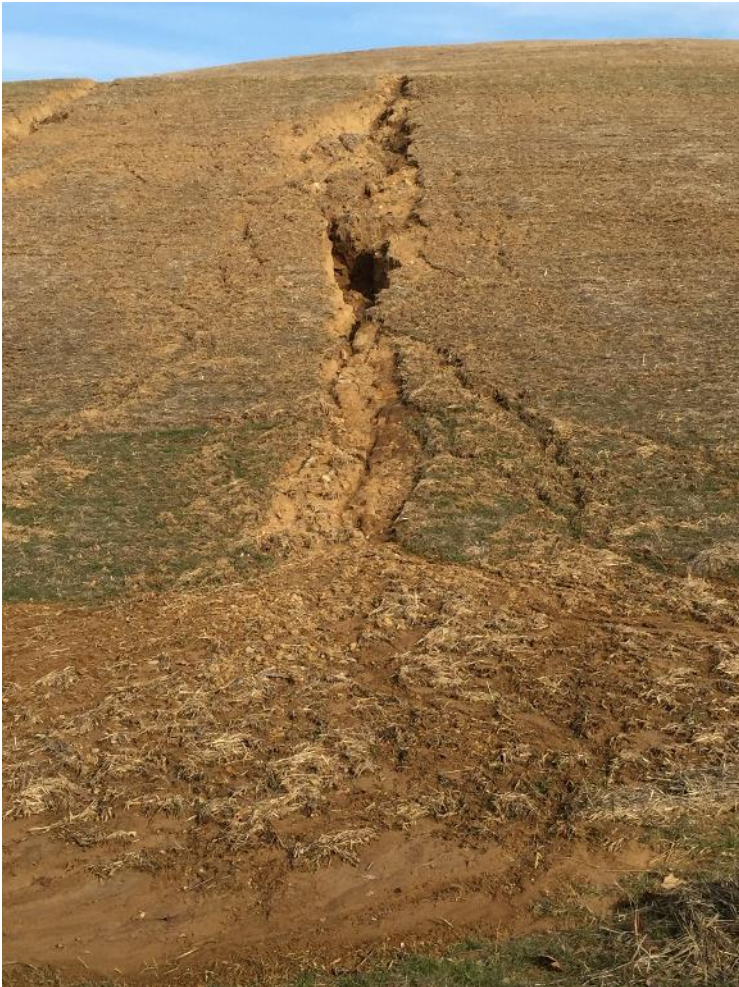
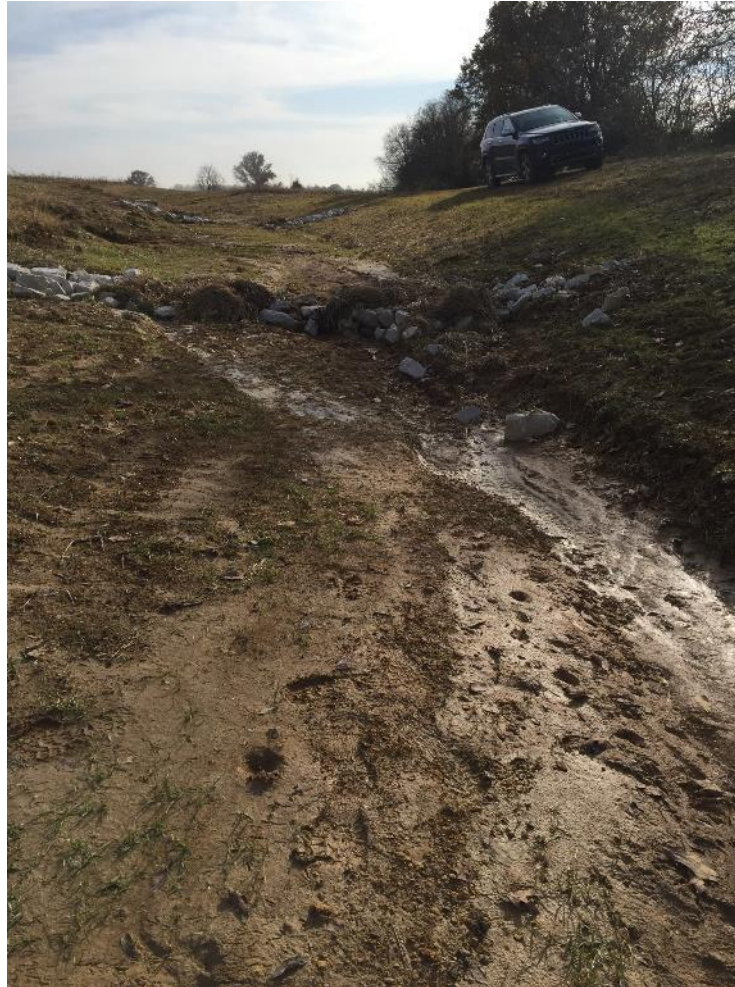
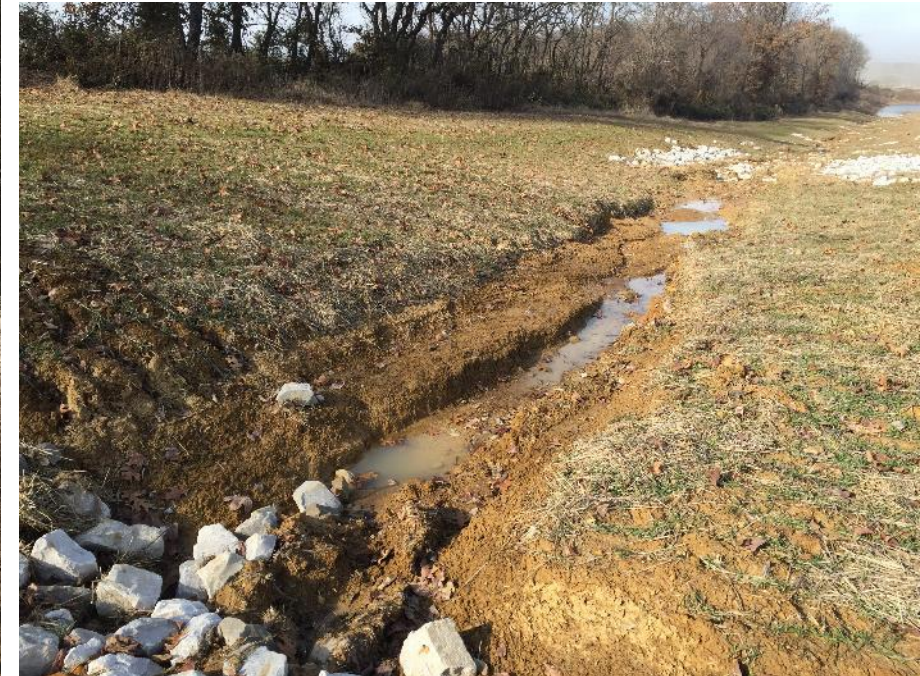
Major Erosion Damage of Unprotected Areas Caused by Late October Storm Flows

...Just two weeks later, the rains came, with major storm events on Oct 21 (1.65 in) and Oct 26 (2.2 in) wreaking havoc on straw mulched slopes/channel bottom and riprap check dams as apparent in these photos taken Nov 20. Over 6.5 inches of rain fell in October, what a mess!

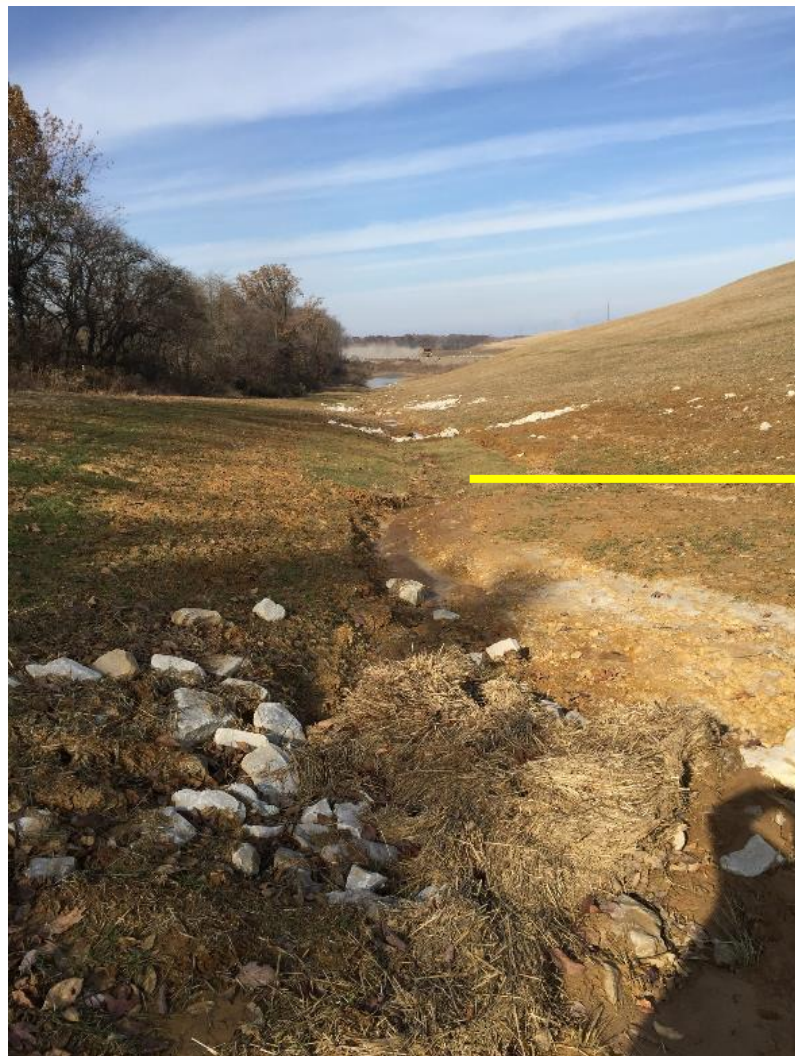
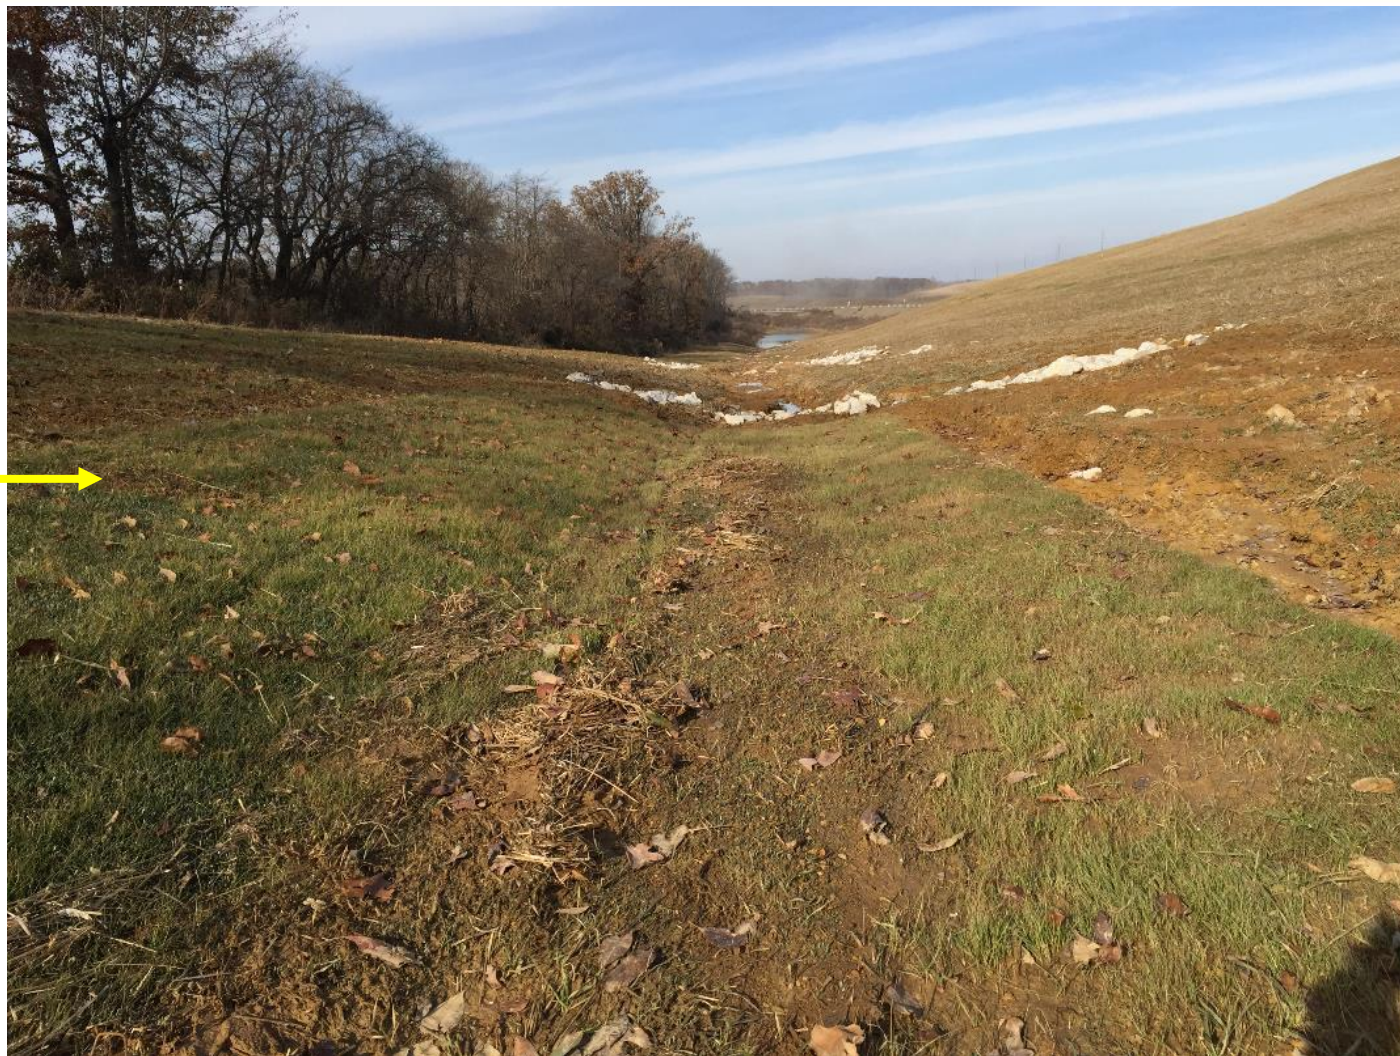
ShearForce10 Protected Section Locked Down Solid!

But wait, what's that green patch between those ugly rock piles? ShearForce10 had survived the multiple deluges with no significant erosion issues. Note new vegetation growth and sediment deposition on top of mats.

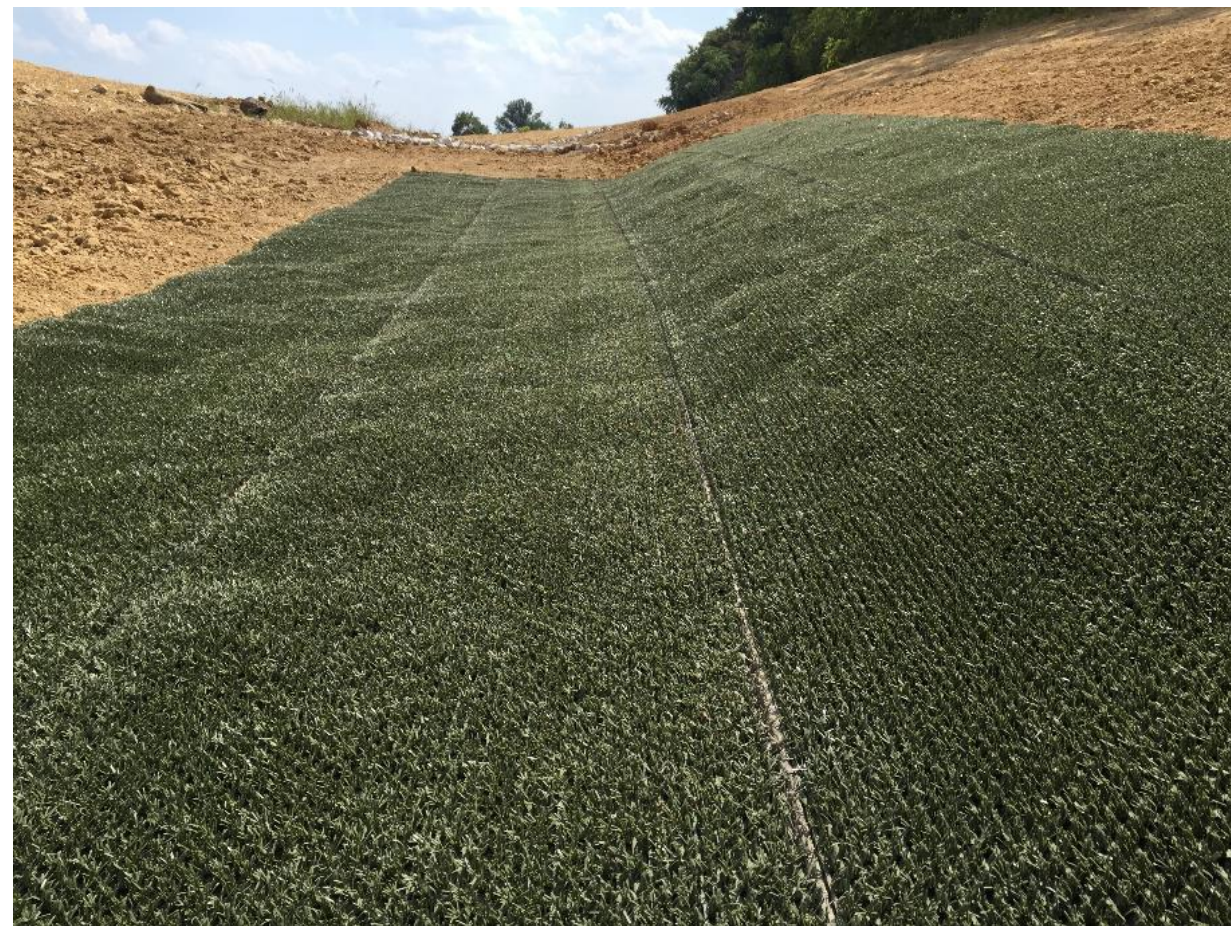
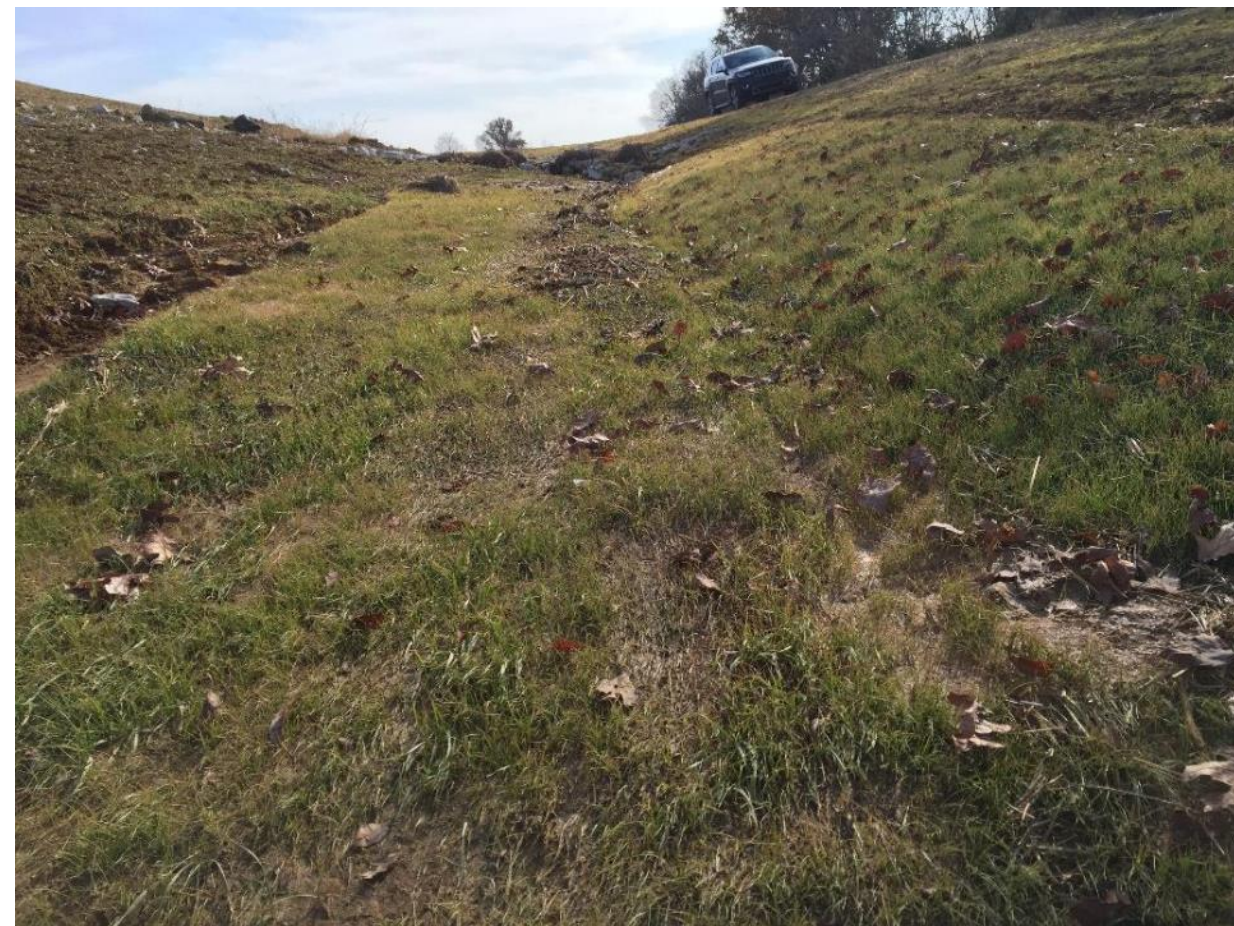
Upslope view of ShearForce10 just after installation on Sep 10 (left) and on Nov 20 (right).

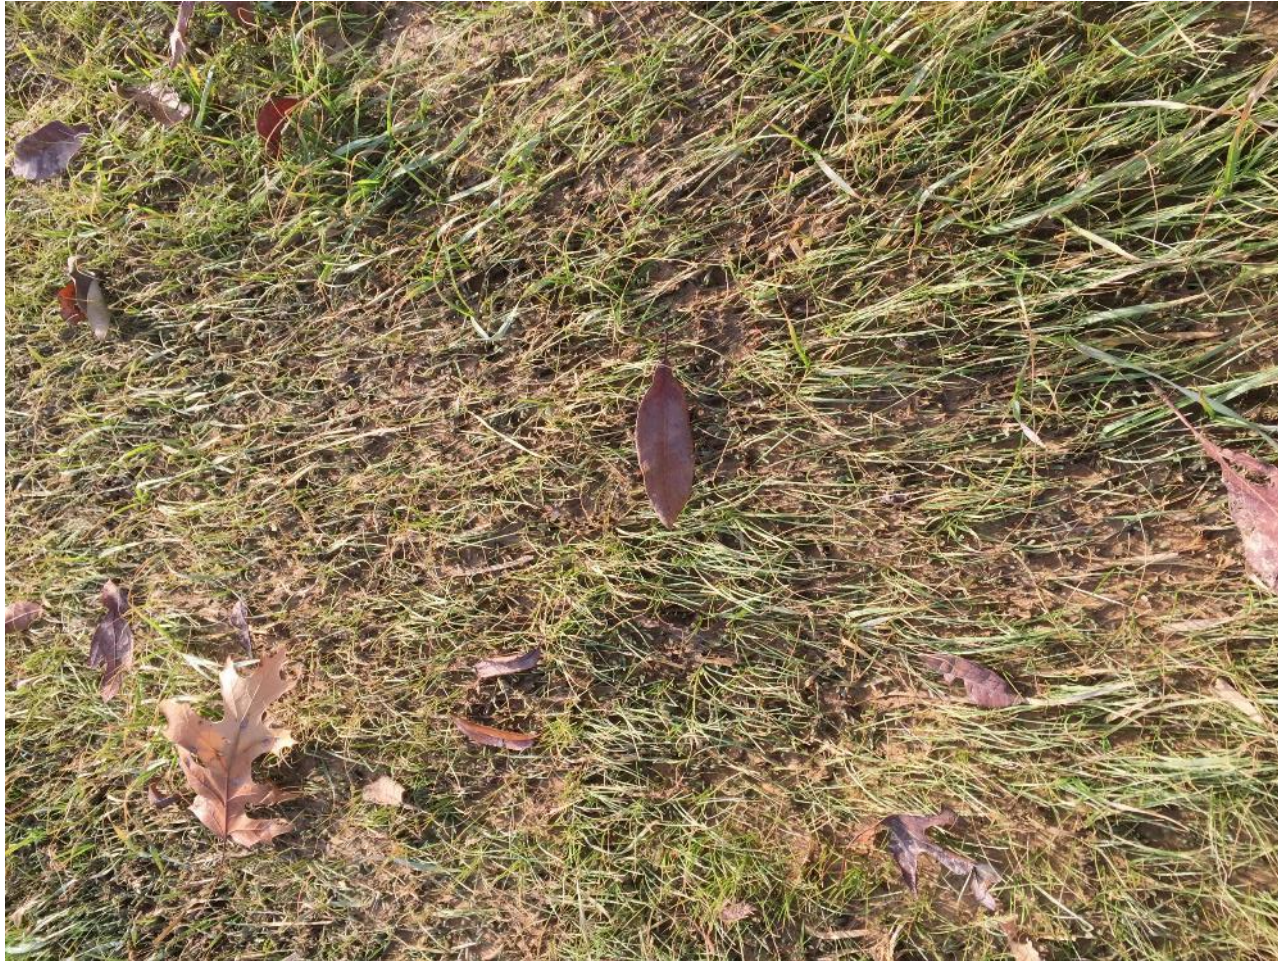
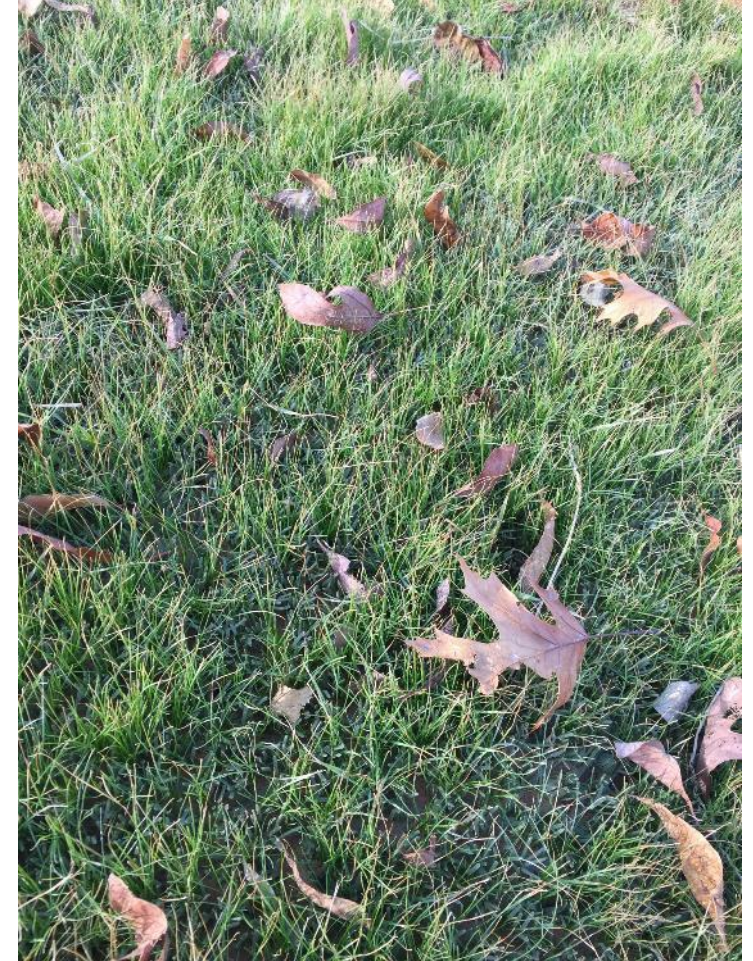
New grass growing on channel bed (left) appeared to be in good condition in spite of being laid over by water flow. Grass on the left sideslope (right) was quite dense, especially compared to surrounding straw-mulched areas.

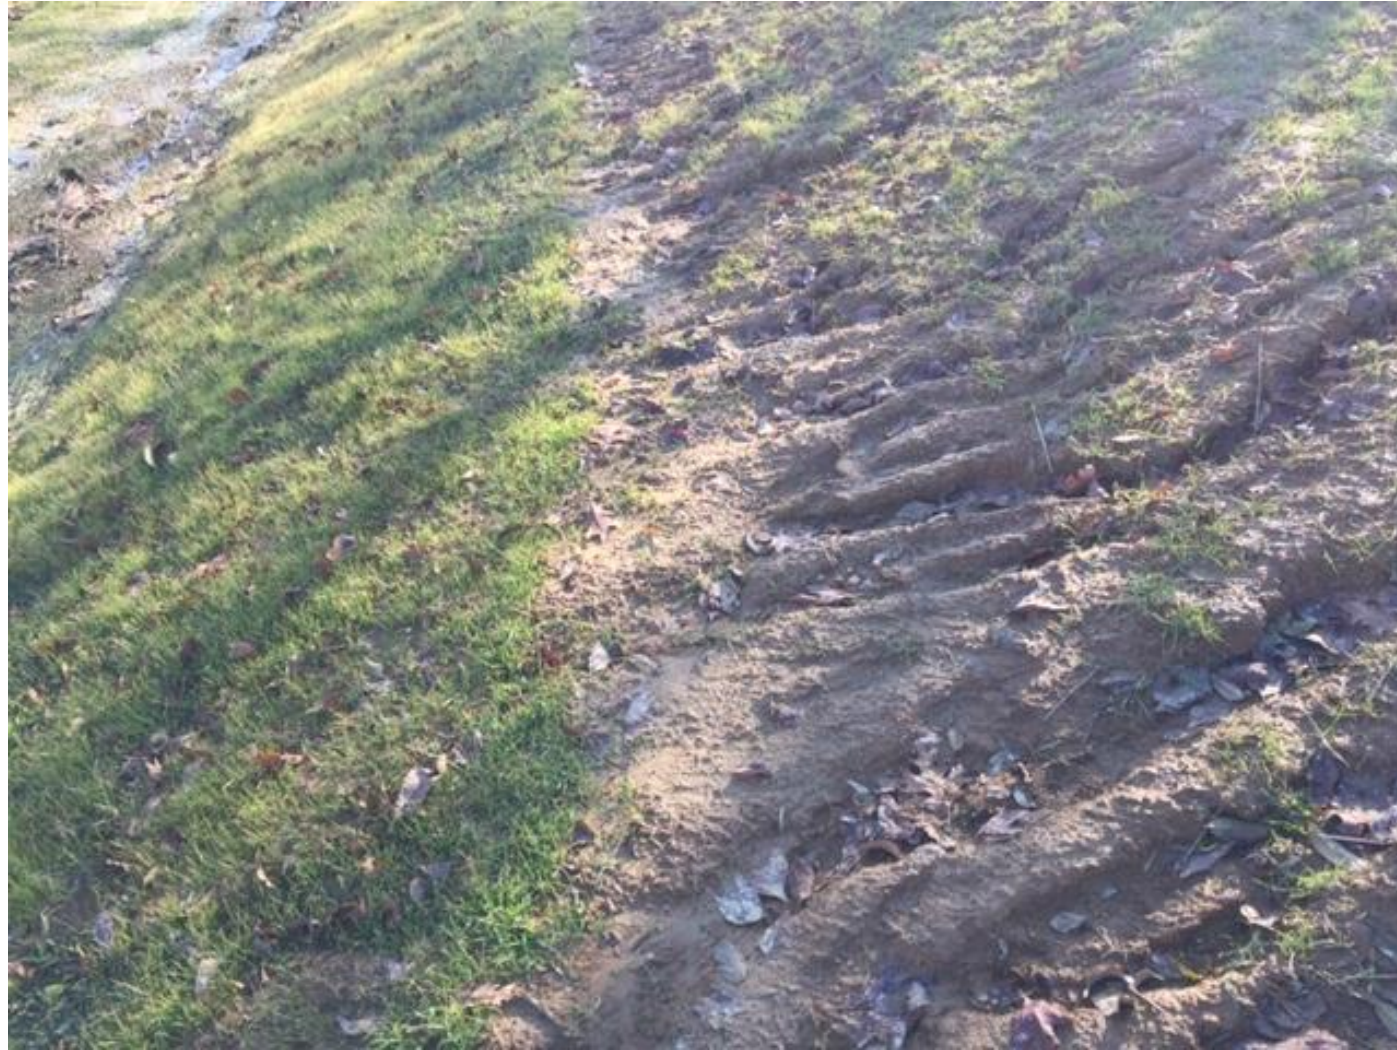
The staple anchor check at top edge of left sideslope effectively prevented rills in unprotected upslope area from undermining the ShearForce10.

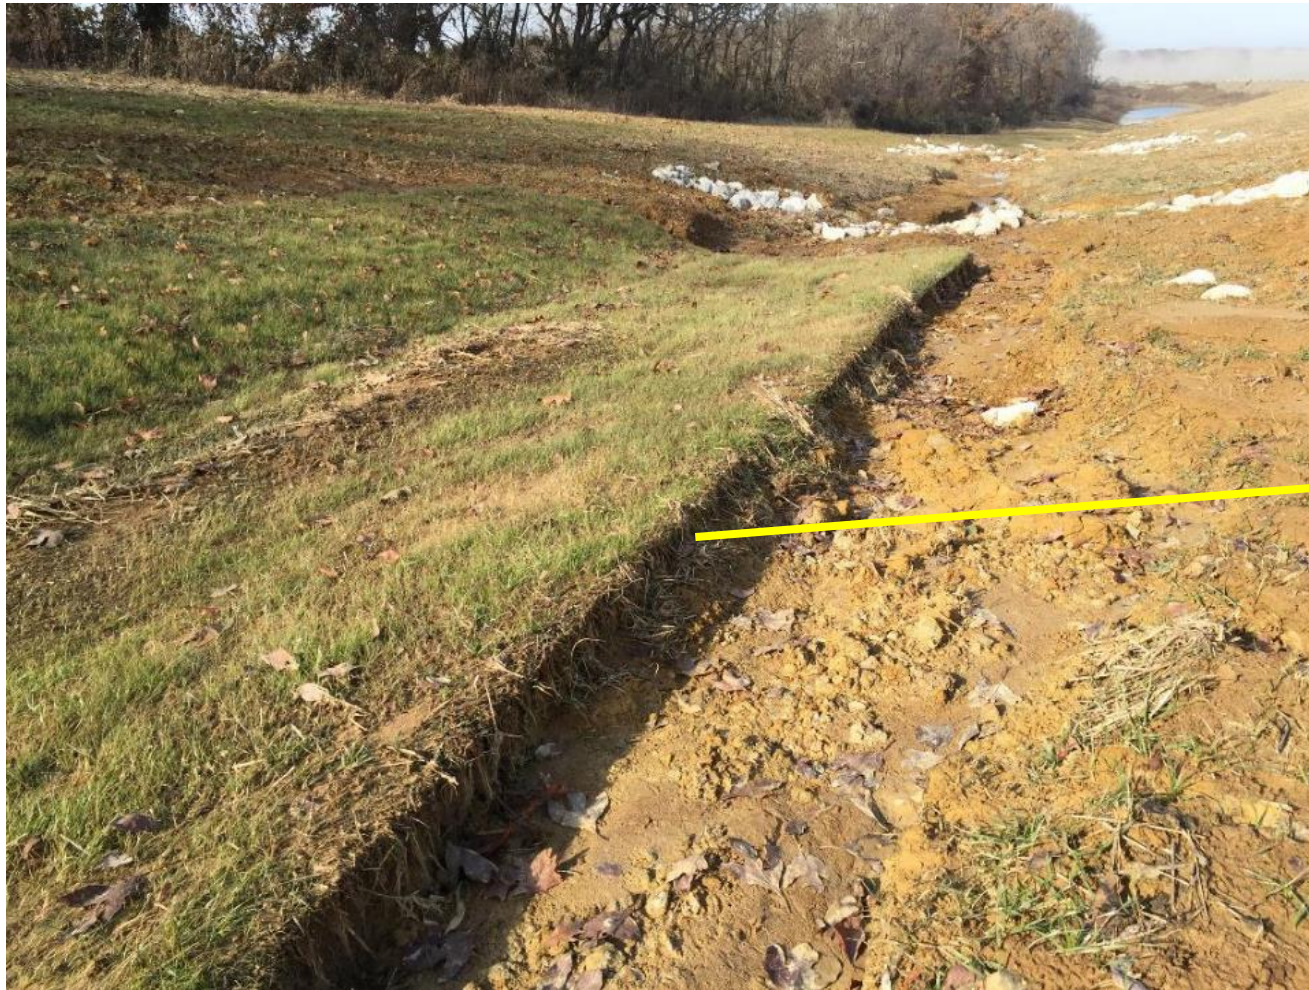
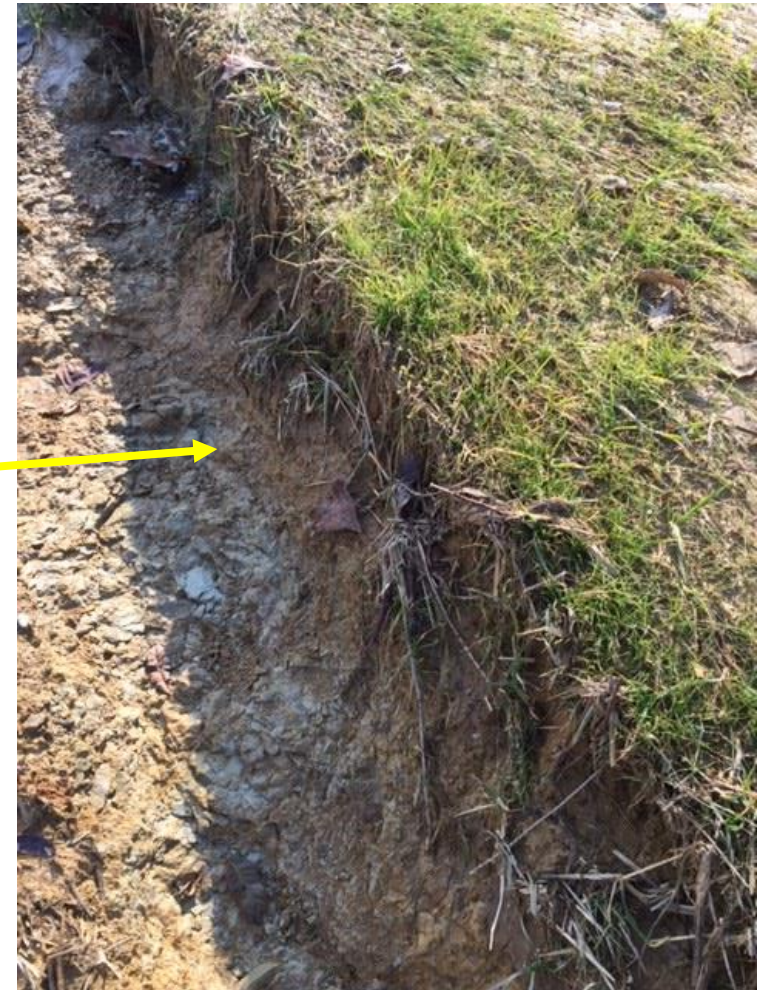
The Consequences of Underestimating Flow Depth

But wait, there's more. Apparently we should've used more ShearForce10! The right sideslope (looking downstream) where no ShearForce10 was used was badly scoured by over 8 inches. Incredibly, the ShearForce10 prevented erosion of soils and vegetation directly under it. Never seen anything like this before!

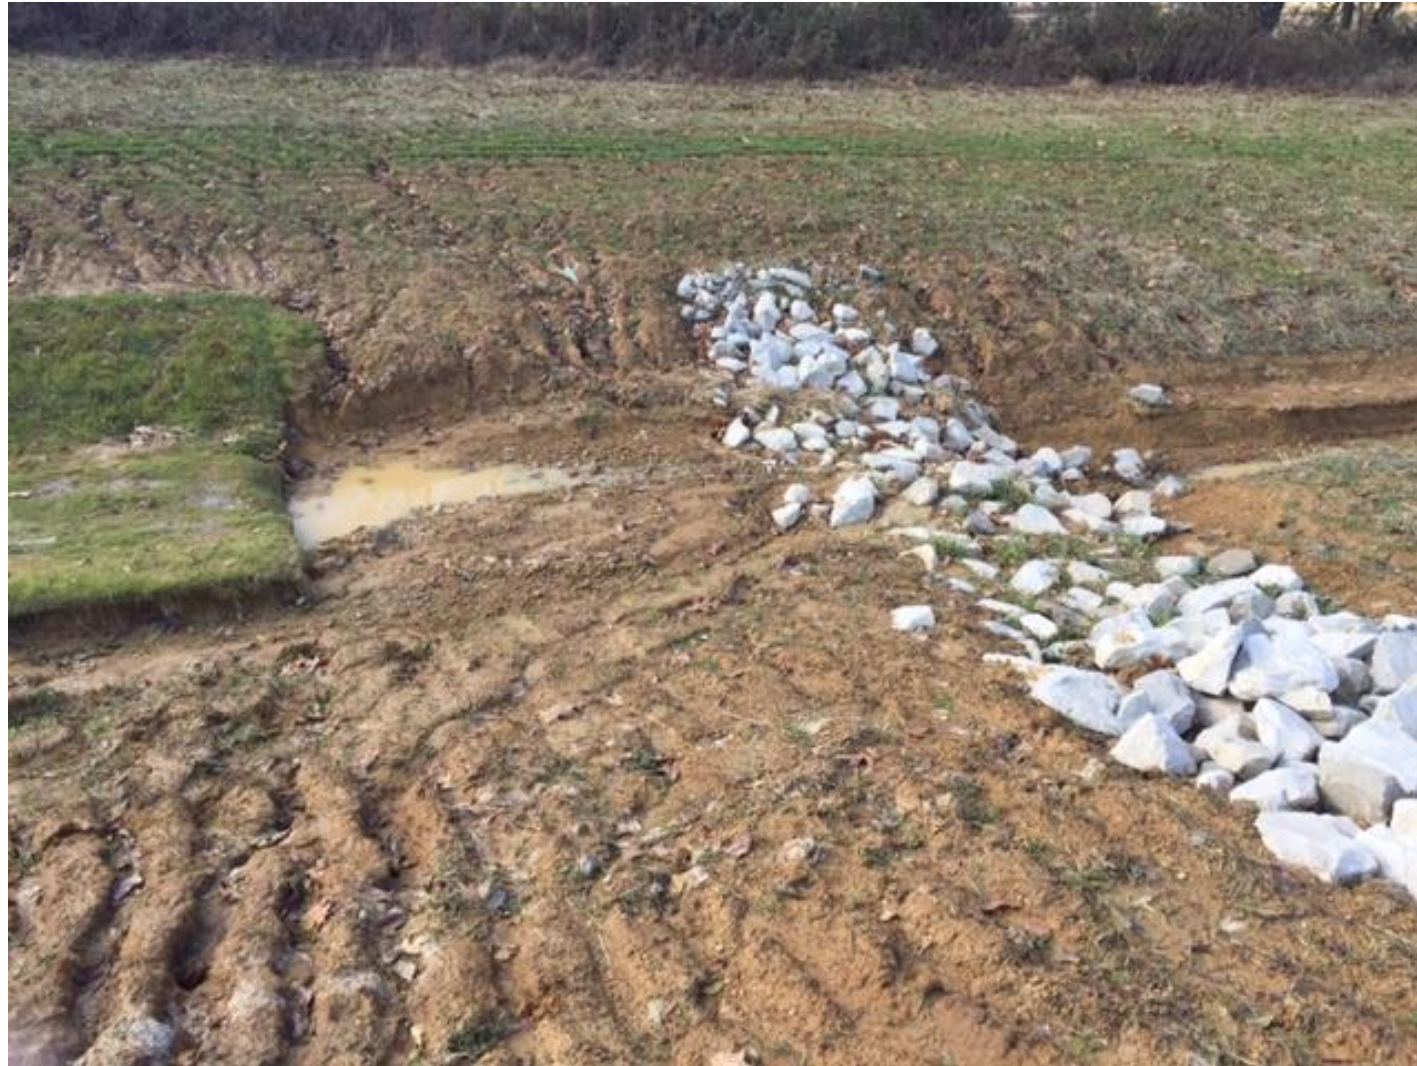
Scour of Unprotected Downstream “Control” Section

The unprotected area downstream from the ShearForce10 and rock check exhibited severe scour.
