ShearForce10 ECTRM Installed over cool season grass mix in high flow channel at the base of an overburden cap on September 10, 2019. Objective: Evaluate potential as rock riprap replacement in high flow areas at the mine

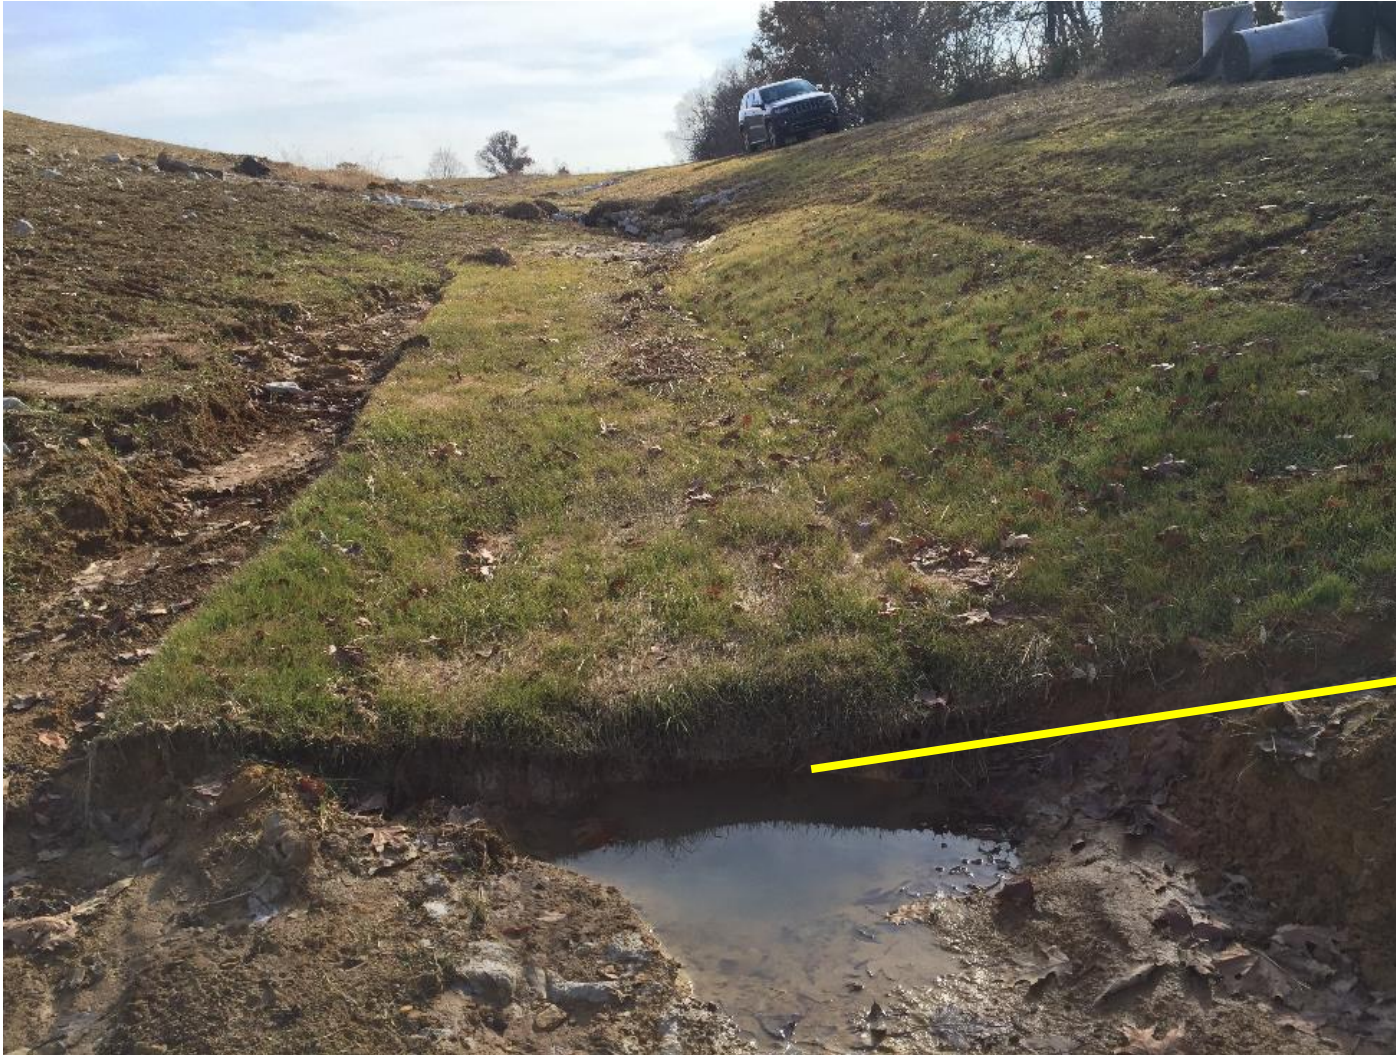
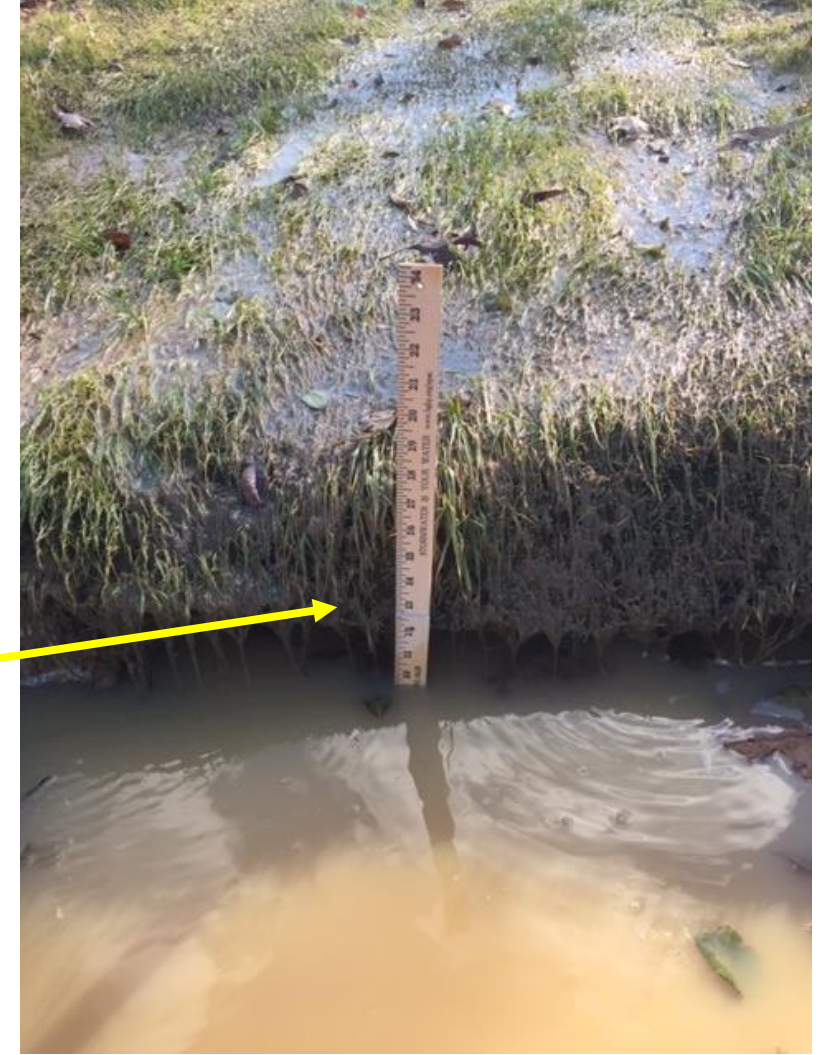
Scour of Unprotected Downstream “Control” Section

The unprotected area downstream from the ShearForce10 exhibited severe scour over 18 inches deep!

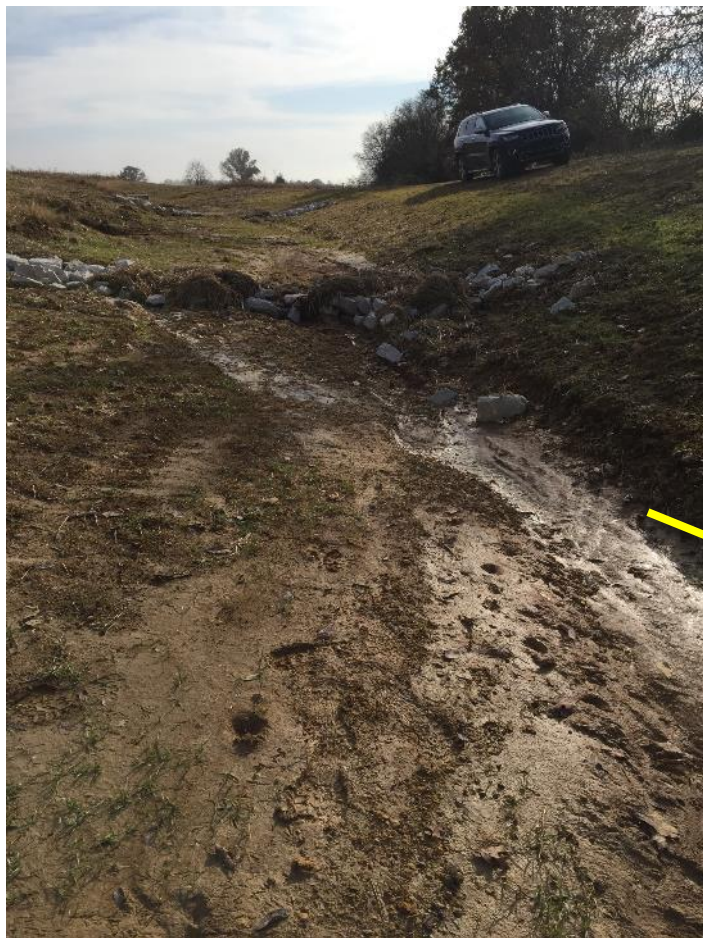
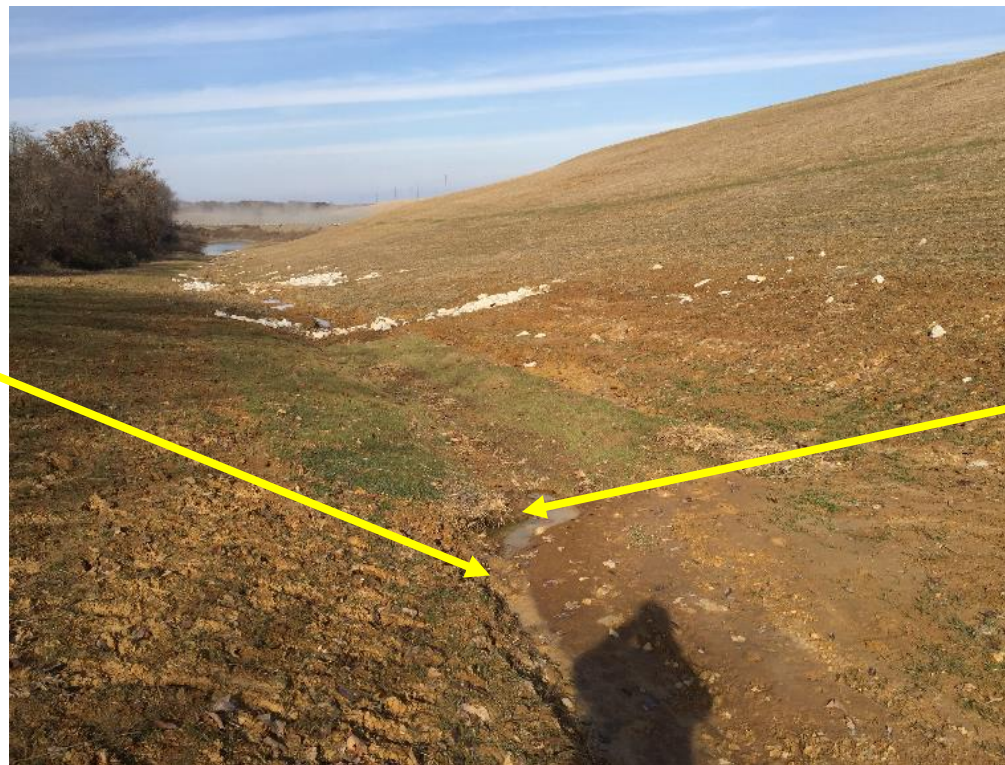
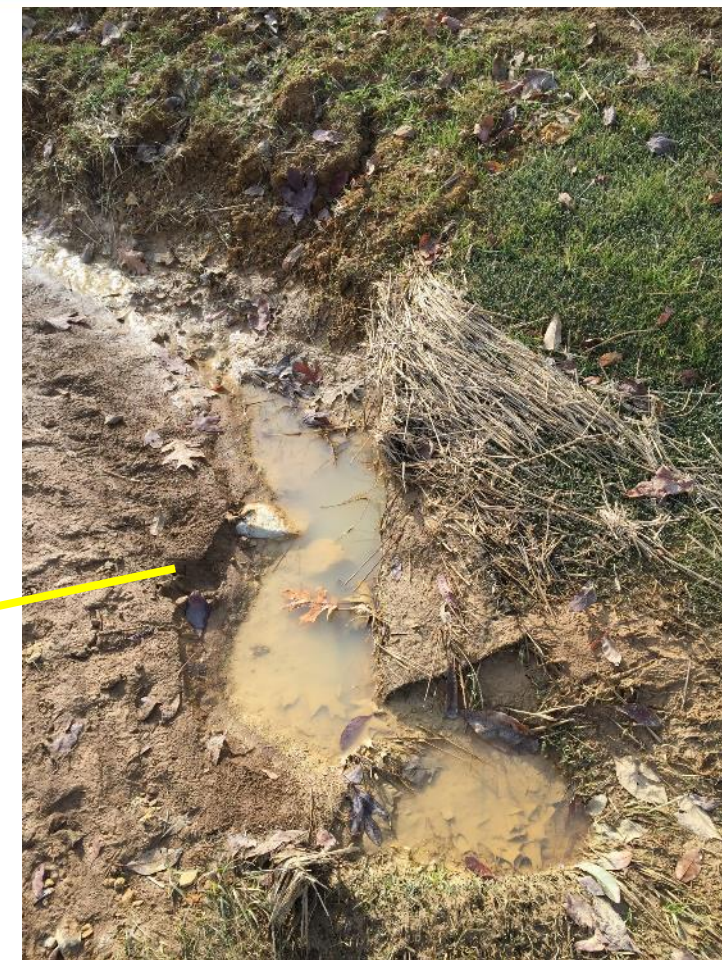
Scour of Unprotected Upstream “Control” Section

The only mat “breach” observed was at the upstream terminal end. Scour from the upstream unprotected area encroached the 6 inch trench and flipped back the edge of one mat. Remarkably the ShearForce10 prevented undermining from progressing. Note: In retrospect, we should’ve installed mat up to and under the rock check dam.

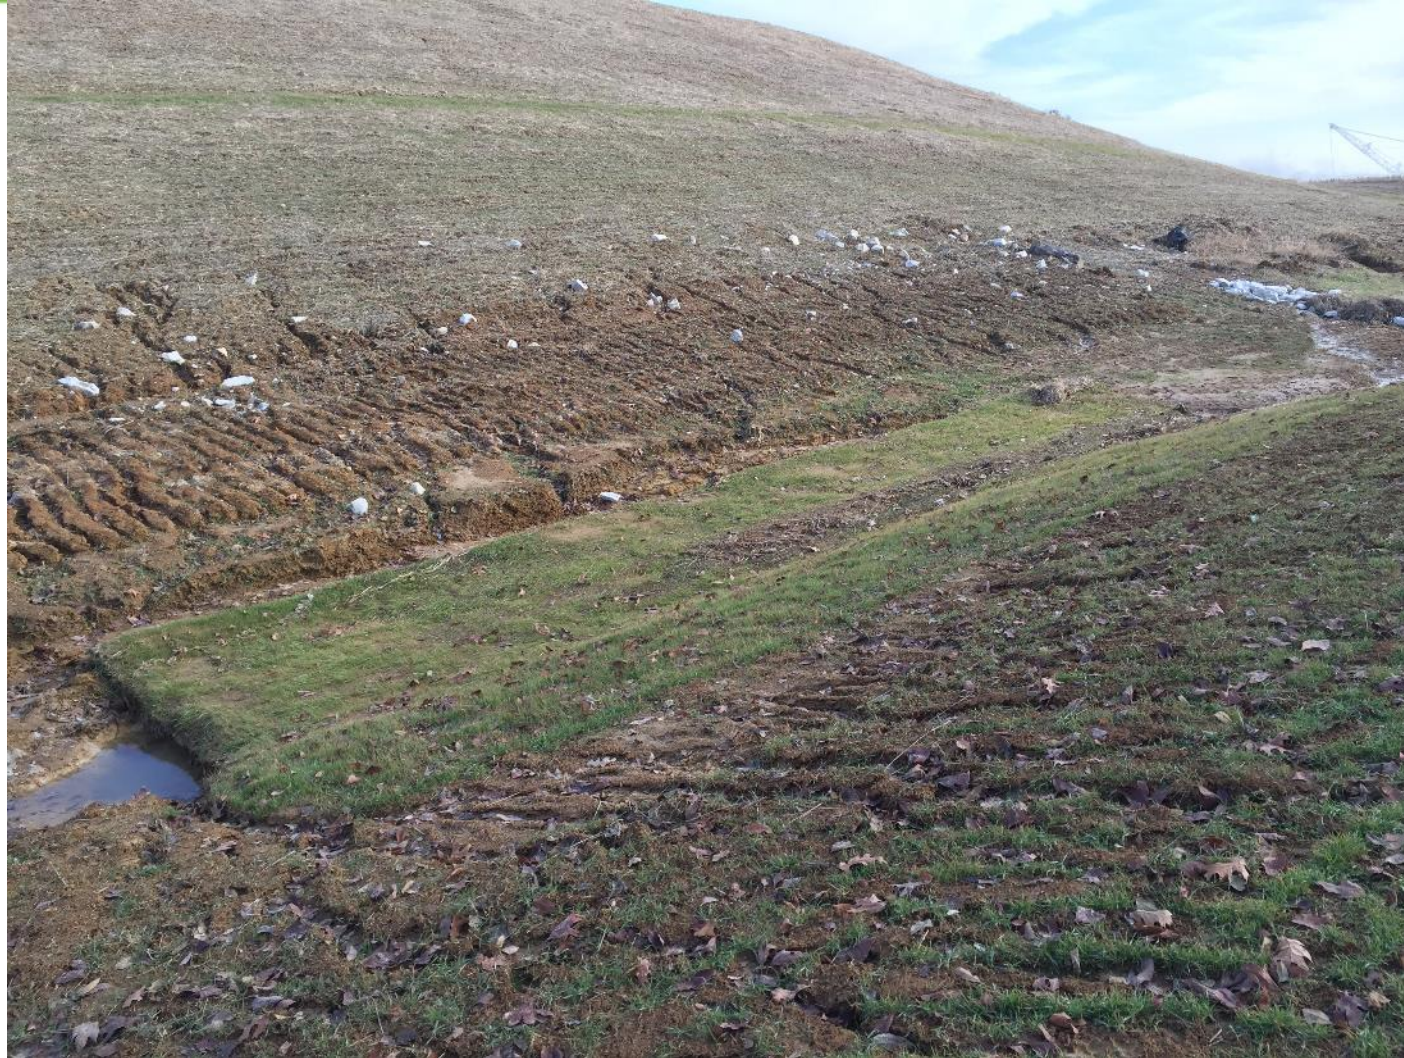
As illustrated by the severe erosion and scour of adjacent unprotected soils , the ShearForce10 performed incredibly well at locking down soils, while growing and reinforcing natural grass under extreme conditions!
