Subject
Lincoln Air Vantage: Compressor Oil in Airstream

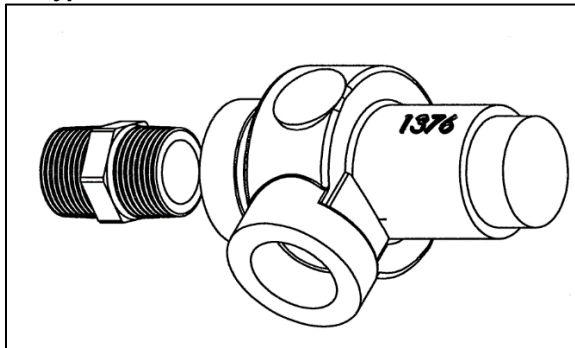
- Excessively high air flow is allowing internal system pressure to drop below 65 psi. The compressor system needs minimum of approximately 65 psi to properly coalesce (separate oil from air).
- The air tool in use may require more airflow (cfm) than the compressor system can produce.
 - Ensure the air tool is rated for 60 cfm @ 100 psi, or less.
 - Ensure that there is a Minimum Pressure Check Valve (MPCV) in place after the coalescing manifold and that it is functioning properly. Figure 1

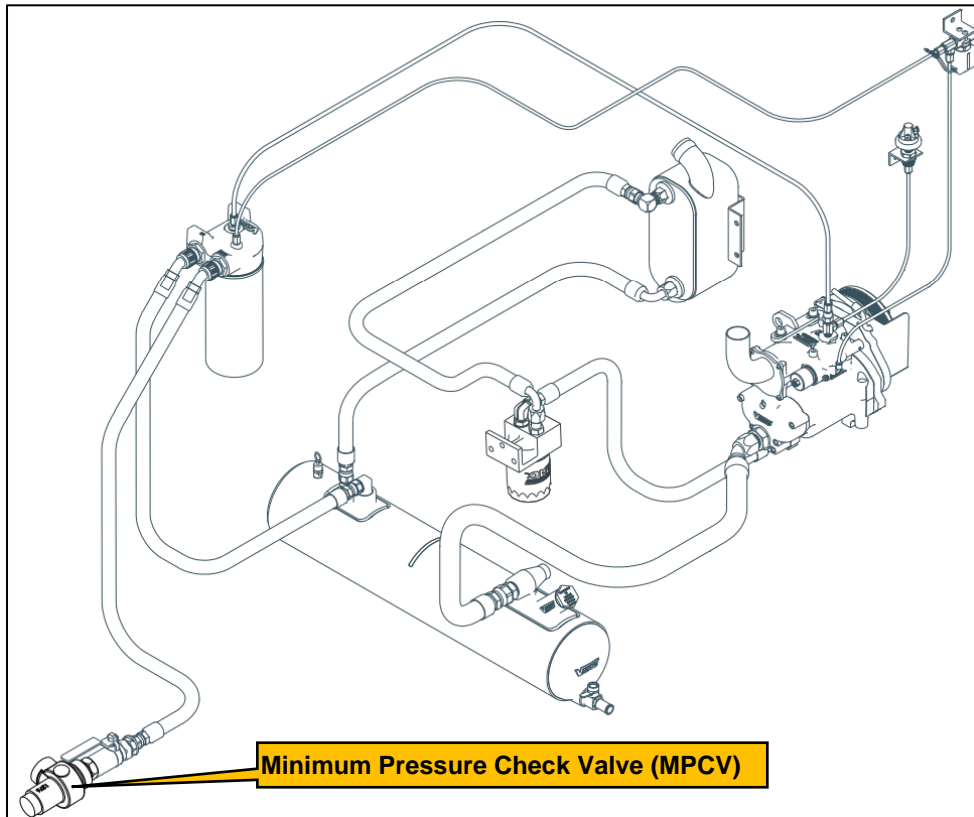
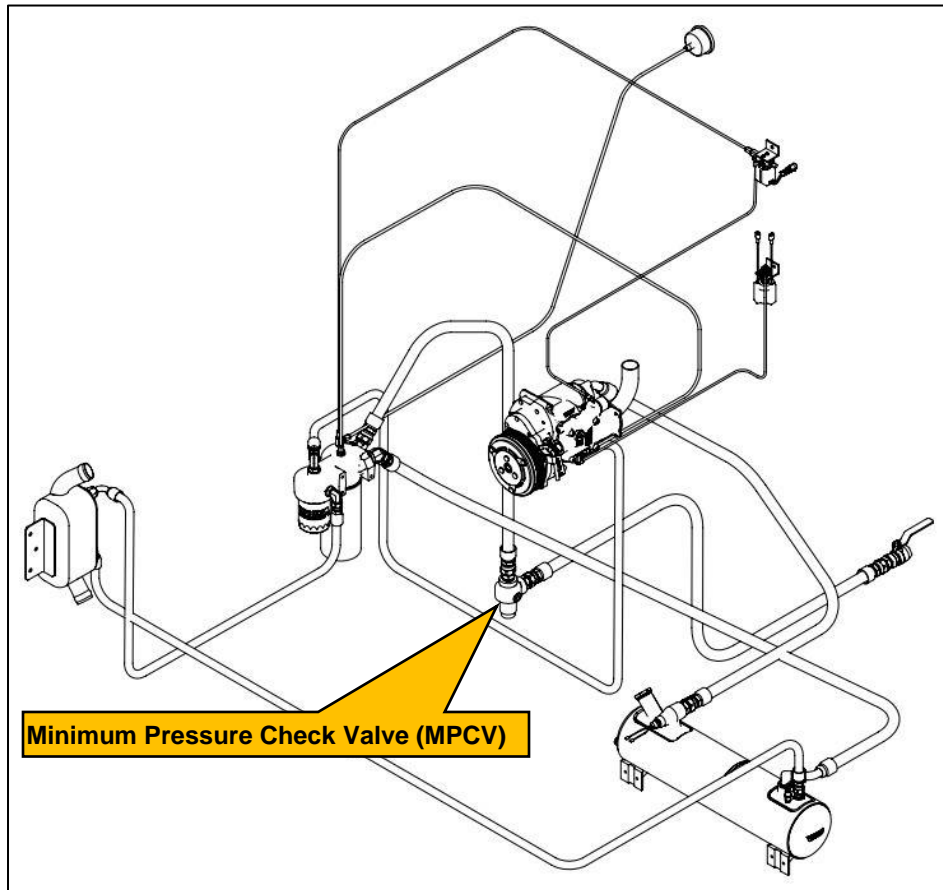
MPCV is standard equipment in some Lincoln Air Vantage models, and optional in others. See Figure 2 - Figure 3 for typical installation locations.

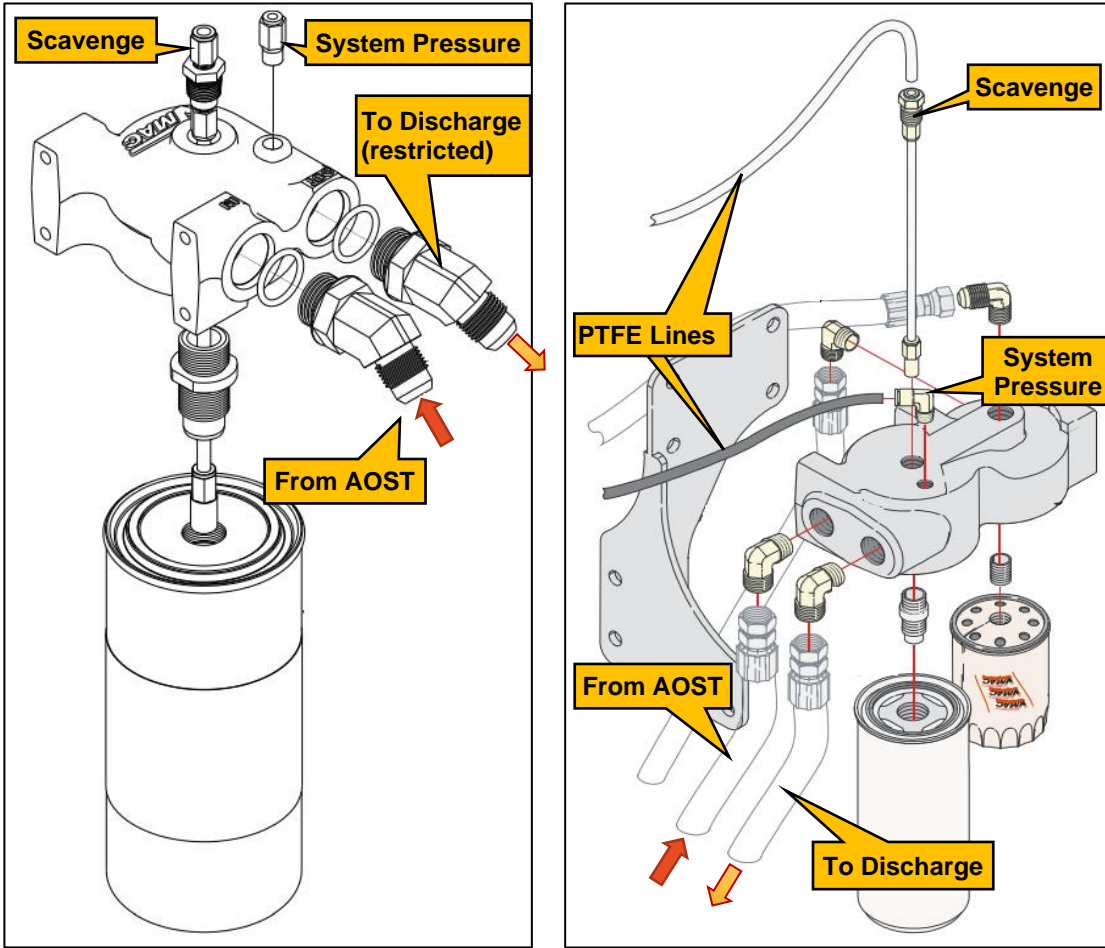
- During service/maintenance requiring removing removal of hoses from Coalescing manifold block, hoses may have been re-installed in reverse causing flow through the coalescing filter in the opposite direction to design.
 - Ensure that hoses are installed as per the Owner's Manual for your specific VMAC system.
See Figure 4 below for a *typical installation*
To find and refer to the owner's manual for your specific system go to <https://www.vmacair.com/support/manuals/> under Lincoln Air Vantage Manuals.
