Airworthiness Directive

Docket No. 92-CE-63-AD; Amendment 39-9251; **AD 95-12-01**

Airworthiness Directives; Piper Aircraft Corporation PA-25 Series Airplanes

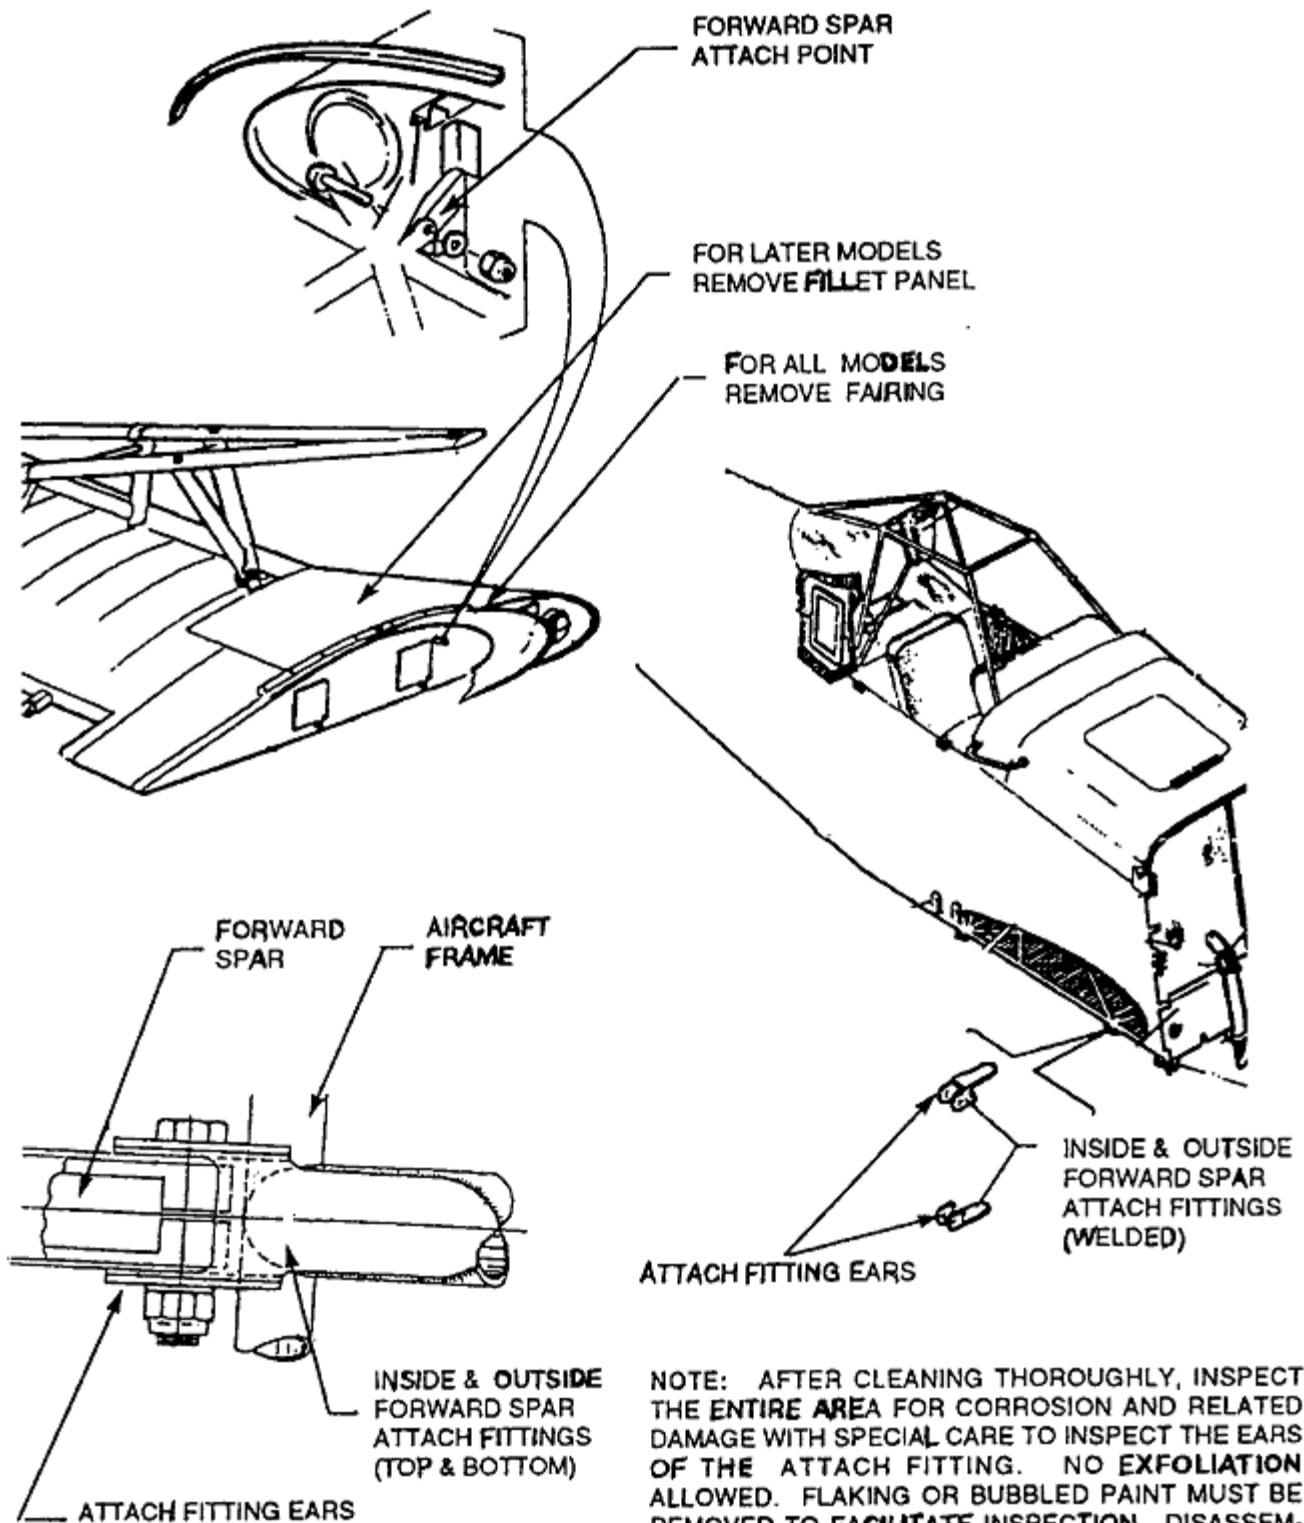
FIGURE 1
AD 95-12-01

PA-25
Side View of the Front Wing
Fitting and Landing Gear Fittings

(a) Gain access to the left and right wing forward spar fuselage attach fittings by removing the screws retaining the wing fairing. Dismantle the wing fillet by removing the screws on the aft edge top and bottom and removing the wing fairing (see FIGURE 1 of the Appendix to this AD).

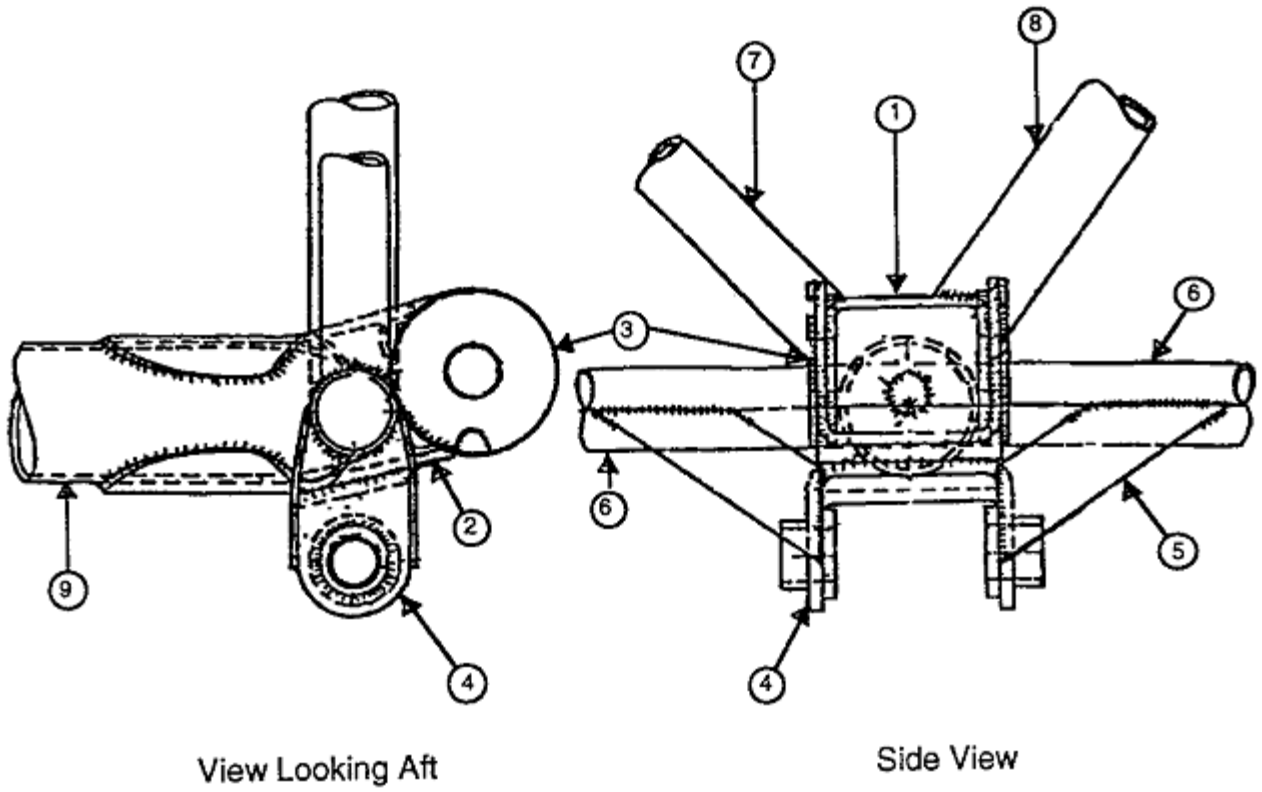
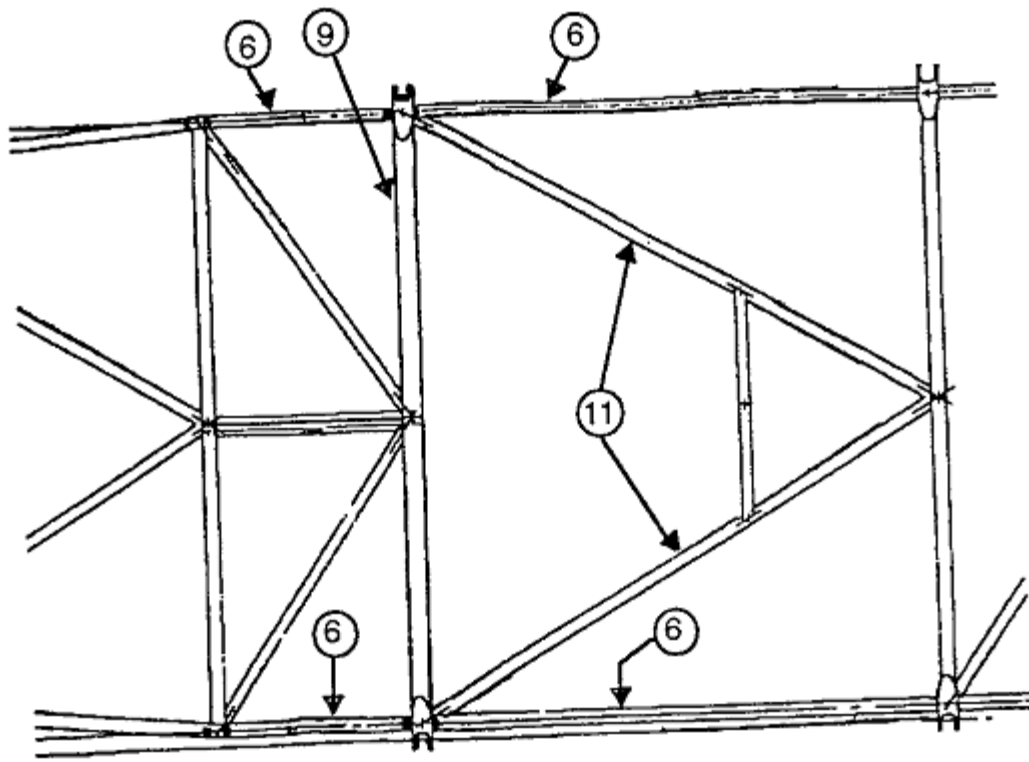
Bottom View (View A-A)
 (Both Sides)
 Figure 3a
 AD 95-12-01

1. Add couplant to the outside inspection surface (Refer to Figures 3a, 4a and 5a, as applicable). Add the appropriate gain to obtain the backwall echo from the inspection surface. If the gain setting is adjusted, re-check the thickness values on the steel shims. To assure proper coupling to the test sample, twist the probe clockwise and counter-clockwise (with a 45-degree twist) and maintain contact with the test surface. During the articulation of the probe, observe the A-trace on the screen and stop the probe twist at the point of adequate back surface signal amplitude to trigger the thickness gate on the first half-cycle. Measure and record the thickness.

2. Add couplant to the inside inspection surface (Refer to Figures 3a, 4a and 5a, as applicable). Add the appropriate gain to obtain the backwall echo from the inspection surface. To assure proper coupling to the test sample, twist the probe (clockwise and counter-clockwise with a 45-degree twist). During the articulation of the probe, observe the A-trace on the screen and stop the probe twist at the point of adequate back surface signal amplitude to trigger the thickness gate on the first half-cycle. Measure and record the thickness. Repeat the above process at eight equally-spaced locations around the surface.

3. If a thickness reading in any one of the eight locations from paragraph 1. of the **INSPECTION PROCEDURES** section (outside section surface) is .085-inch or less for the PA-25 Model or .055-inch or less for the PA-25-235 and PA-25-260 Models, or if a thickness reading in any one of the eight locations from paragraph 2. of the **INSPECTION PROCEDURES** section (inside section surface) is .055-inch or less for the PA-25 Model or .085-inch or less for the PA-25-235 and PA-25-260 Models, prior to further flight, replace the forward spar fuselage tubular attach cluster with serviceable parts in accordance with FAA AC No. 43.13-1A, Acceptable Methods, Techniques, Practices - Aircraft Inspection and Repair. This procedure requires the following:

b. Cut the tubular members as referenced and specified in Figure 2 and either Figures 3a and 3b; Figures 4a and 4b; or Figures 5a and 5b, as applicable.

c. Fabricate a cluster using all applicable part numbers referenced in Figures 3b, 4b, or 5b, as applicable; and
