## Airworthiness Directive

Docket No. 80-ASW-42; Amendment 39-3934; **AD 80-21-08**

Airworthiness Directives; Piper Model PA-25 Series Airplanes

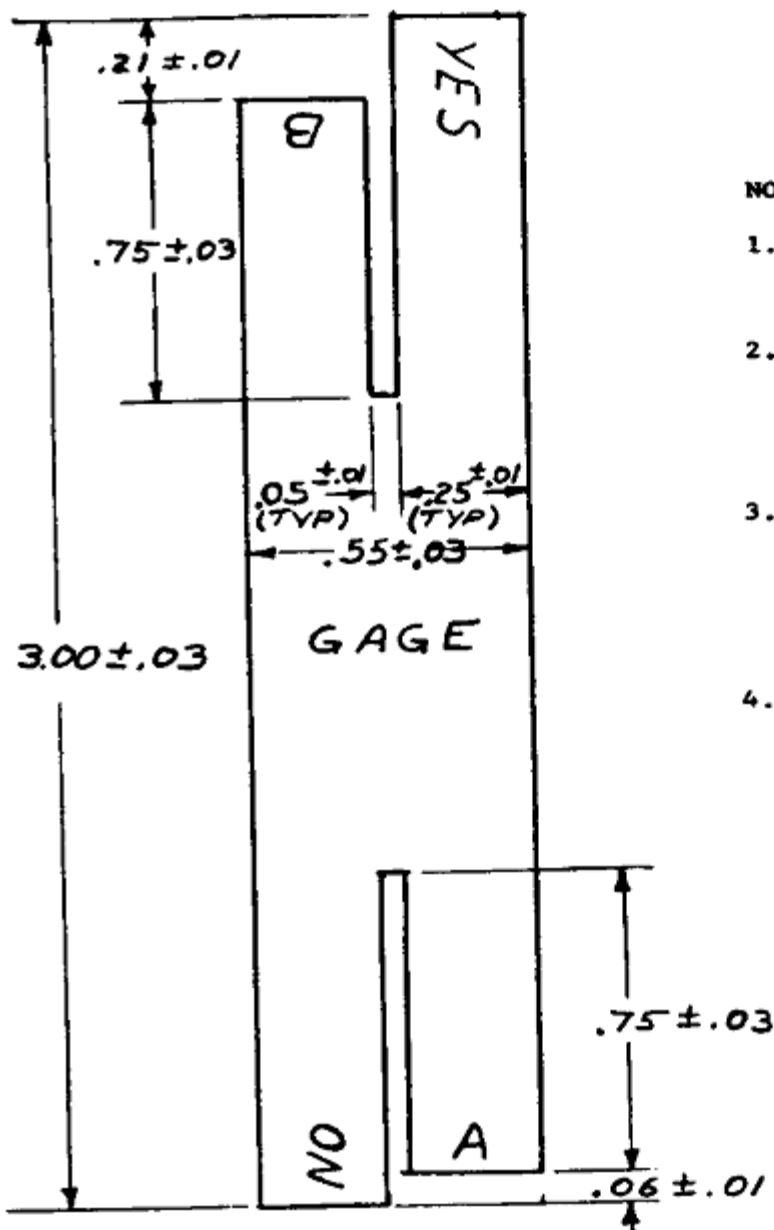
FIGURE NO. 1 GAGE (.06" ALUM. OR STL.)

(1) The center unit of each fastener hole must be between .18 and .34 inches from the free end of the bulbed spar flange.

(2) A gage fabricated as shown in figure number 1 may be used to check for misdrilled holes.

1. Check rivets with both "A" and "B" ends of gage.
2. The "A" finger must touch the spar flange before the "no" finger touches the rivet head.
3. The "yes" finger must touch the rivet head before the "B" finger touches the spar flange.
4. See Figures 2 and 3 for acceptable and unacceptable fastener installations.

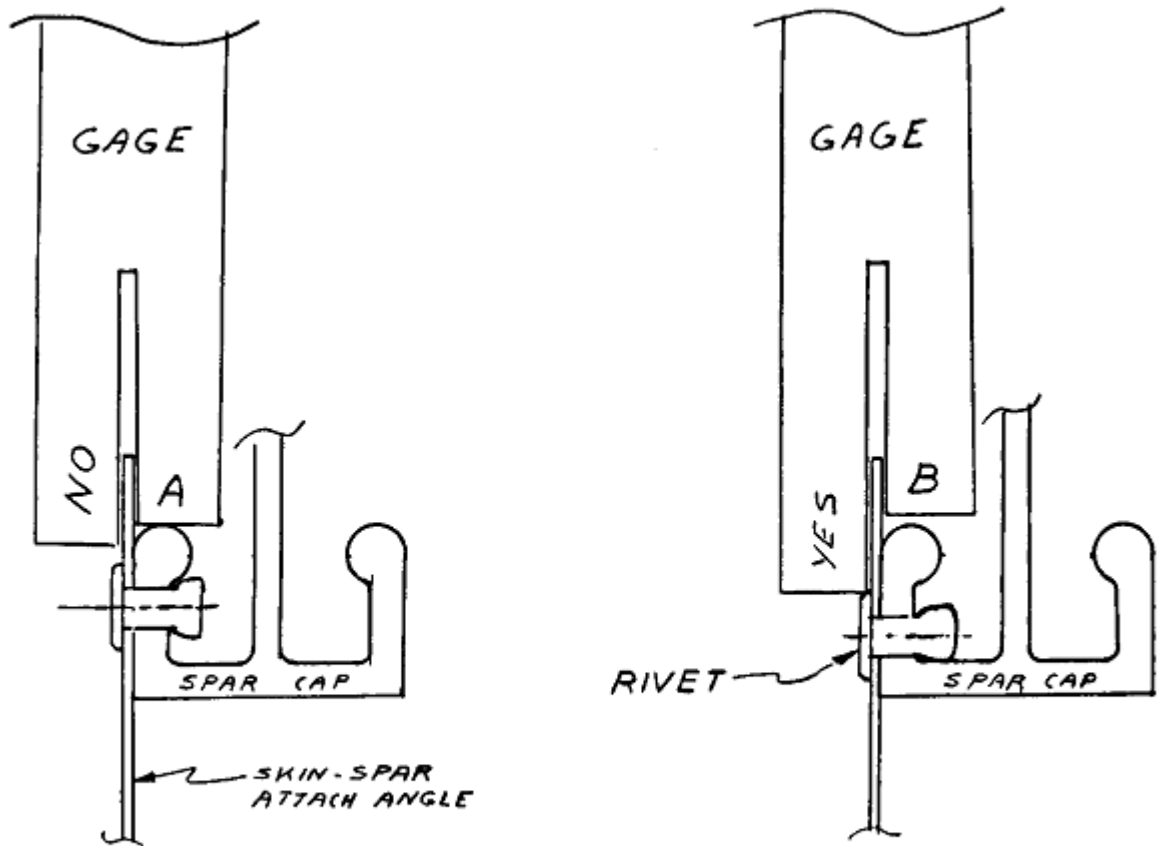
FIGURE NO.2 ACCEPTABLE FASTENER INSTL.

(3) Figures 2 and 3 show how the gage is used.

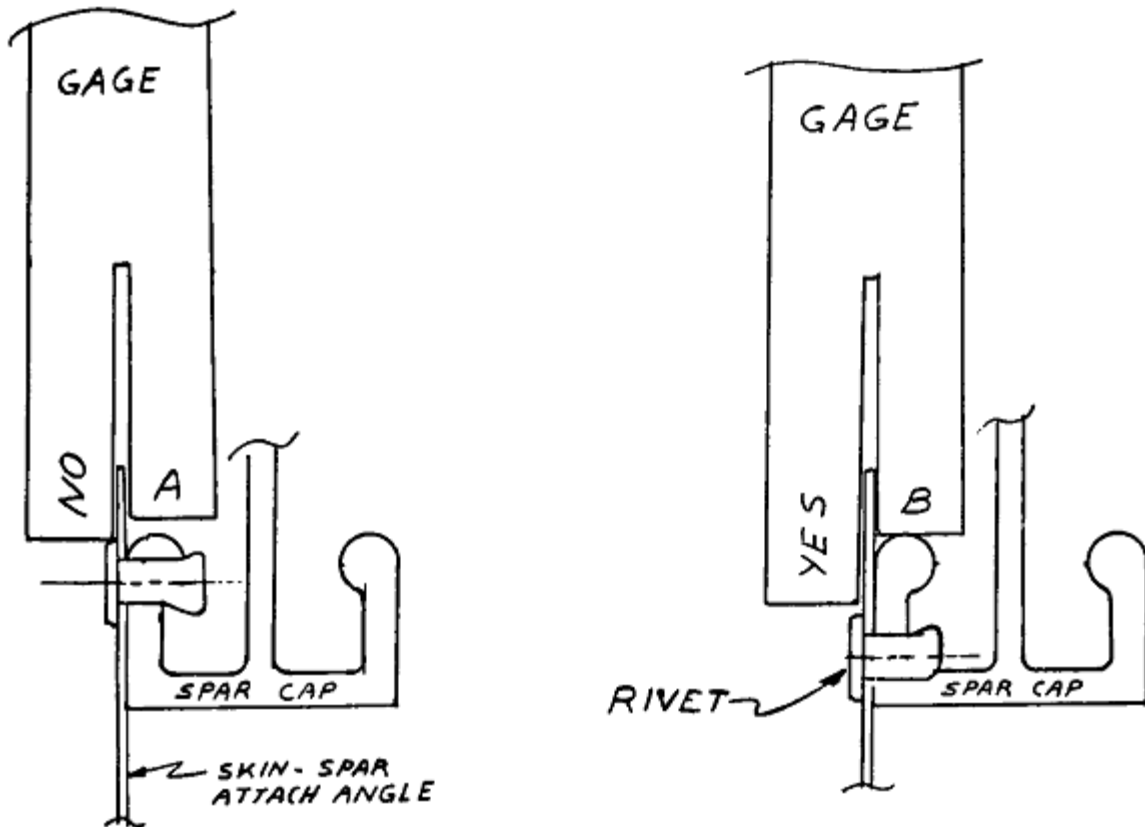
FIGURE NO.3 UNACCEPTABLE FASTENER  
INSTL.

(c) Visually inspect the upright, bulbed flange on the aft side of the front and rear spars (upper and lower) of both wings for misdrilled holes common to the bulbed spar flange and skin attach angles. Conduct this inspection in the areas uncovered by (a) and (b).

(e) If misdrilled holes or cracks are found in (c) or (d), parts must be replaced with serviceable parts of the same part number. Replace blind fasteners common to the spar cap and skin angles (if removal is necessary) with MS20600M4 rivets.
