Airworthiness Directive

AD 50-25-01

Airworthiness Directives; STINSON Model All Model 108 Series Aircraft
PDF Copy (If Available):

50-25-01 STINSON: Applies to All Model 108 Series Aircraft.

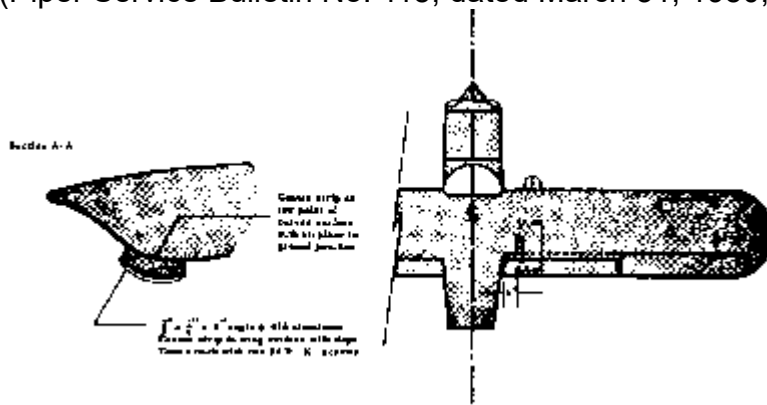
Reports have been received of fuel seepage into the space between the inner cabin trim and the outer fabric covering of the fuselage. This results in soaking of insulating material in the cabin wall. The source of the fuel can be spillage during filling of tanks, thermal expansion of fuel in full tanks, or tank leakage. This fuel runs to the under surface of the wing, adhering to the lower curved surface of the trailing edge of the wing at the flap well, thence inboard to the fuselage and across the rear window. Since the window seal is often not perfectly tight the fuel may then enter the cabin wall.

To preclude the fire hazard of fuel soaked insulation within the cabin wall due to these causes, a drip strip similar to that shown in Figure 1 should be installed on the underside of each wing. This drip strip will prevent fuel from flowing from the wing to the

fuselage.
