ALON

**SERVICE BULLETIN**

NO. SB-7

Model: A2**Serials:** A-2 through A-84**Subject:** Eliminate possible cracking of skin around Camloc fasteners and reinforcement on engine cowling door.

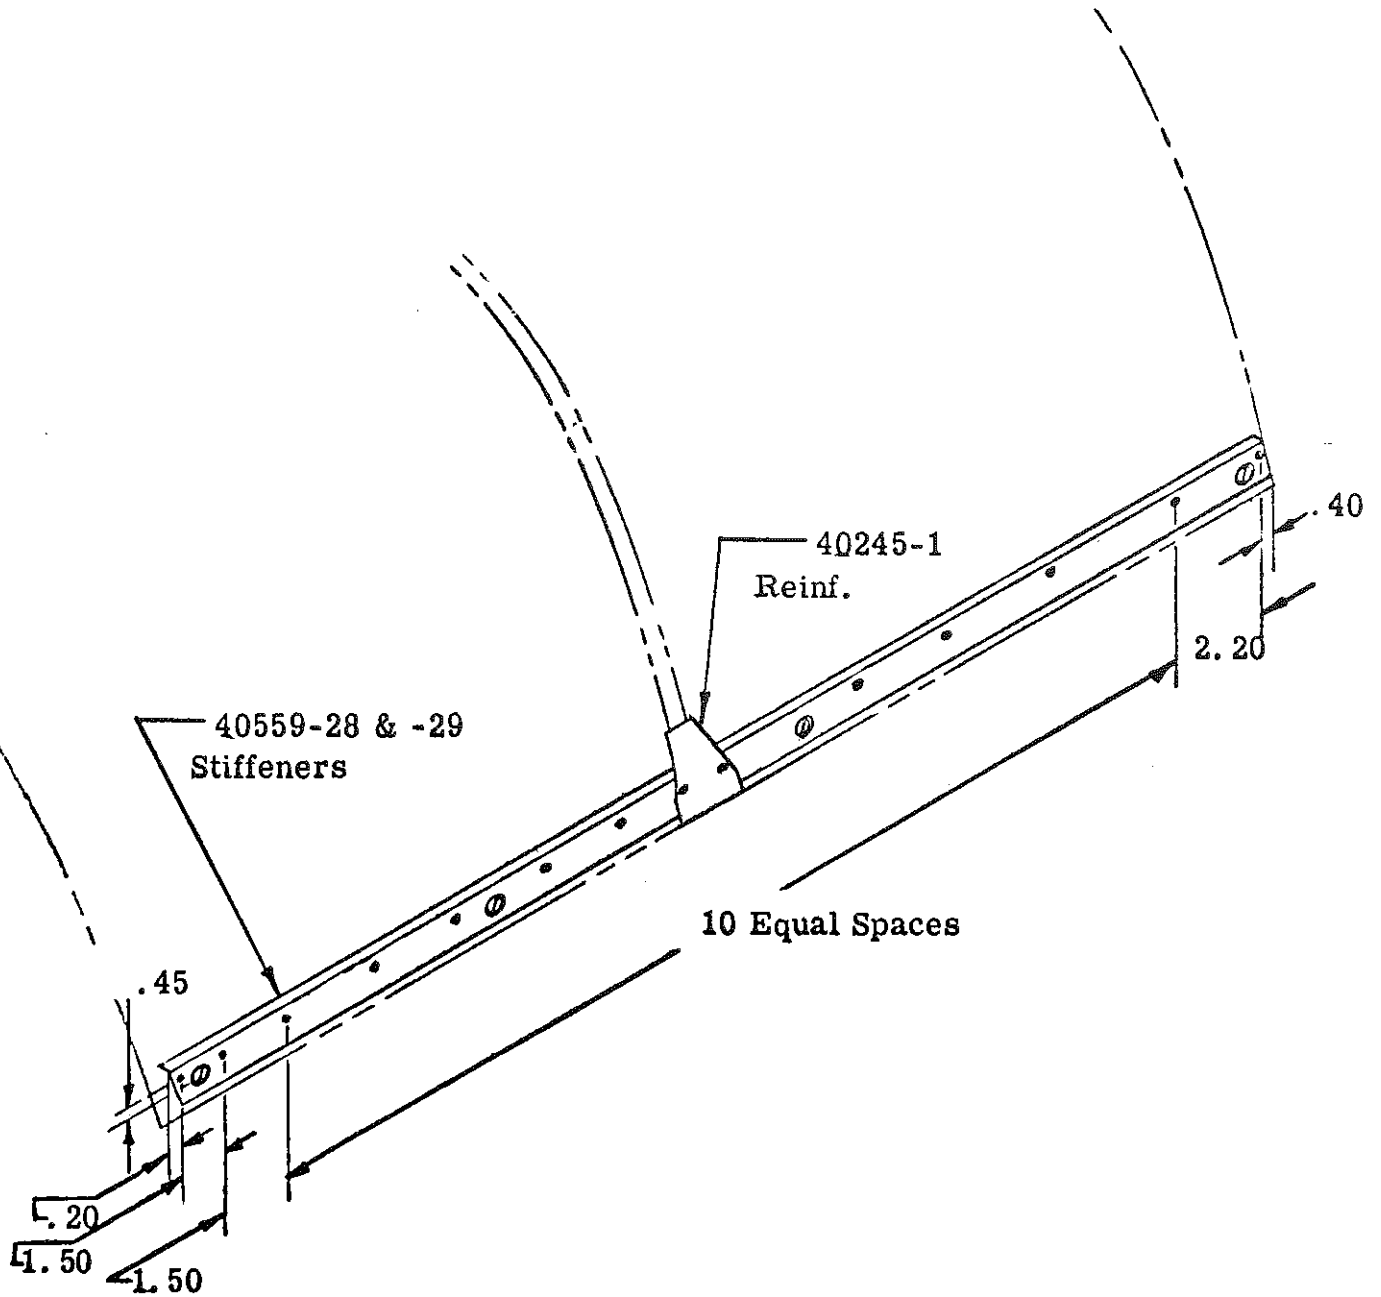
Figure 1

To preclude the possibility of skin cracking around the Camloc fasteners and reinforcement on the engine cowling doors, Alon recommends the following stiffener and reinforcement be added on each door:

1. Remove the four (4) Camloc fasteners on each door.
2. Drill out the two (2) rivets which secure the 40245 reinforcement to each door, and remove the reinforcement.
3. Install the 40245-1 reinforcement in same location and secure with two (2) MS20470AD3-4 rivets.
4. Install 40559-28 stiffener on the LH door, and 40559-29 stiffener on the RH door, aligning Camloc fastener holes in each stiffener with the holes in the door.
5. Per figure 1, drill fourteen (14) No. 40 (.098) holes through door and stiffener and secure each stiffener with MS20470AD3-4 rivets.
6. Reinstall the four (4) Camloc fasteners on each door.
7. Trim stiffeners, as required, to achieve a flush fit. Note: Do not crimp 40559-28 and -29 over the 40245-1 reinforcements.
