ERCOUPE
SERVICE
BULLETIN

No. **29**
Revision C

SUBJECT: Mandatory Outer Wing
Panel Inspection

SERVICE BULLETIN NO. 29, REVISION C
OUTER WING PANEL INSPECTION

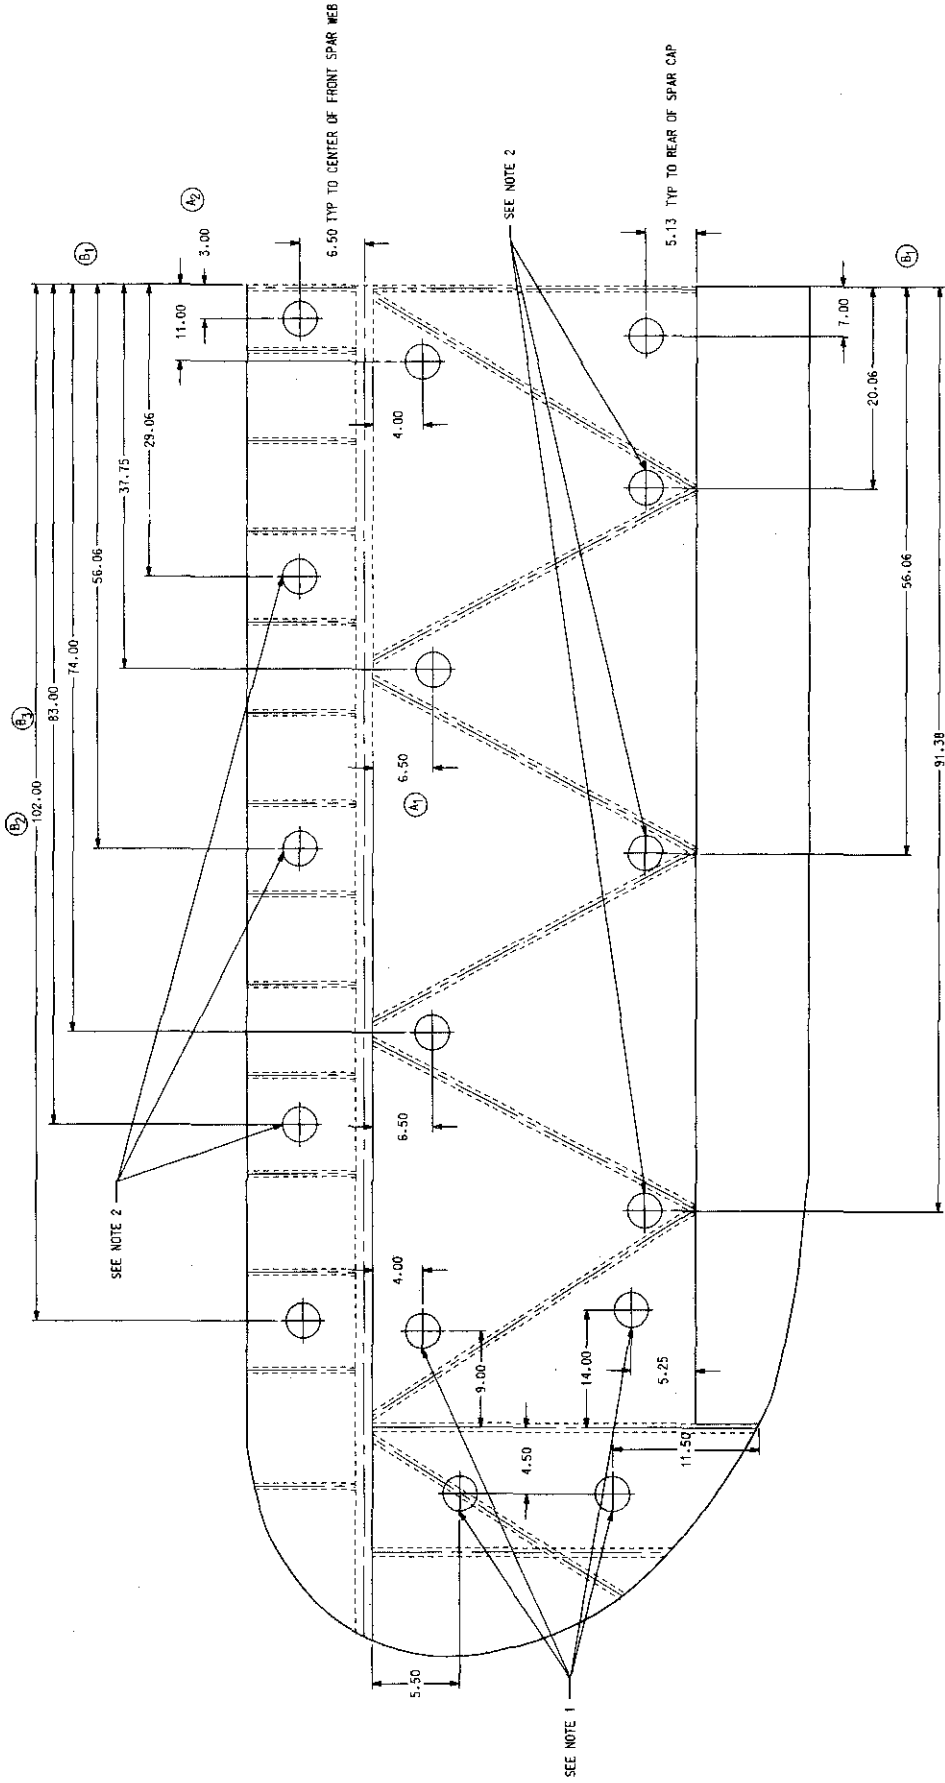
BOTTOM VIEW

Locate inspection openings on the lower wing surface per the enclosed diagram, SB-29, Rev. B. Aircraft with factory covered metal skinned wings may already have existing inspection openings. SB-29, Rev. B, includes these openings.

CAUTION: If the opening locations specified by the diagram interfere with any skin stiffeners on metal skinned wings, alter the opening location to clear the stiffener.

Metal skinned wings - Cut 3.50 inch diameter inspection openings at the locations of No. 2 above and deburr.

Fabric covered wings - Remove finish to bare fabric at the locations of No. 2 above. Attach reinforcing ring (P/N 483-15) with Rand-O-Bond, Super Seam or cement approved for use with covering process STC. If the wing is covered with synthetic fabric, it is recommended that a cover patch be applied over the inspection ring to prevent the ring peeling away from the fabric surface. Apply finish as required to touch-up area surrounding reinforcing ring. Carefully cut out center opening of ring.

After inspection is complete, install cover plates (P/N 483-10) in each opening. On metal skinned wings, secure each cover plate at the leading edge with one 4 X 3/8 TRA sheet metal screw.
