ERCOUPE SERVICE BULLETIN NO. 35

AILERON PUSHROD AND INBOARD AILERON INSPECTION

SUBJECT: Inspection of Aileron Pushrod Tube, Ercoupe p/n F52034 and 914078-001, for Evidence of Internal Corrosion.

MODELS AFFECTED: All Ercoupe 415-C, 415-CD, 415-D, 415-E and 415-G
All Forney F-1, F-1A (p/n F52034)
All Alon A-2, A-2A aircraft (p/n A52436-1)
All Mooney M-10 aircraft (p/n 914078-001)

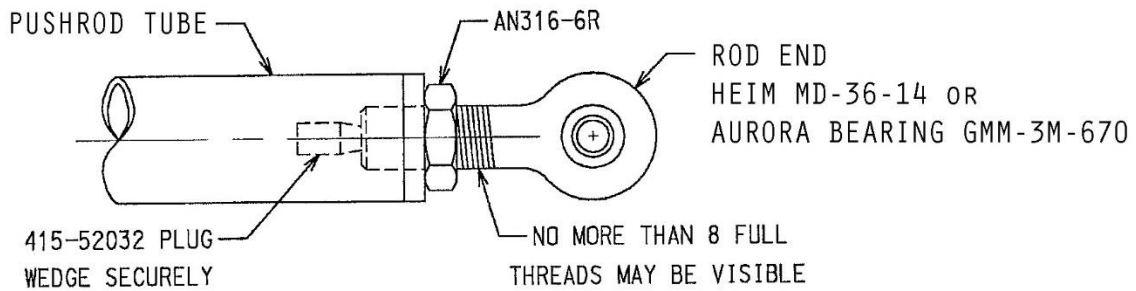
FIGURE 1

There have been several field reports of internal corrosion found on Ercoupe aileron pushrod tubes, p/n F52034, p/n A52436-1, and 914078-001. This is the short pushrod from the bellcrank to the aileron. This internal corrosion was detected at the low side of the aft end of the pushrod where moisture may collect. Typically, the extent of this corrosion has only been found by removing paint from the tube.

415-52032
FABRICATE FROM DOWEL

6. Inspect for any signs of internal corrosion and rust, paying particular attention to the lower side of the aft end of the tube. Tap pushrod on its end on a bench and look for any rust particles exiting open end of tube.
7. If any corrosion or rust is found, replace the aileron pushrod tube with a new or used serviceable unit.
8. Prime and paint pushrod tube per paint manufacturer's directions. Internally oil tube with Val-Oil, or any alternate preservative conforming to Federal Specification TT-S-176D or MIL-C-16173E Grade IV.
9. Service rod-end bearings per Ercoupe Memorandum No. 46, Relubrication of Sealed Bearings. Insure that 415-52032 wooden plug is installed in the end of each rod-end bearing. See Figure 1 at the end of this bulletin.
10. Install rod-end bearings in pushrod tube in accordance with existing data. See Figure 1 of this Service Bulletin.
