ERCOUPE  
SERVICE  
MEMORANDUM

No. **18**

**SUBJECT: Engine Side Cowls  
Reinforcement of**

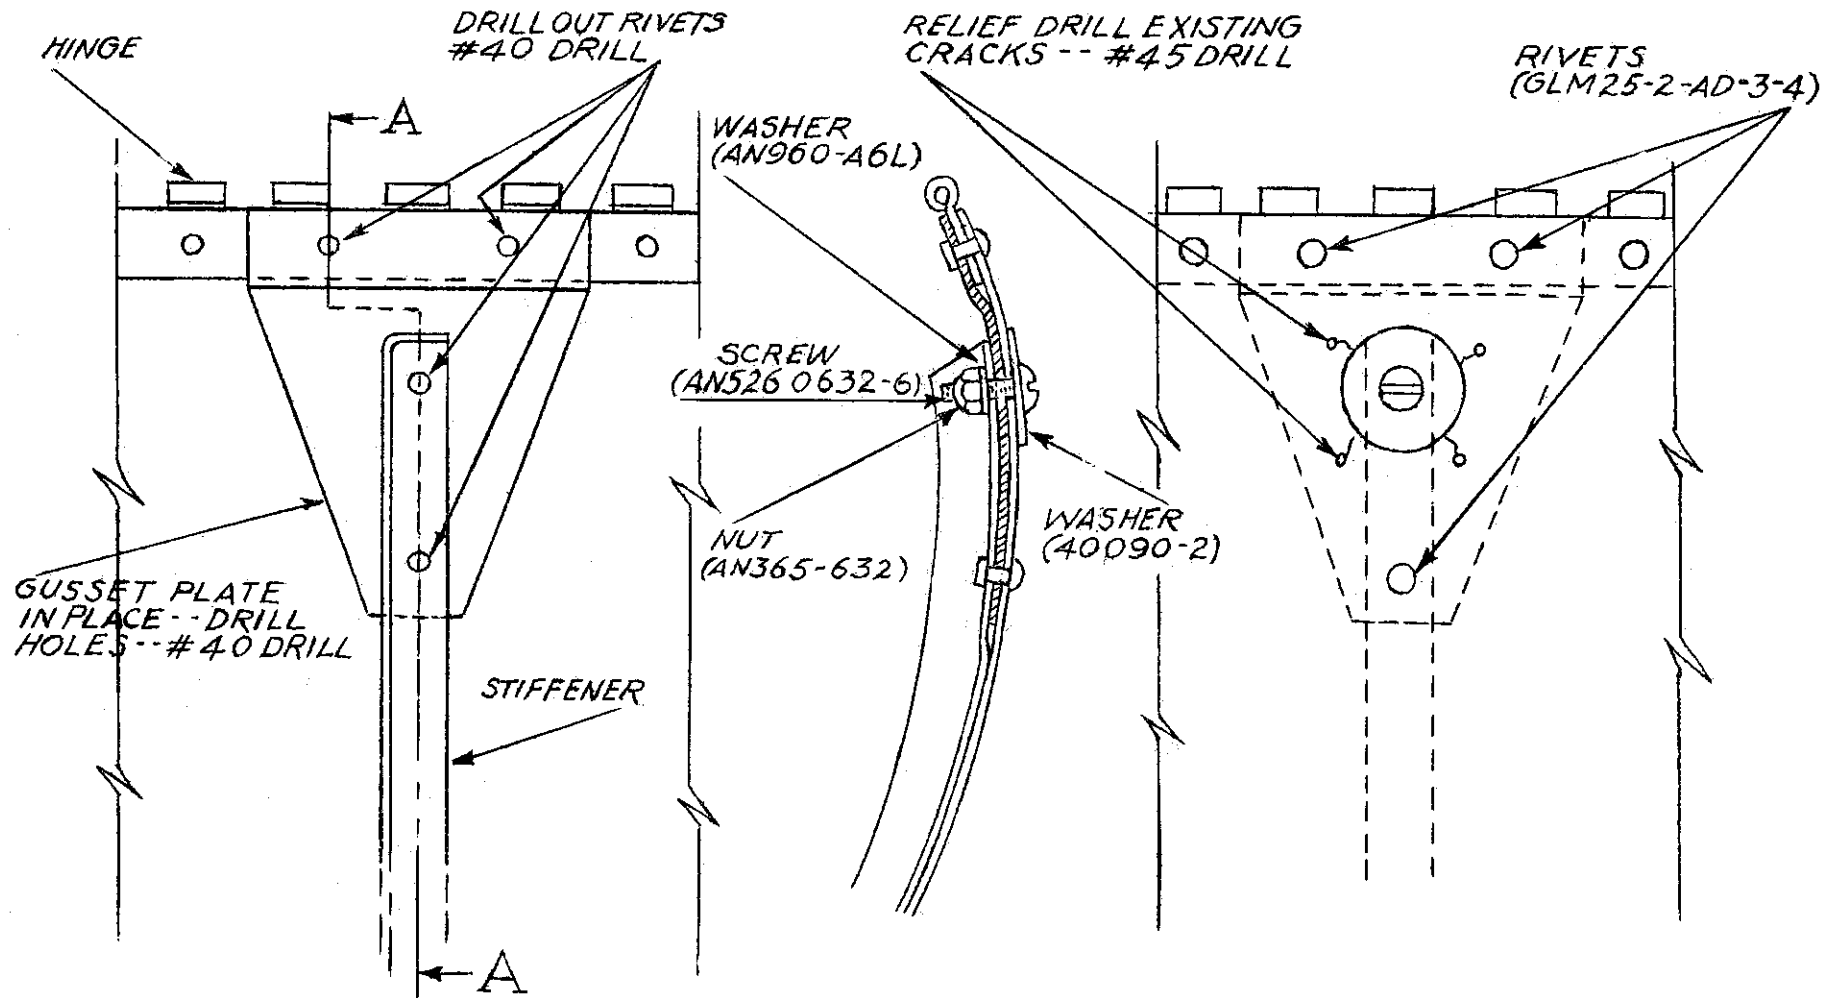
INSTALLATION OF GUSSET PLATE AND WASHER  
ON ENGINE SIDE COWL

2. The change has been found necessary to prevent cracks occurring in the region of the uppermost rivet used to attach the stiffener to the side cowl. The cracks occur, we believe, as a result of the loads imposed when the cowl is opened and left to rest in the open position. The change is being made on current production, having started on Ercoupe airplane serial number 1123.

C. Existing cracks should be relief drilled to prevent further cracking.

1. Drill holes at ends of cracks with a No. 45 drill.

D. Locate gusset plate and rivet in place.

1. Slide gusset plate under stiffener with wide end over hinge.
2. Drill holes in plate at points where rivets were removed from hinge and stiffener. Use No. 40 drill.
3. Rivet gusset plate, on hinge (two rivets) and at second hole from top of stiffener (1 rivet).
4. Install large washer, bolt, small washer and self-locking nut, over first hole in top of stiffener. Large washer on outside of cowl. Draw nut tight to assure lock.
5. Shape large washer to fit flush against surface of cowl flap.
