ERCOUPE
SERVICE
MEMORANDUM

No. **47**

**SUBJECT: Seat Back Assembly
Reinforcement of**

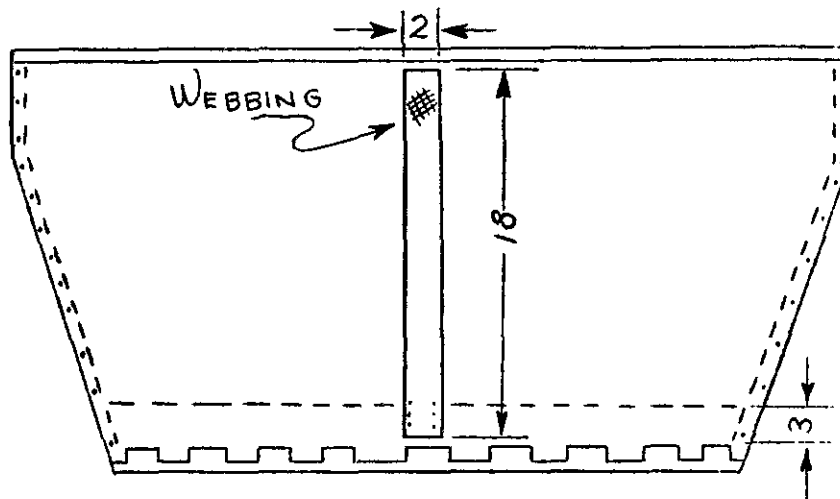
1. It has been found desirable to reinforce the Seat Back Assembly (cover) in the area of contact with the Seat Assembly Center Frame in order to provide additional service life. This improvement was effective in production starting with Ercoupe Serial No. 3623. This Memorandum, therefore, covers all Ercoupes from Serial No. 1 to 3622 inclusive. It is recommended that Seat Backs without the reinforcement be inspected at each 100 hour Inspection and that this Memorandum be followed in making repairs.

2. The procedure, outlined below, and the accompanying sketch are provided for your guidance in modifying the Seat Back:

2. Remove Cushion (matting) from Seat Back by pulling it out through top of the Seat Back.
3. Remove the aluminum Stiffener from the top of the Seat Back Rear Cover Assembly.
4. Pin Reinforcement in position shown in sketch.
5. Sew the bottom 3" of the Reinforcement through Rear and Front Cover Assemblies.
6. Sew the remaining 15" of the Reinforcement through the Rear Cover Assembly only. (All stitching should be approximately 1/8" from the edges of the Reinforcement.)
7. Assemble Seat Back and reinstall into the Airplane, lacing as tightly as is possible without bending the lacing hooks.
