1. This bulletin affects Ercoupes serial 113 to 2162 inclusive. The modification has been incorporated in Ercoupe serial 2163 and subsequent.

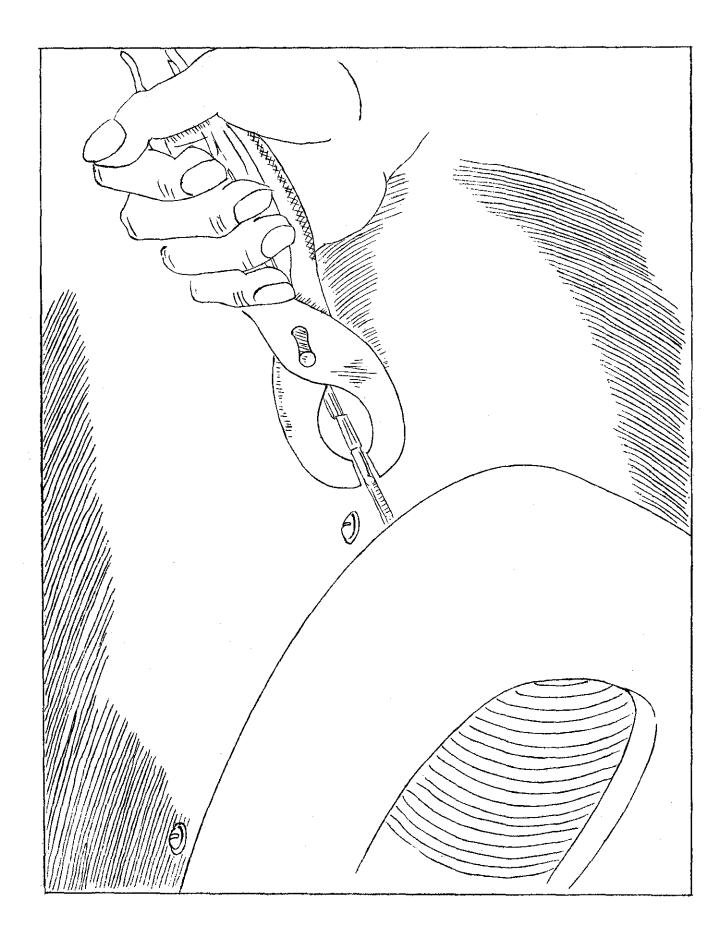
2. This change provides means of preventing the hinge pins from vibrating loose and moving forward into the propeller. Several reports on this discrepancy were instrumental in causing the change to be made.

**3.** The change consists of moving the hinge pins half-way back into the leading hinge leaf and crimping the leaf with pliers, or other suitable tool, as shown on the attached sketch.

4. The crimping of the hinge as described in the preceding paragraph will make it very difficult to

remove the pin. The pin may be removed by withdrawing it to the rear. The latter operation will be made easier by loosening the screws attaching the top cowl to the longitudinals. However, we suggest hat the top and side cowls be removed as an assembly, rather than the pin, whenever any service work is to be done to the engine. This may be done by removing the ten truss head screws which hold the top cowl to the nose cowl and the upper longitudinals.
