Ercoupe BULLETIN

**SUBJECT: Center Section Belly Skin
Reinforcement of**

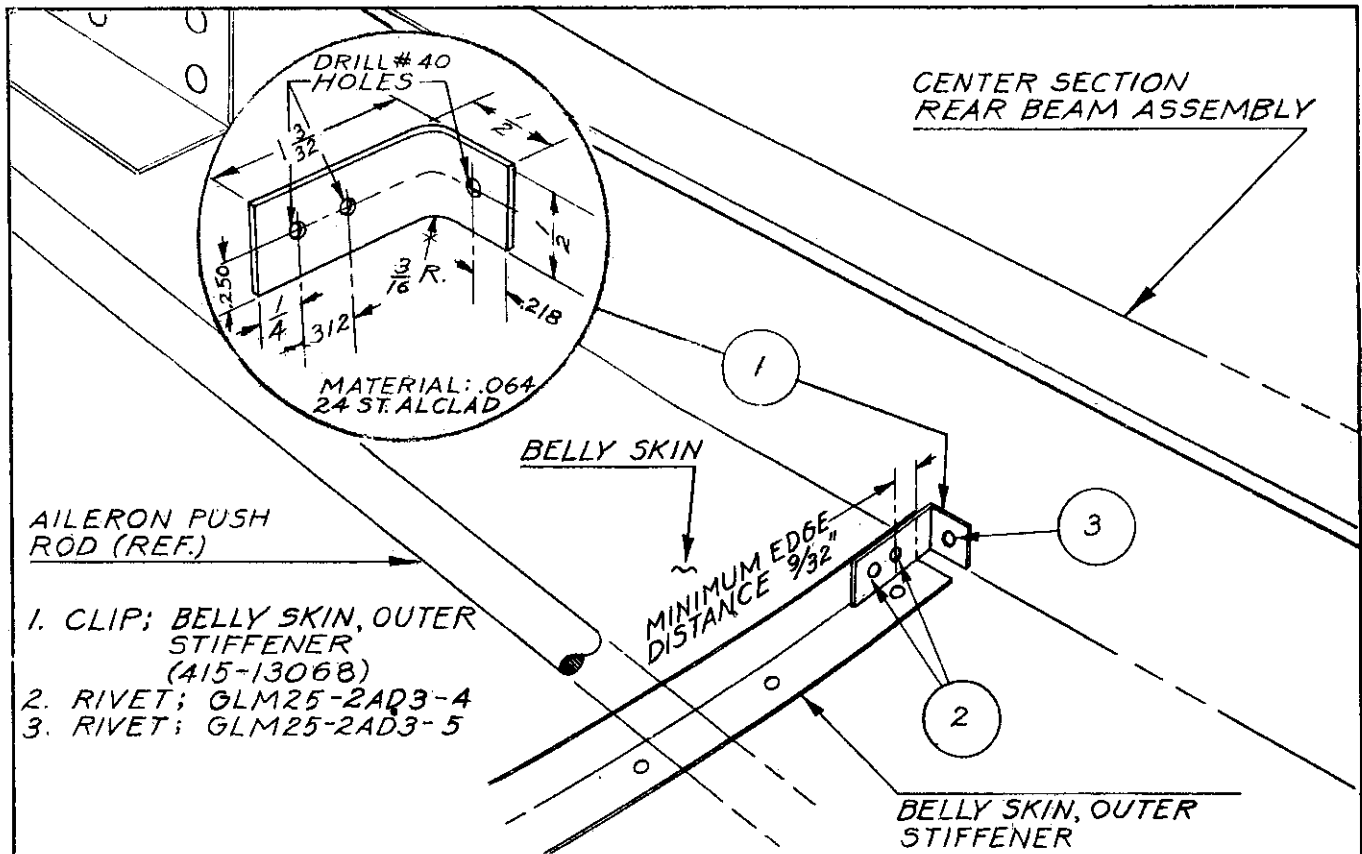
FIG. 1 INSTALLATION OF C.S. BELLY SKIN, OUTER STIFFENER, CLIP (CLIPS ARE TO BE INSTALLED ON BOTH R. & L. OUTER STIFFENER, LEFT HAND SHOWN)

1. Failures, occurring as cracks in the center section belly skin at the rearmost rivet attachment in the center section belly skin outer stiffeners, (415-13056 L/R), have been reported. At Ercoupe Serial No. 2038, the outer stiffeners were modified to include an attachment to the center section rear beam, therefore, the affected Ercoupes are Serial Nos. 113 to 2037, inclusive. It is recommended that this bulletin be complied with no later than the next 25 hour check.

1. Preliminary Operations:
 - a. Remove baggage compartment end trim (415-53114 L/R)
 - b. Remove screws along front section of Baggage Compartment (415-53121) at seat back attachment.
 - c. Fold baggage compartment to lay on cabin rear deck.
 - d. Remove Battery (415-54044-20)
 - e. Remove Battery Box Assembly (415-54035).
2. Installation of Stiffener Clips (415-13068) (Ref. Page 2, Fig. 1)
 - a. Install stiffener clips on aft end of each outer stiffener (415-13056 L/R) as follows:
 - (1) Clamp, with "C" clamp, clip on outboard side of upper stiffener flange

with clip flange facing toward outside of ship. The first rivet hole should be no less than 9/32" from the aft end of the stiffener.

- (2) Drill two No. 40 holes through stiffener, using clip as template. A 90° or 45° angle drill is recommended for drilling these holes.
- (3) Rivet clip to stiffener with two GLM25-2AD3-4 rivets.
- (4) Drill one No. 40 hole through rear beam, using clip flange hole as template.
- (5) Rivet clip to rear spar with one GLM25-2AD3-5 rivet. To buck this rivet, the lightening hole in fuselage side skin can be used to get behind rear spar.
