ERCOUPE
SERVICE
BULLETIN
No. 27

SUBJECT: Wing Tip Inspection

SERVICE BULLETIN NO. 27 October 12, 1987
WING TIP INSPECTION

MODELS AFFECTED: All Ercoupe 415-C, 415-CD, 415-D, 415-E and 415-G aircraft.
All Forney F-1 and F-1A aircraft.
All Alon A-2 AND A-2A Aircraft.
All Mooney M10 aircraft.

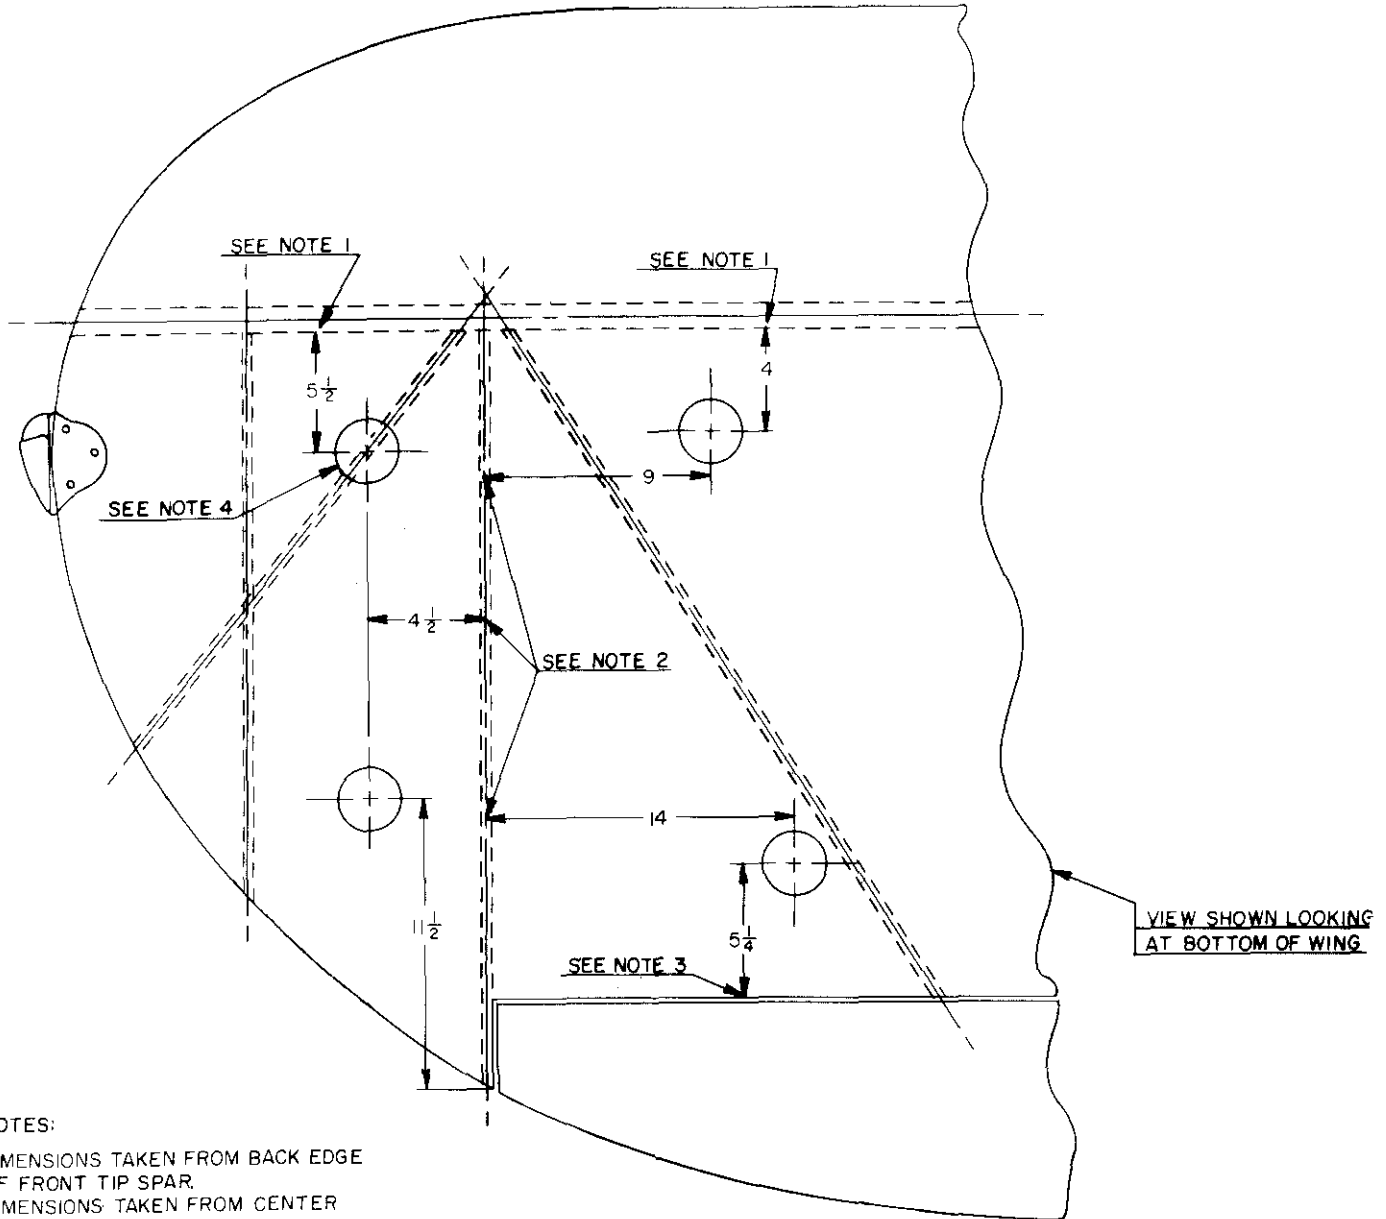
A. Locate the inspection openings in lower wing surface per the enclosed wing diagram. For metal covered wings the rib centerline can be determined by the row of rivets that secure the skin to the rib and the back edge of the tip spar is even with the back edge of the skin section. CAUTION: If the hole locations specified will cut into any skin stiffeners on metal covered wings alter the hole location as required to clear the obstruction

B. On metal covered wings cut 8 each $3\frac{1}{2}$ inch diameter inspection holes and deburr openings. On fabric covered wings remove finish to bare fabric at each opening location and attach reinforcing ring P/N 007-85012-78 (or equivalent) with Rand-O-Bond or Super Seam fabric cement (or equivalent). Apply finish as required to touch up area surrounding ring and 8 new cover plates. Cut out center opening of ring carefully.

D. After inspection is complete install 8 new cover plates P/N 007-12761-02 (or equivalent) over openings in lower wing. On metal covered wings secure each cover plate at the leading edge with one AN530-4-6 sheet metal screw (or equivalent).
