ERCOUPE  
SERVICE  
BULLETIN  
No. 32

**SUBJECT:** Mandatory Wing Center Section  
Inspection

## MANDATORY SERVICE BULLETIN NO. 32 WING CENTER SECTION INSPECTION

**MODELS AFFECTED:** All Ercoupe 415-C, 415-CD, 415-D, 415-E and 415-G aircraft.  
All Forney F-1 and F-1A aircraft.  
All Alon A-2 and A-2A aircraft.  
All Mooney M10 aircraft.

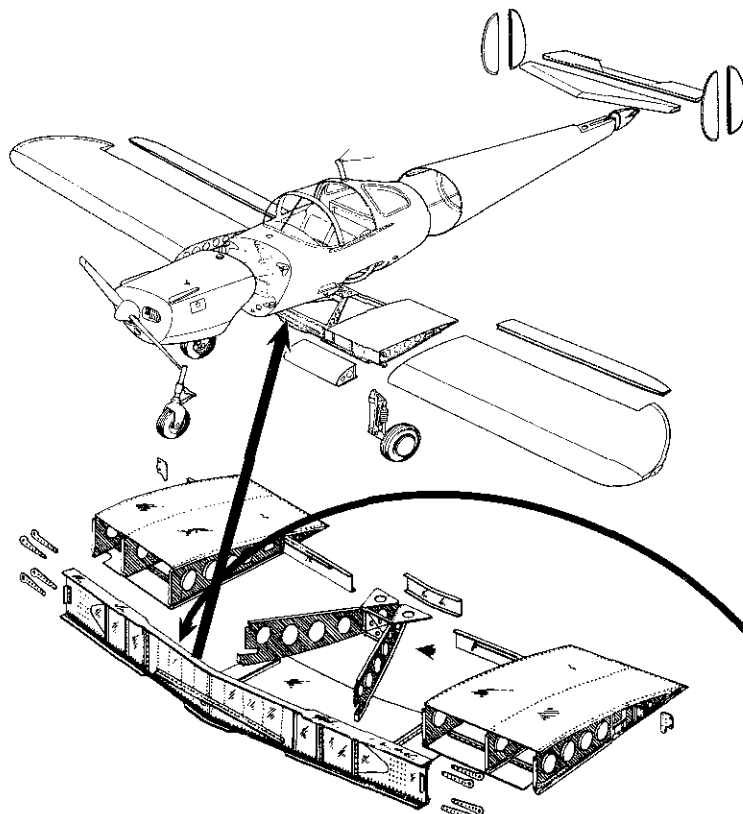
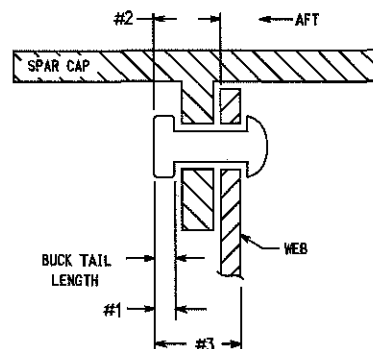
EXAMPLE FOR AREA "A"  
TABLE 1: CRITICAL FASTENER DIMENSIONS

**SUBJECT:** Mandatory ultrasonic examination of all the upper and lower spar cap 5/32-inch, 1/4-inch and 5/16-inch fasteners (rivets) in the Main Spar Center Section carry through structure. See Figure 1.

3.1 The critical area of inspection for each fastener is where the fastener shank meets the bucked tail, where the fastener shank meets the head of the fastener and the shear plane between the spar web and the spar cap. These dimensions can be found in Table 1.

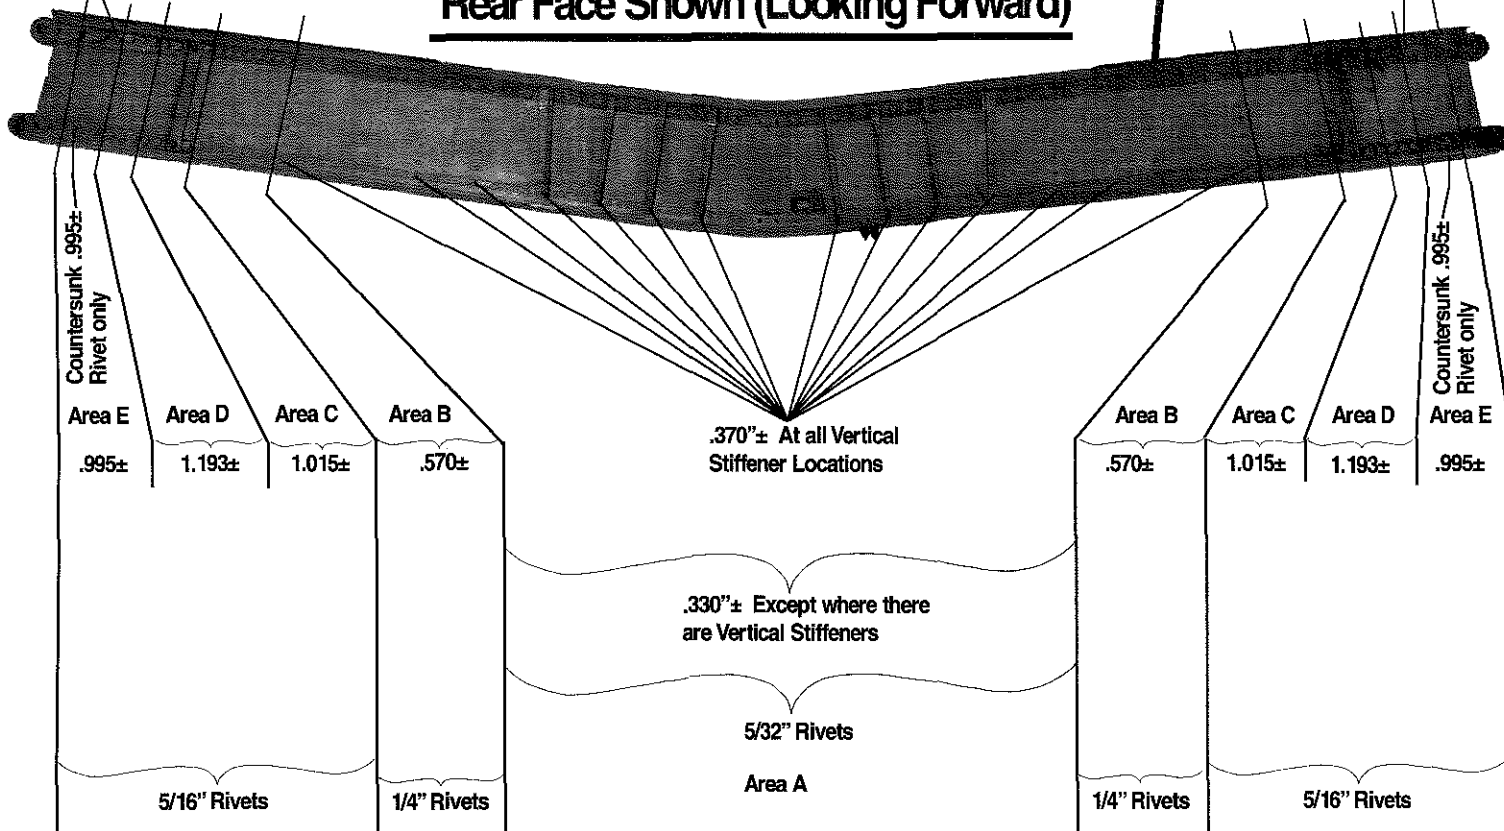
**Main Spar Carrythrough (Beam) Location  
Rear Face Shown (Looking Forward)**

Based upon inspections in accordance with Service Bulletin 31, there have been reports of light to severe corrosion and/or damage, (broken rivets attaching center section shear web to the upper and lower spar caps), in the wing center section structures of several aircraft. If corrosion has been detected anywhere in the wing center section additional hidden corrosion may be present in the main center section spar cap rivets. This corrosion cannot be seen by the visual inspection methods outlined in Service Bulletin 31. If the aircraft has experienced hard landings the main spar rivets may be damaged. Internal corrosion or internal damage of the rivets in the spar caps, if severe enough, could lead to structural failure of the wing center section, which could result in loss of control of the airplane. Consequently, this Service Bulletin provides for the ultrasonic inspection of the wing front spar carry through beam assembly rivets to establish the airworthiness of the center section structure.

Carefully drill out each rivet that shows signs of corrosion or damage, **NOTE: Caution following this section.** Inspect the holes where the rivets have been drilled out. If there are no signs of corrosion or damage in the holes, the rivets may be replaced with the same size and type of rivets after corrosion prevention measures are taken (see instructions below). If there are signs of corrosion or damage in the holes, carefully inspect the holes to determine if the corrosion or damage extends to the interfaces between the spar caps, spacers, and web.
