ERCOUPE SERVICE BULLETIN NO. 34

ELEVATOR CONTROL HORN INSPECTION

DATE: January 4, 2013 Revision None

MODELS AFFECTED: Ercoupe 415-C, 415-CD, 415-D or other Ercoupe models with a continuous trailing edge elevator.

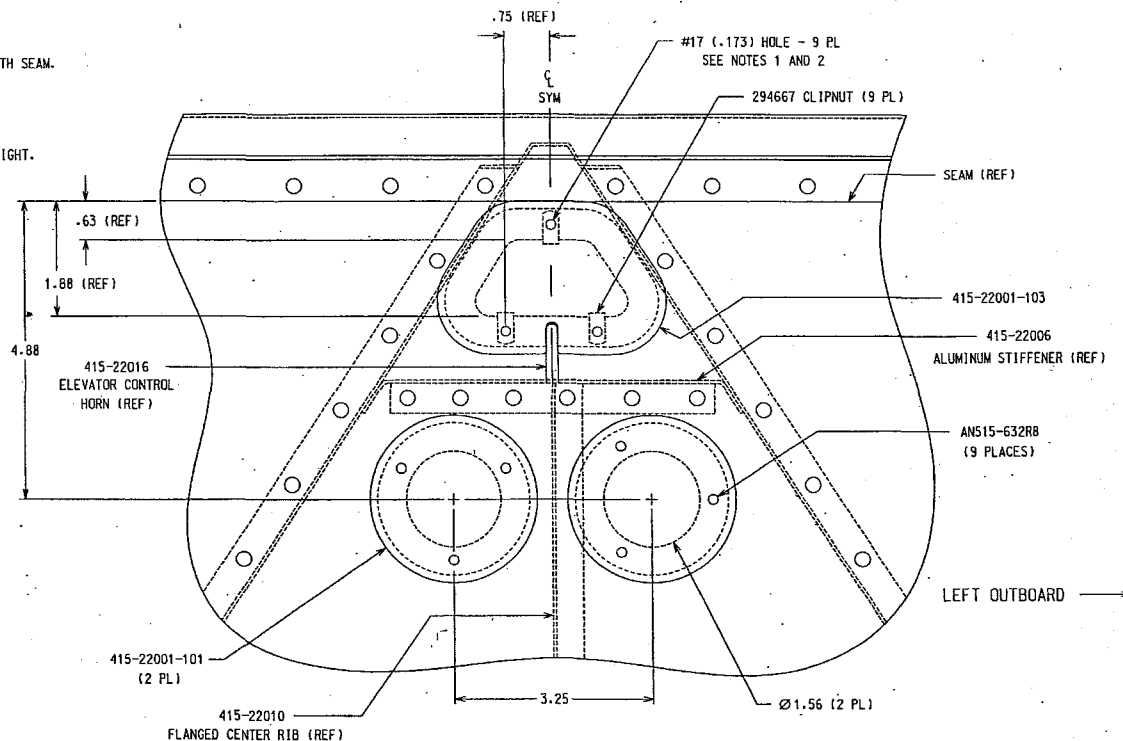
Univair has determined that two 1.56 diameter holes and one trapezoidal shaped hole located at the center of the bottom elevator skin will provide adequate inspection coverage of the attachment area of the steel elevator control horn. See Univair drawing 415-22013 INSP for layout dimensions of inspection holes.

4. Cut two 1.56 diameter holes in lower elevator skin aft of the aluminum stiffener per drawing 415-22013 INSP. Locate the inspection hole forward of the aluminum stiffener using template 415-22001-105, per drawing 415-22013 INSP. Locate and drill #17 holes as required.
