# SERVICE BULLETIN

## **Fornaire**

No. 109

**Subject:** Addition Of Drain Holes, Concerning All Ercoupes, Aircoupes, and Fornaires Up To Serial #5714

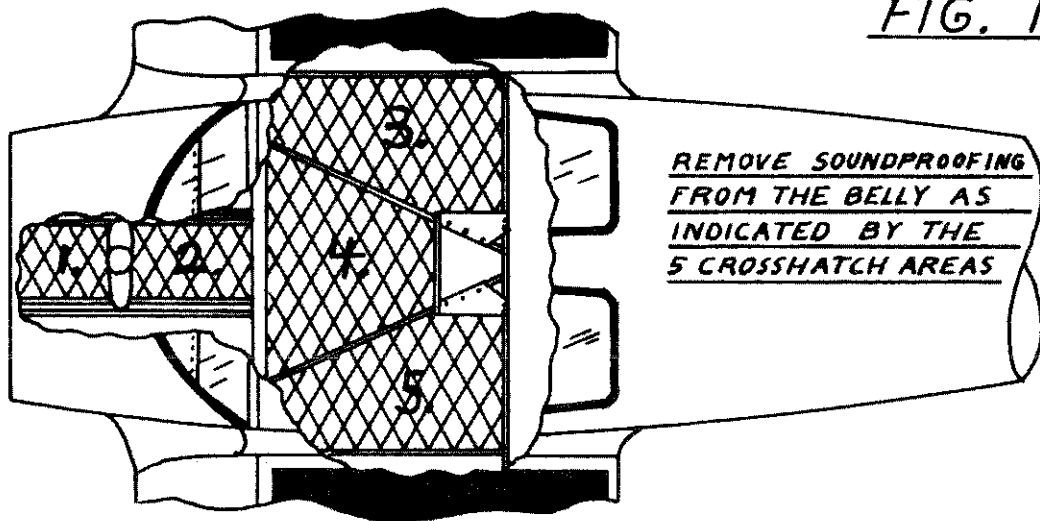
FIG. 1.

It has been noticed that water can collect in the forward belly regions of the airplane, and that there is no provision for expelling the water to the outside. The trapped water (if acidic) can cause decay and corrosion to the belly structure. Trapped gasoline is another dangerous possibility. Tests have been made to find drain hole locations which will completely drain the problem area for all normal parking attitudes.

- c. Remove (if present) all soundproofing in the lowest belly regions as shown in Fig. 1.

Note: Tests have been conducted and the result of increase noise upon removal of soundproofing in these areas is negligible. Therefore, do not replace the soundproofing. This will enable unobstructed drainage and prevent water from being held by absorption into the soundproofing.
