SERVICE BULLETIN No. 4

LANDING GEAR REINFORCEMENT-REAR

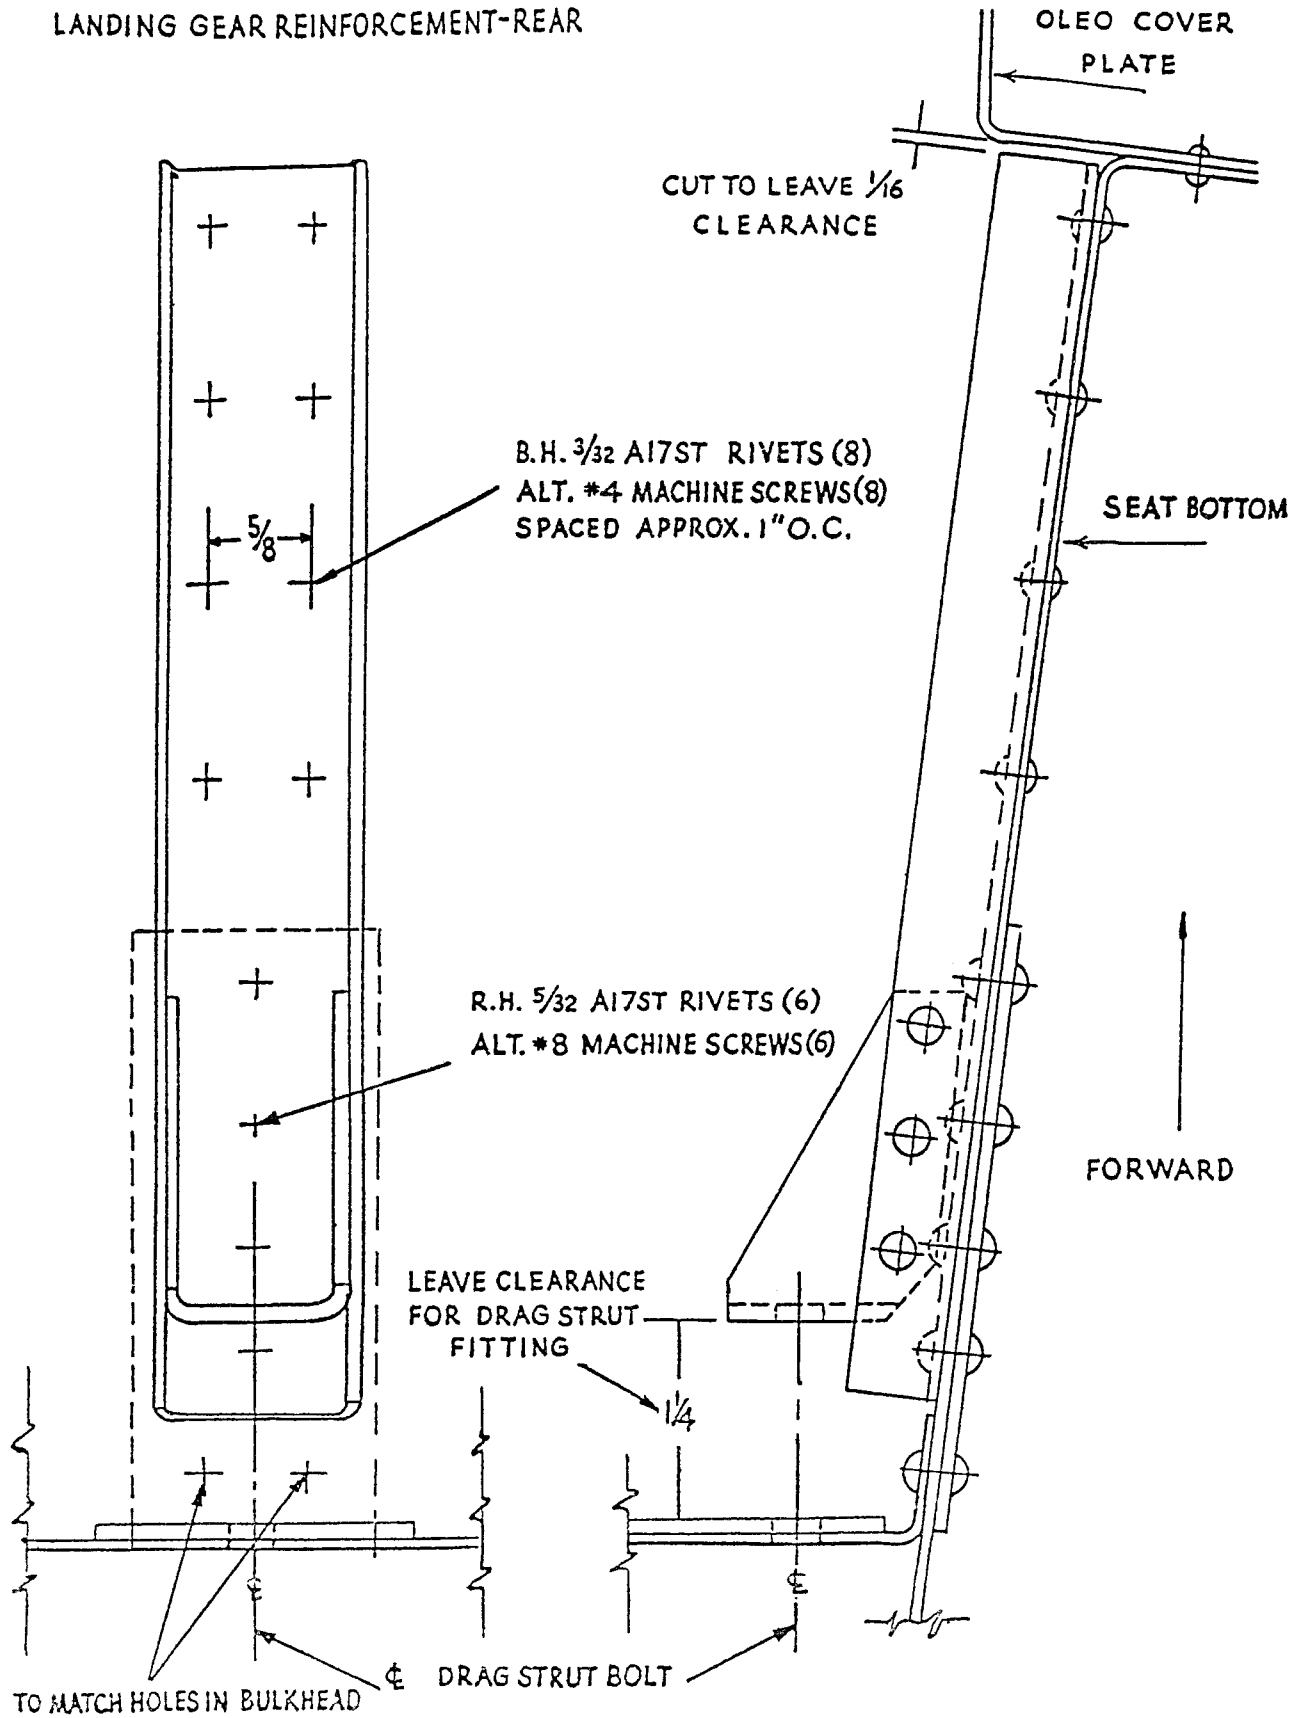
A report has been made to us of a fatigue failure on our Model "8" in the bulkhead to which the rear landing gear strut is bolted. The failure started as a crack in the bend of the top bulkhead flange, just over the landing gear attachment fitting. We therefore advise you to carefully inspect this place and if a crack is found get in touch with us immediately for instructions as to how to make the repair.

To lessen the danger of a fatigue failure occurring, a reinforcement fitting should be installed in your airplane as shown on the enclosed sketch. This fitting is to be installed on both sides of the airplane in accordance with the following instructions.

1. Remove from under side of seat the triangular shaped reinforcing sections which are approximately in line with landing gear fittings.

2. Cut off reinforcement fitting to proper length to fit under seat and line up $\frac{5}{16}$ hole in steel bracket with landing gear bolt, which passes through it. This may necessitate placing a shim between channel and seat bottom.
3. Rivet reinforcement to seat, being sure to include steel strap on top of seat as shown. If impossible to rivet, steel machine screws and elastic nuts or other approved locking device may be used as noted on sketch.

If your bulkhead is sound, make this installation at once to avoid the possibility of a more difficult repair job. If a crack has developed, do not make the installation until you receive further instructions.
