SERVICE BULLETIN No. 7

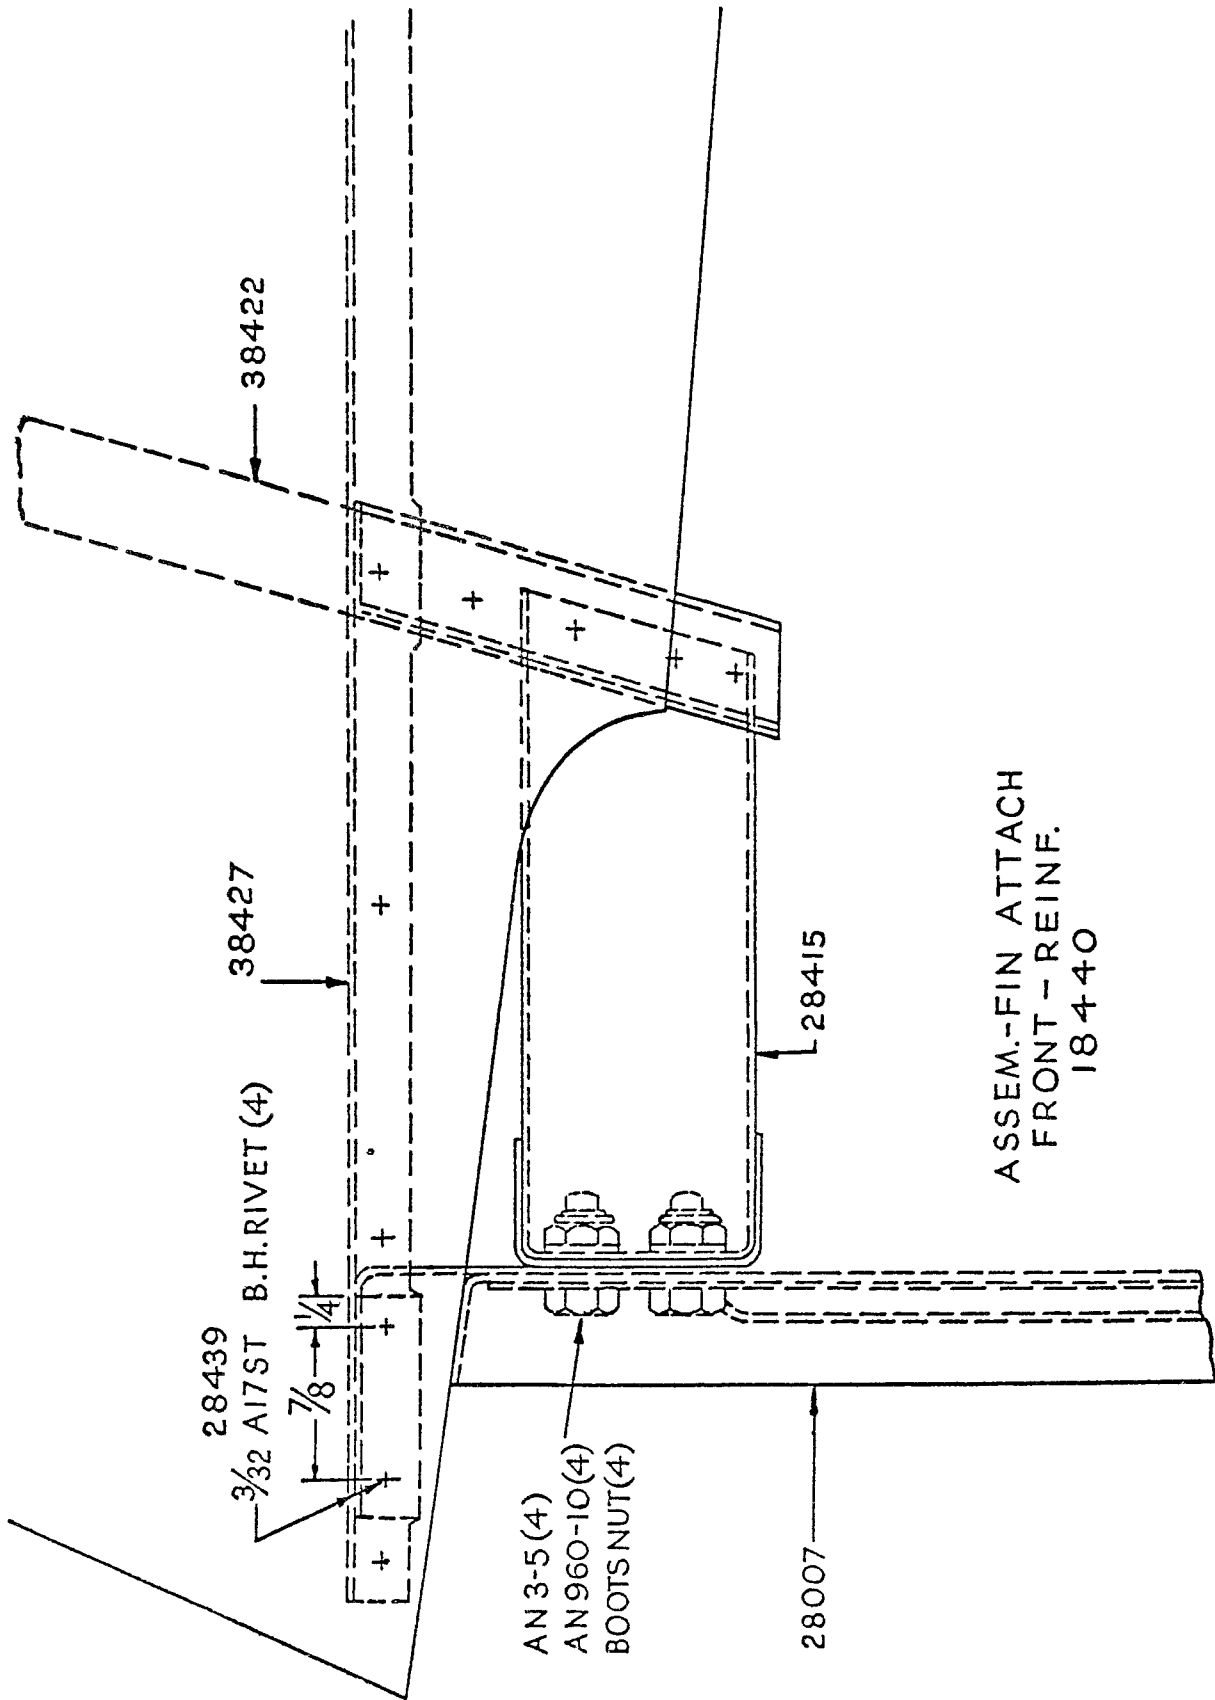
Inspection has disclosed that in two cases at least, the front fin attachment fitting has cracked around the weld at the fin end. The aircraft on which these cracks were found both had 500 hours of service. It is felt that this failure will not occur much before the 500 mark.

1. Remove fin.
2. Inspect forward fin fitting for cracks, also the bulkhead at the attachment point.
3. (a) If the forward fin attaching fitting is *definitely* not cracked, Part #28439 is to be installed as shown on drawing #18440.

(b) If the forward fin attaching fitting is cracked, remove same and install 28415A (new front fin attachment fitting).

(c) If the bulkhead is cracked at the attachment point, reinforce with #28151 (bulkhead reinforcements).
