SERVICE BULLETIN No. 8

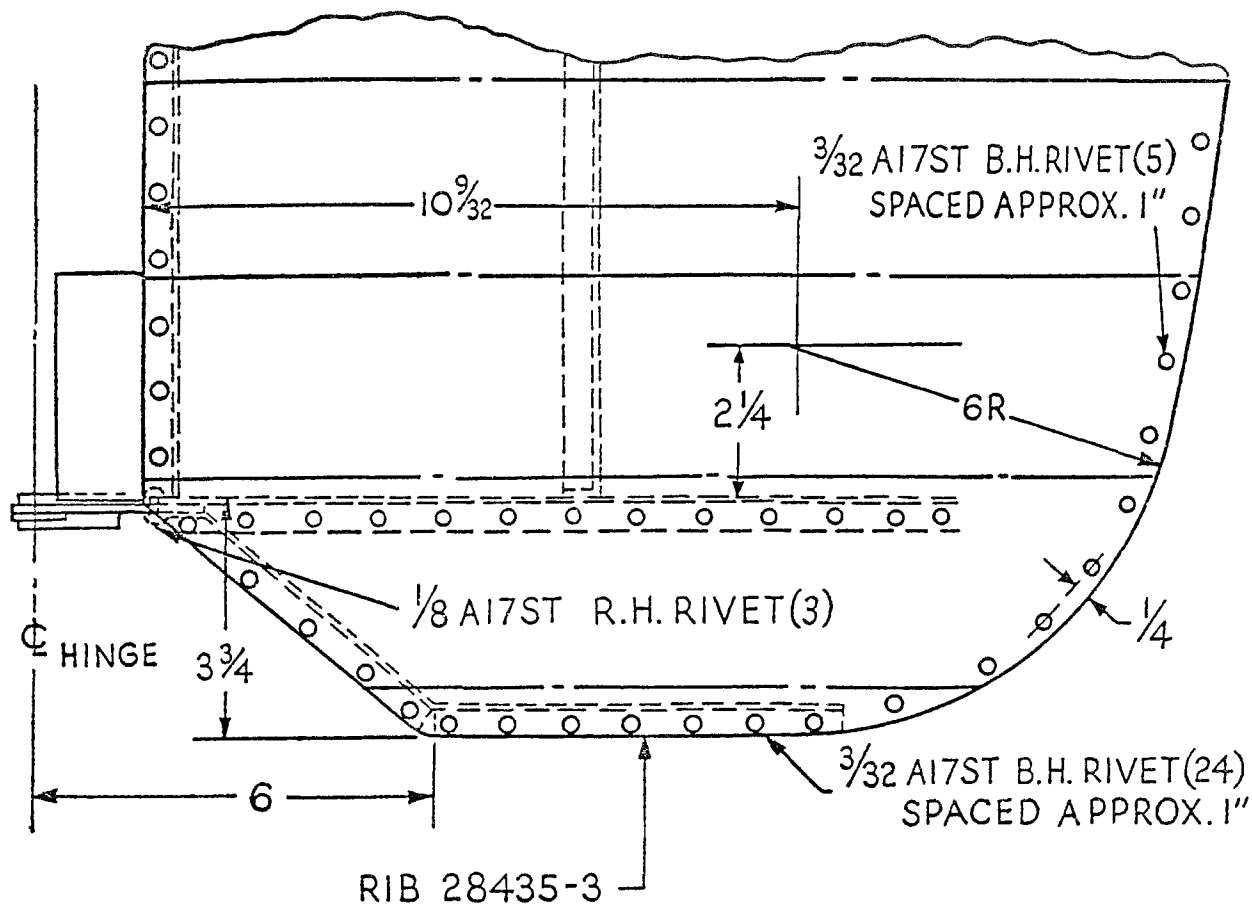
It has been found that on most of our Model 8 and 8A airplanes, the rudder bottoms have been considerably damaged by the tailwheel.

To prevent the tailwheel from hitting the rudder, it is permissible to trim the bottom of the rudder as shown in the sketch below.

If the lower rib 28435-3 is in good condition, it may be used to make the repair; otherwise a new one should be ordered from the factory, or made to match the old one. (Material 020 17ST Alclad.)

The flange of the rib should be slit, and the rib bent to shape as shown in the sketch below.
