ENGINEERING BULLETIN No. 15

**Recommended Repair for Fuselage Skin Cracks
at Rear Wing Spar**

Aircraft affected: All Luscombe Model 8 Series up to and including Serial No. 1789.

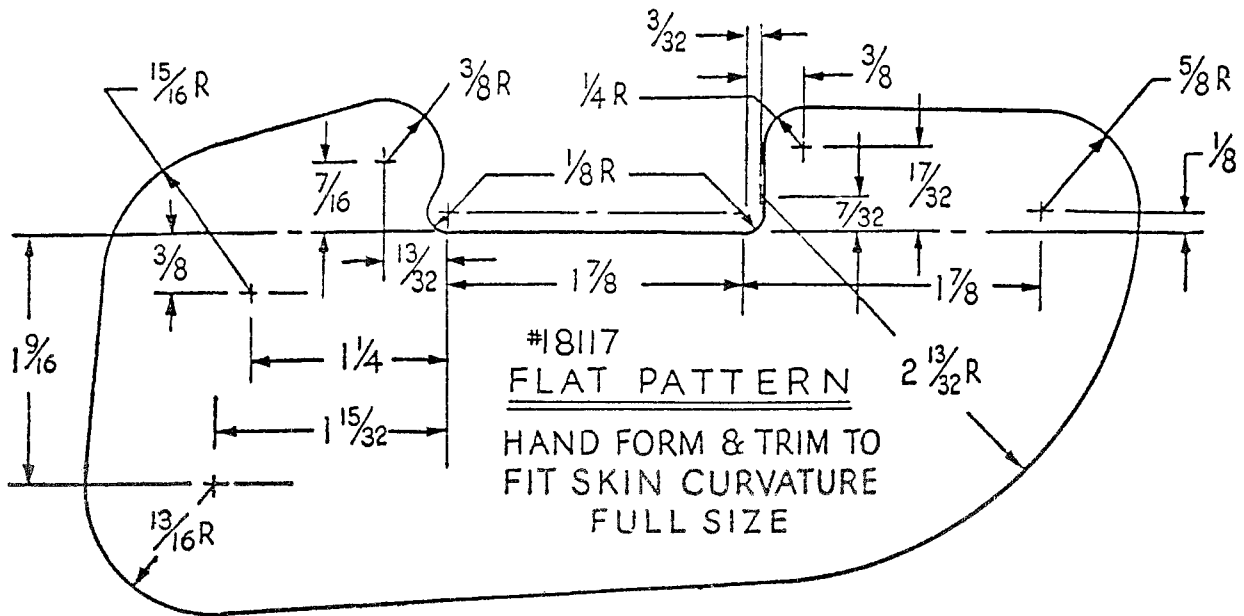
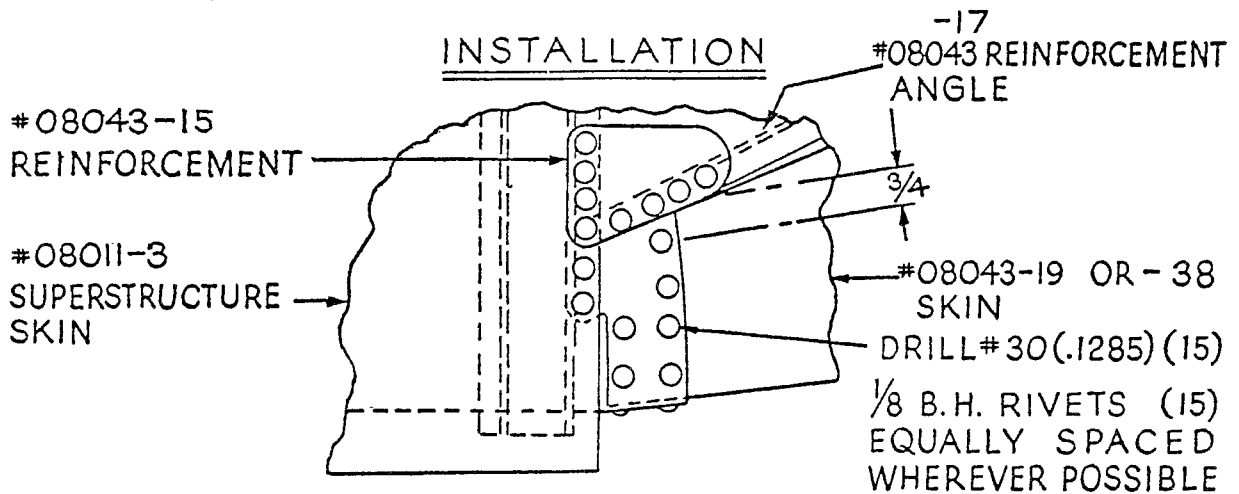
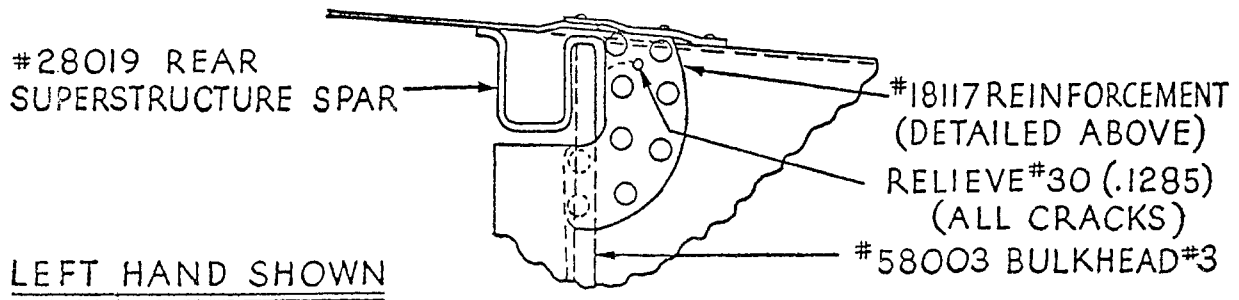
Skin cracks have occurred in the fuselage skin at the rear wing spar which have led us to add a reinforcement, part No. 18117, at our factory, and to recommend that you make the same change on any and all subject aircraft in your possession. The Civil Aeronautics Administration has been informed of this change, and it will probably recommend or in-

sist that all Luscombe aircraft showing evidence of cracks be repaired as illustrated on the following page.

The necessary reinforcement plate and rivets for this repair may be obtained for \$.50 net. In ordering please refer to Engineering Bulletin No. 15.

A record of the inspection and/or repair should be entered in the airplane log book.
