ENGINEERING BULLETIN No. 16

**Recommended Repair for Cracks in Rear Fin
Spar at Upper Hinge Bracket**

Aircraft affected: All Luscombe Model 8 Series up to and including Serial No. 1776.

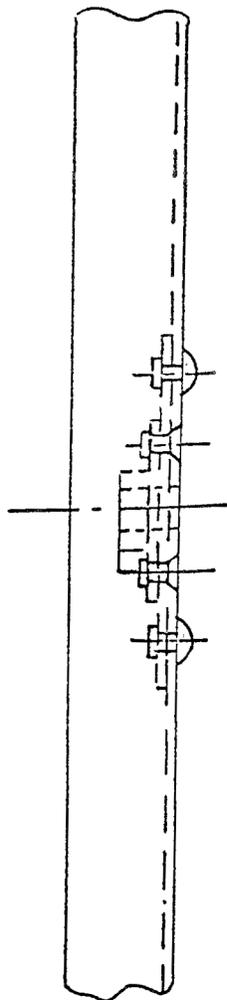
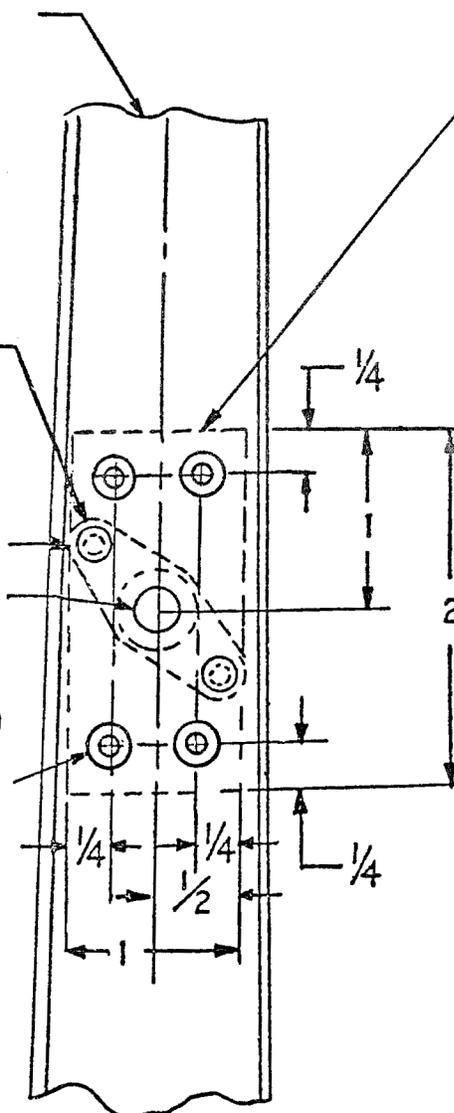
The occurrence of cracks in the rear fin spar at the upper hinge bracket has led to the addition of a reinforcement plate on all fin spars for new aircraft at our factory. The Civil Aeronautics Administration has been informed of these facts, and it will probably recommend or insist that all Luscombe aircraft manufactured before this addition be inspected and that all aircraft having these failures be repaired as outlined below and illustrated on the accompanying page.

REINFORCEMENT PLATE-
LUSCOMBE PART #18451
MAT'L: .040 17ST ALC.

REAR FIN SPAR
LUSCOMBE PART #38411

PLATE NUT
AC 366-F428

$\frac{3}{32}$ A17ST C'T'SK
RIVETS (2)
DRILL 'F' (.257)

DRILL #40 (.098) (6)
 $\frac{3}{32}$ A17ST B.H.
RIVETS (4)

1. Should the reinforcement plate (Luscombe part #18451) be insufficiently large to fully cover all cracks, or should any crack be more than one-half inch long, the spar should be replaced.
2. Providing the spar is repairable, remove enough rivets to allow the fin skin to be peeled back sufficiently to allow room for a dolly, and remove anchor nut (AC 366-F428).
3. Relieve all cracks with a #30 (.1285) drill.
4. Drill spar to match reinforcement plate.
5. Rivet plate in place.
6. Drill plate to match anchor nut.
7. Rivet a new anchor nut in place.
8. Replace removed rivets in skin.
