ENGINEERING BULLETIN No. 18

**Recommended Repair and Alteration for
Fraying Rudder Cables**

Aircraft affected: All Luscombe Model 8 Series aircraft up to and including Serial No. 1894.

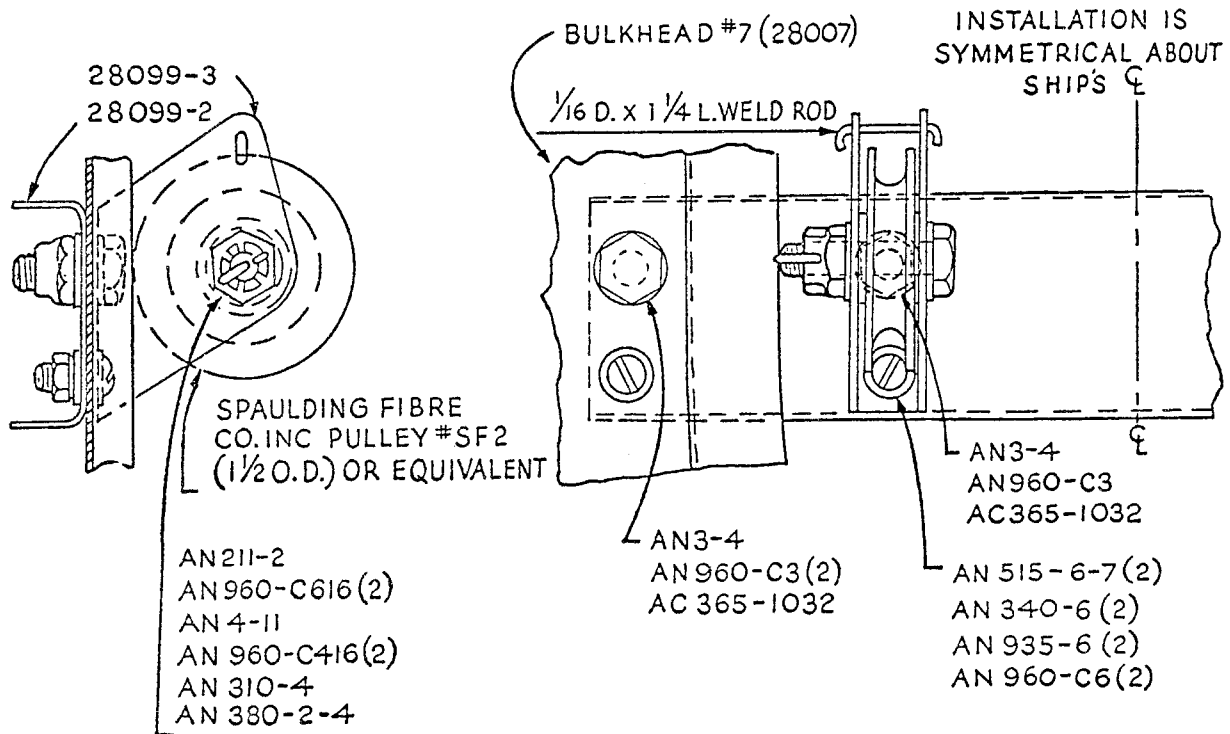
INSTALLATION DETAILS

The fraying of rudder cables at bulkhead #7 has led to the substitution of pulleys (LAC Drawing #28099) for the former fairleads (LAC Drawing #18058), and to our recommendation that you make the same change on any and all subject aircraft in your possession as soon as possible.

1. Replace the worn rudder cables with new ones. Luscombe Airplane Corporation parts #48501-2 and #48501-3.
2. Locate pulley bracket as per sketch, making sure the rudder cables do not rub against the skin slots, and drill bulkhead #7 to match.
3. Bolt bracket in place.
4. Safety cables over pulleys as per sketch, and adjust.
