ENGINEERING BULLETIN No. 21

August 29, 1944

Subject: Reinforcement of Rudder horn on Luscombe Model 8 series airplane

Aircraft Affected: All Luscombe Model 8 series up to and including No. 920

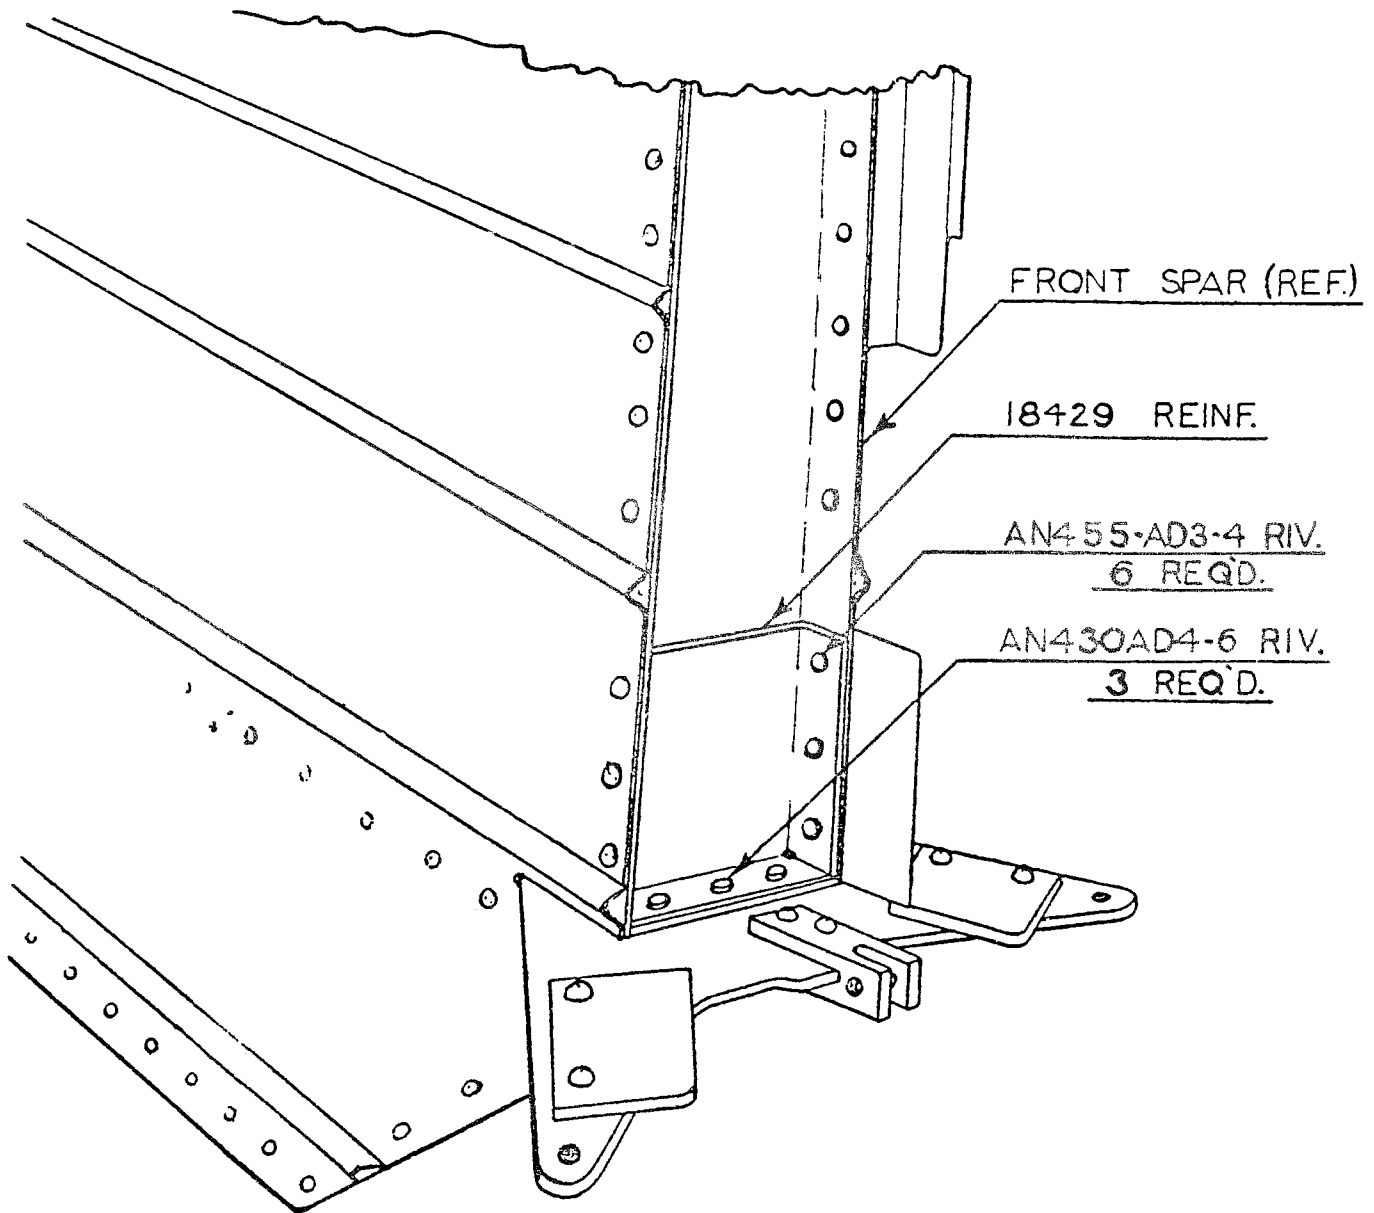
A recent minor accident involving one of the above early serial numbered aircraft during the takeoff run resulted when the rudder broke loose from the rudder horn.

As a precautionary measure to prevent further failures at this point on these serial numbers it is suggested that you reinforce the horn with part 18429 as shown in sketch. All serial numbers above 920 had this reinforcement installed before leaving the factory.

1. Remove Rudder from airplane
2. Drill out the nine rivets
3. Clamp fitting 18429 in place as shown
4. Drill six holes No. 40 and three holes No. 30 thru 18429 using old rivet holes as guides
5. Remove fitting and clean away all burrs
6. Replace fitting and rivet in place
