**ENGINEERING BULLETIN No. 23**

**November 6, 1944**

**Subject:** Inspection and alteration of tail bulkhead and fin spar for clearance of elevator horn

**Aircraft Affected:** All Luscombe Model 8 series aircraft. (8, 8A, 8B, 8C, and 8D) serials 801 and up.

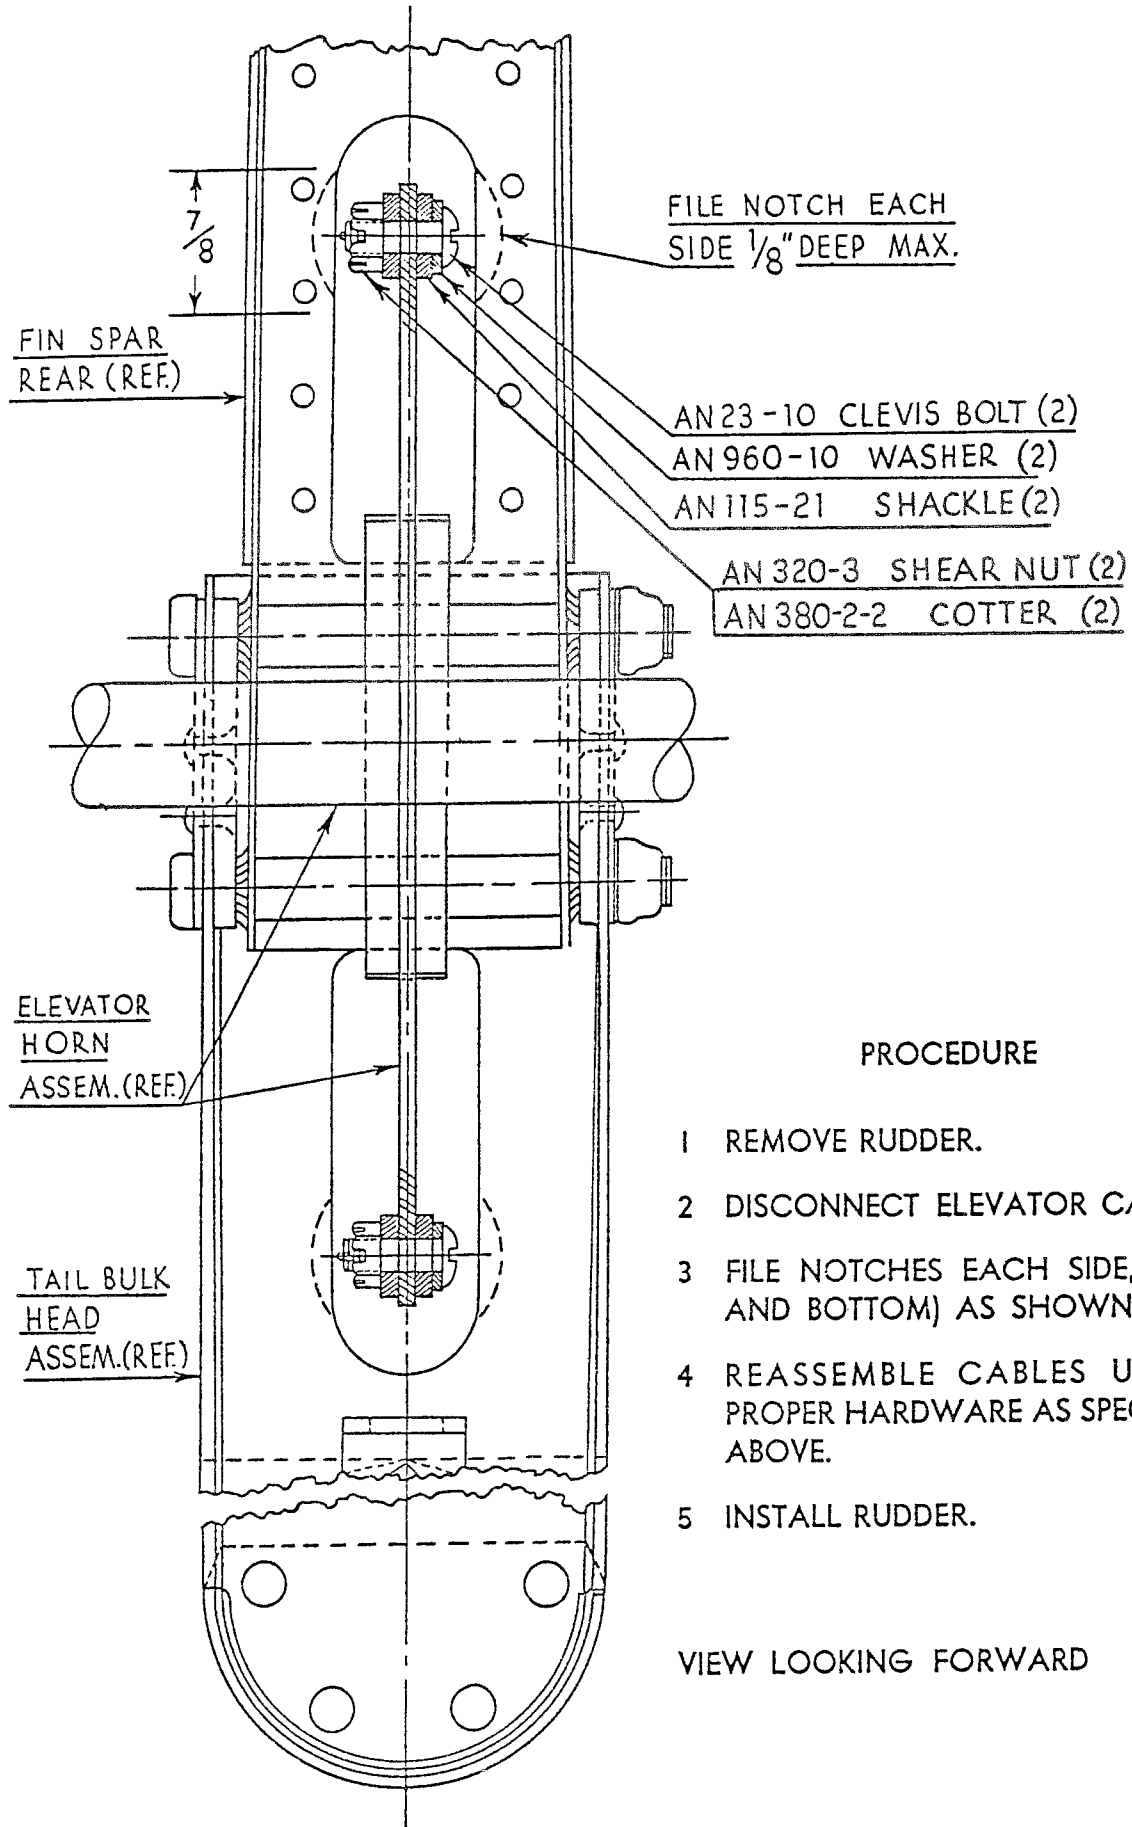
VIEW LOOKING FORWARD

Reports have reached us recently concerning the lack of clearance between the bolts in the elevator cable attachment to the elevator horn and the openings in the fuselage tail bulkhead and rear fin spar, when standard AN hex head bolts are used. Occasionally mechanics in the field have changed elevator cables and replaced the original clevis head bolt with a hex head bolt. Any wear in the elevator hinges which may allow the elevator to shift its position may then cause the elevator horn to jamb the controls.

You are therefore urged to inspect this point immediately to determine that the proper bolt is used as shown in sketch and that there is ample clearance for the elevator horn travel. In order to obtain ample clearance it is suggested that notches be filed in the bulkhead and fin spar not more than  $\frac{1}{8}$  inch deep, as shown in sketch.

PROCEDURE

- 1 REMOVE RUDDER.
- 2 DISCONNECT ELEVATOR CABLES.
- 3 FILE NOTCHES EACH SIDE, (TOP AND BOTTOM) AS SHOWN.
- 4 REASSEMBLE CABLES USING PROPER HARDWARE AS SPECIFIED ABOVE.
- 5 INSTALL RUDDER.
