LUSCOMBE AIRPLANE CORPORATION
P.O. Box 2128, Dallas 1, Texas

SERVICE BULLETIN NO. 3-47

SUBJECT: Inspection of Fin, Rear Spar Attachment Fitting

Model 8 Series

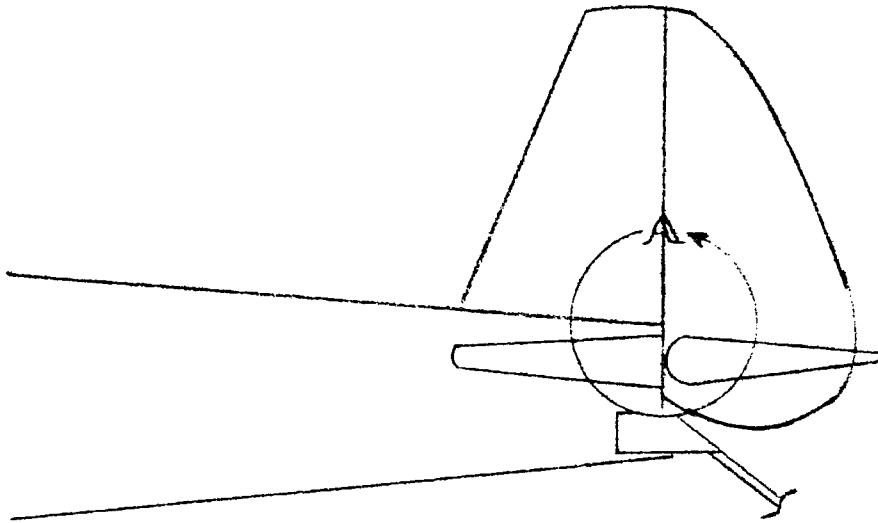
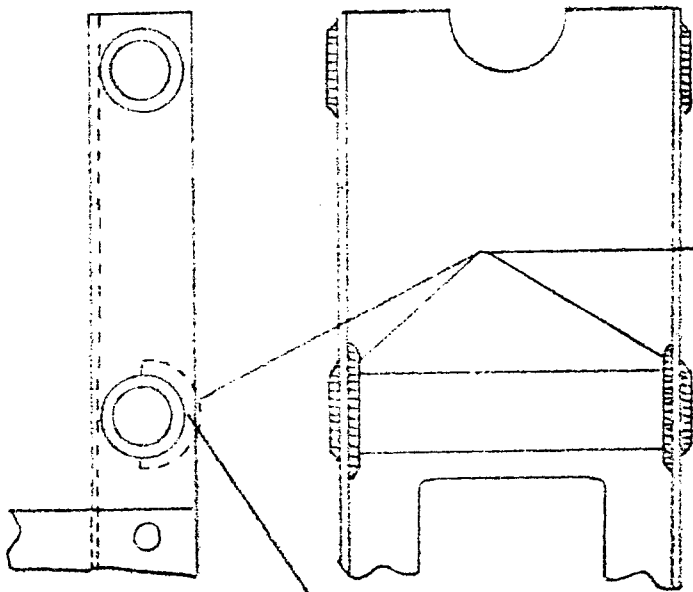
VIEW A FULL SIZE

Upon receipt of this Service Bulletin an inspection should be made of the rear fin (vertical stabilizer) attachment fitting for evidence of cracks in the flange of the fitting adjacent to the 3/8" bushing welded across the web between the flanges.

If an inspection does or does not reveal a crack or fracture in the areas as indicated per the attached sketch the fitting should be reworked immediately in accordance with the rework instructions. If the cracks are found to have progressed further than indicated on the sketch the fitting should be replaced.

LOCATION OF POSSIBLE CRACK

1. Remove Rudder and Fin from Airplane.
2. Remove Fitting from rear Spar and remove paint.
3. Weld half of AN960-616 Washer, or equivalent as shown in sketch.
4. Prime and repaint Fitting.
5. Reassemble to Spar
6. Reinstall Fin and Rudder.
7. Indicate compliance with this Bulletin by suitable entry in Aircraft Log Book.

ONE HALF AN 960-616
WASHER WELDED TO
18419 FITTING
