LUSCOMBE AIRPLANE CORPORATION  
P.O. Box 2128, Dallas 1, Texas

SERVICE BULLETIN NUMBER 1-48

SUBJECT: Decker 501A Tail Installation on Model 8 Silvaire,  
Serial Nos. 5824 to 5854.

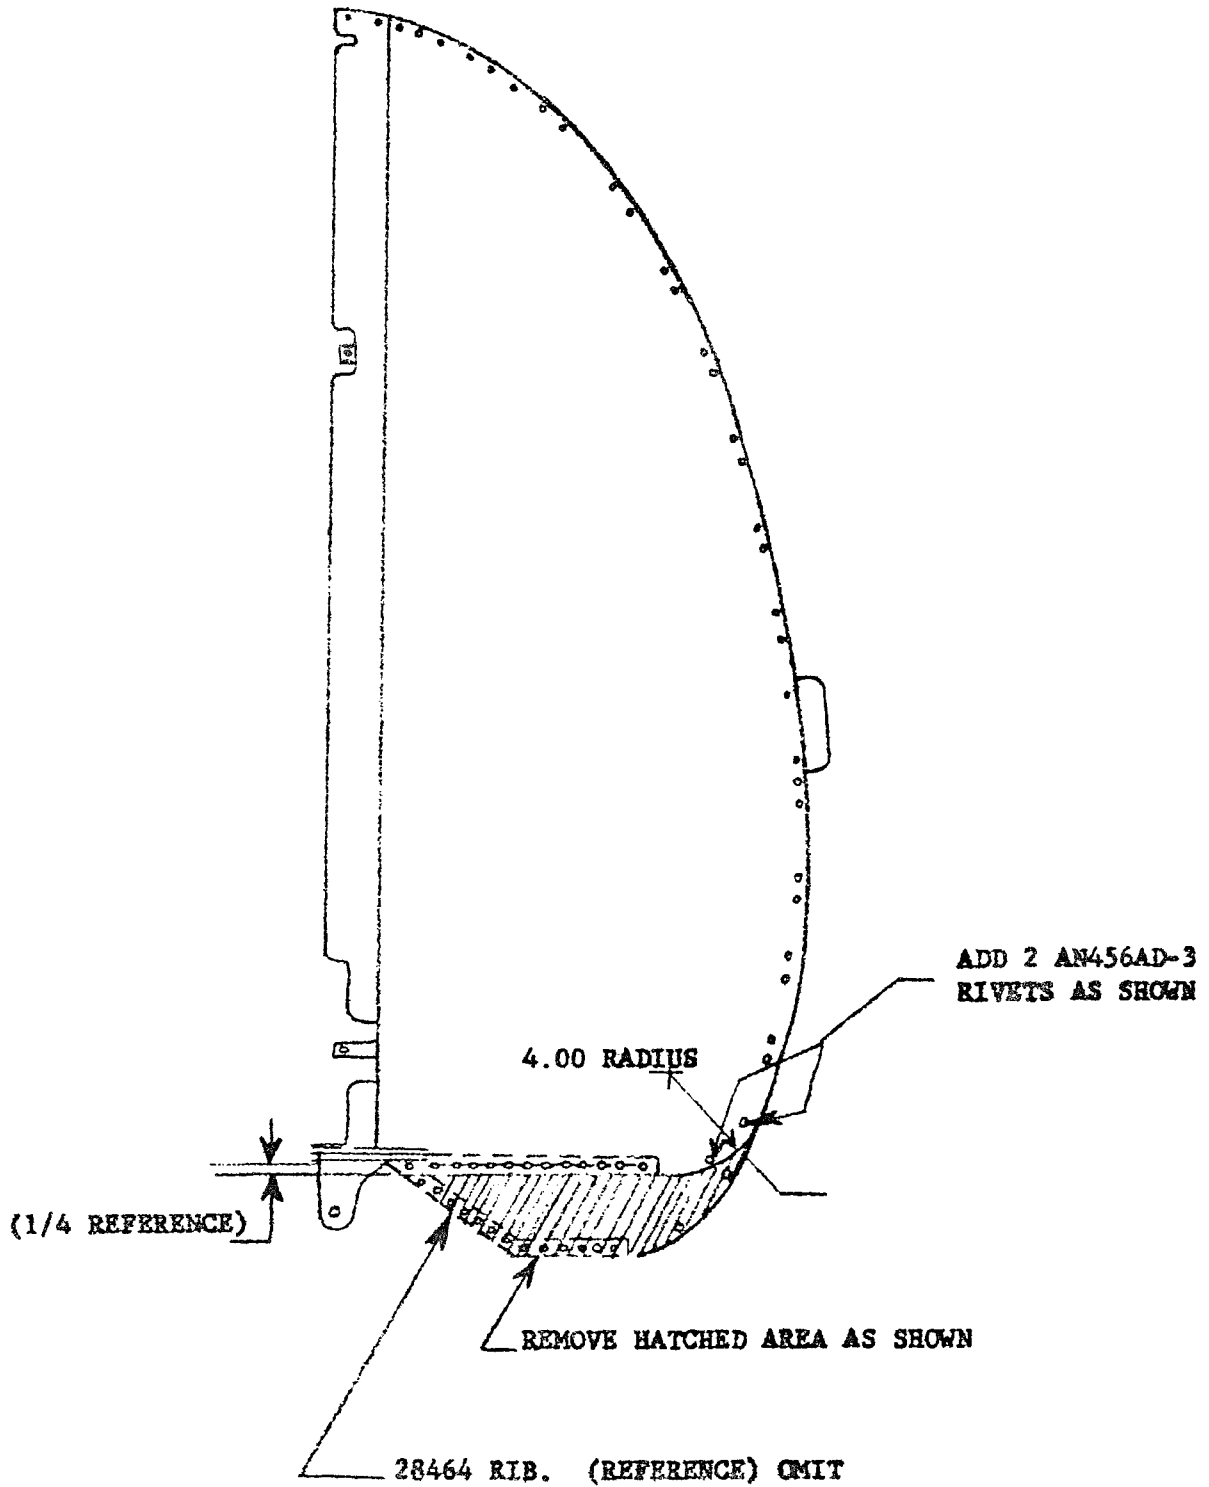
RUDDER REWORK INSTRUCTIONS FOR  
DECKER TAIL WHEEL MODEL 501A

It has been found that the height of the steerable mechanism on the Decker 501A tail when as installed on the above aircraft causes interference with the lower edge of the rudder under certain conditions. This condition has been corrected on subsequent aircraft by removing the lower portion of the rudder, as shown on the attached sketch. It is suggested that the modification described be incorporated on your aircraft at the earliest opportunity. This revision, which can be accomplished without removing the rudder from the aircraft, is approved and recommended by CAA.
