LUSCOMBE AIRPLANE CORPORATION
P.O. Box 2128, Dallas 1, Texas

TO: All Silvaire Owners & Operators
FROM: Service Department, Luscombe Airplane Corp.
SUBJECT: Inspection of 18432 Rudder Horn
SERIAL NOS. AFFECTED: 1934-5724

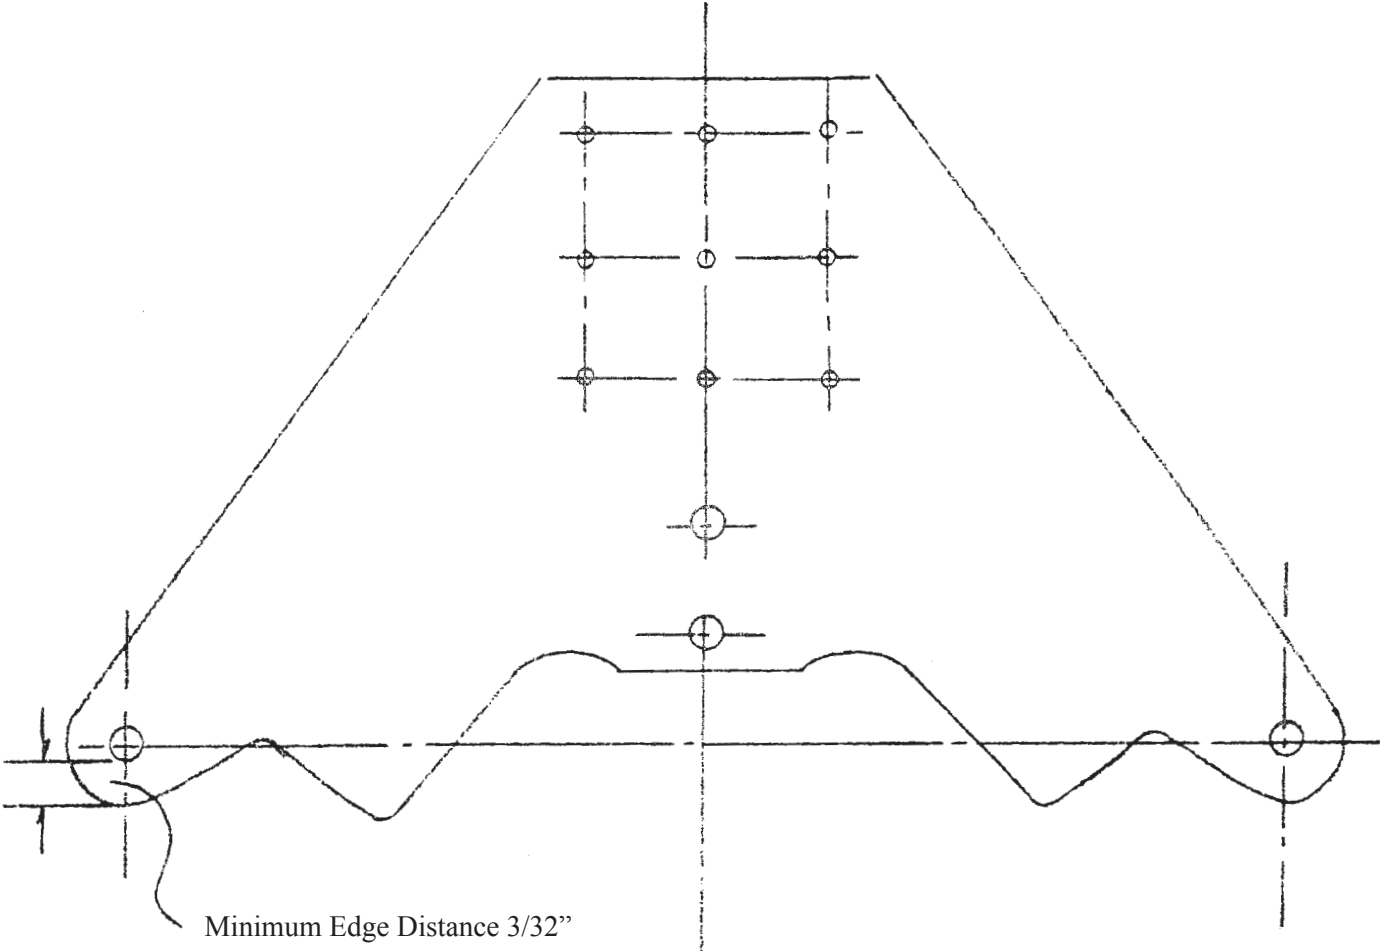
RUDDER HORN MINIMUM EDGE DISTANCE REQUIREMENTS

Several cases of excessive wear and elongation of eyebolt attachment holes in the rudder horn have been reported to the factory.

In all cases, the subject aircraft have from 500-600 total hours operation at time of discovery of this condition.

All aircraft should be checked at each one hundred hour inspection for excessive wear at this point, minimum allowable edge distance being 3/32". (See attached sketch)

Marginal cases discovered upon inspection may be corrected by adding two rudder arm extensions, part number SK4149. These parts may be procured through the Service Department.
