LUSCOMBE AIRPLANE CORPORATION
DALLAS, TEXAS

SERVICE BULLETIN NUMBER 4-46

SUBJECT: Inspection of Rudder Pedal Horn

Model: 8A

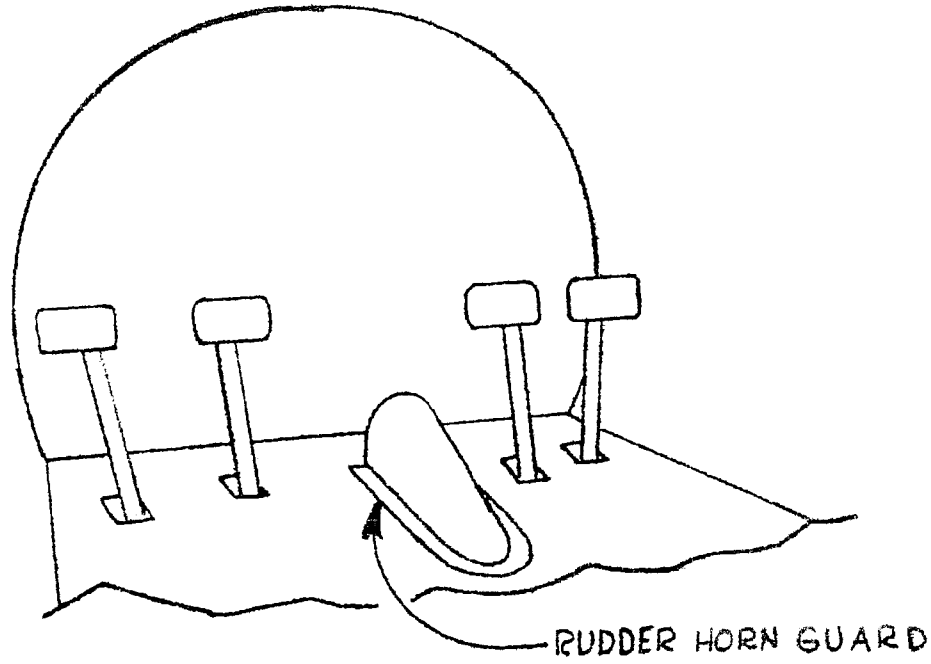
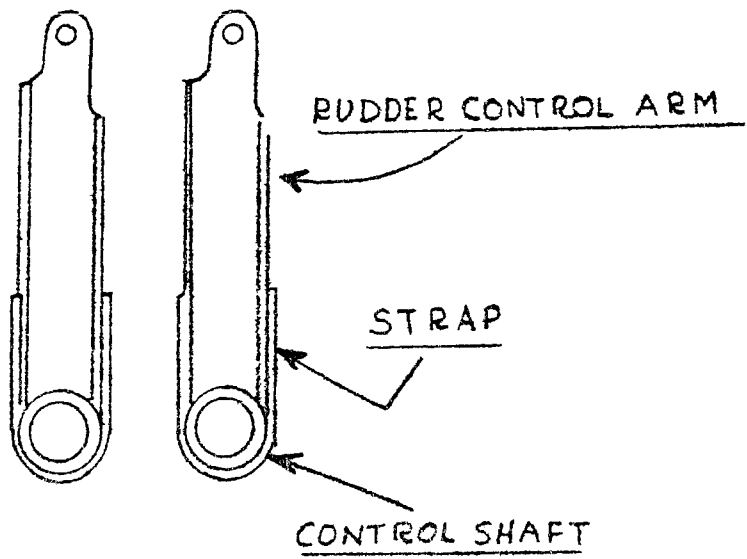
- (1) Remove the rudder horn guard from the cabin floor between the right and left sets of pedals (see attached sketch.)
- (2) Check the attachment of the rudder control arm on the torque tubes. The reinforcing steel strap should extend around the tube and be securely welded to both the fore and aft flanges of both rudder control arms.
