LUSCOMBE AIRPLANE CORPORATION
DALLAS, TEXAS

SPECIAL SERVICE BULLETIN

SUBJECT: Rework Required to Permit Interchangeability of New Type (Square Tip)
Stabilizer with Old Elevators.

MODEL: 8A and 8E

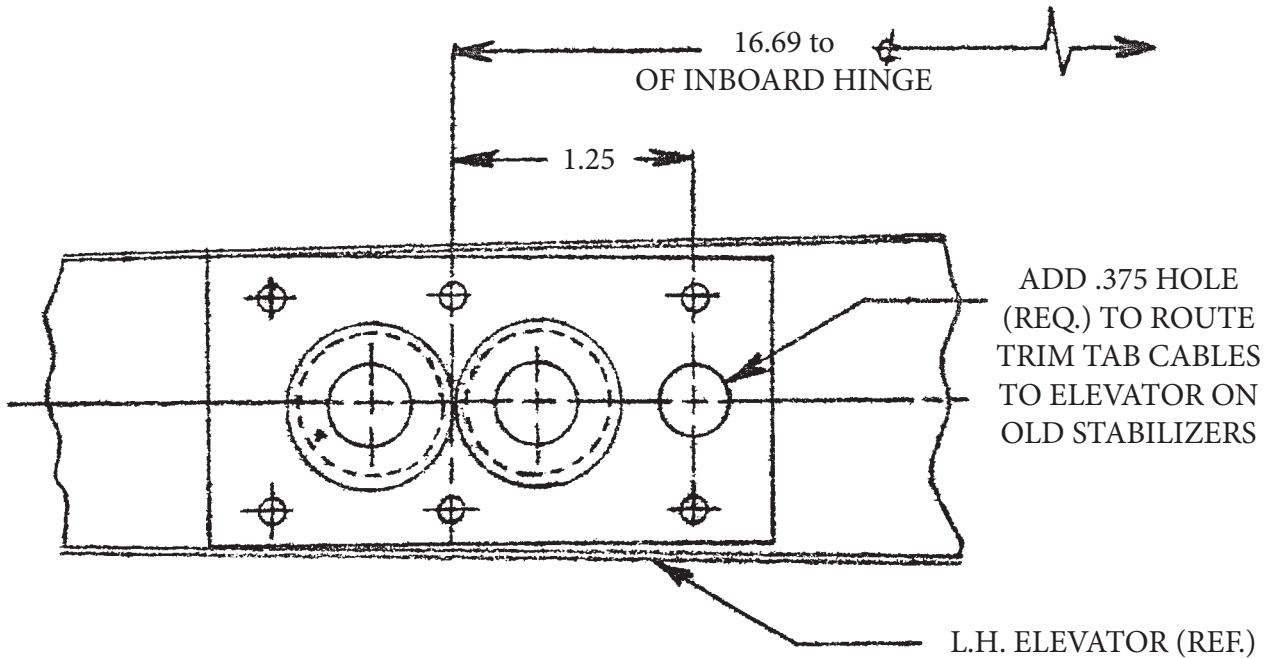
FIGURE I---NEW ELEVATOR USED WITH OLD STABILIZER MADE PREVIOUS TO AIRPLANES SERIAL NO. 5075 (ROUND TIP TYPE)

At the time the Silvaire stabilizer was redesigned to simplify construction the tab cable routing was modified to reduce tab system friction. The attached diagram has been prepared to describe the simple rework required when installing old elevators on the new stabilizer or vice-versa. Revision required is in the elevator spar and consists of merely revising the hole pattern through which the tab cables are routed.

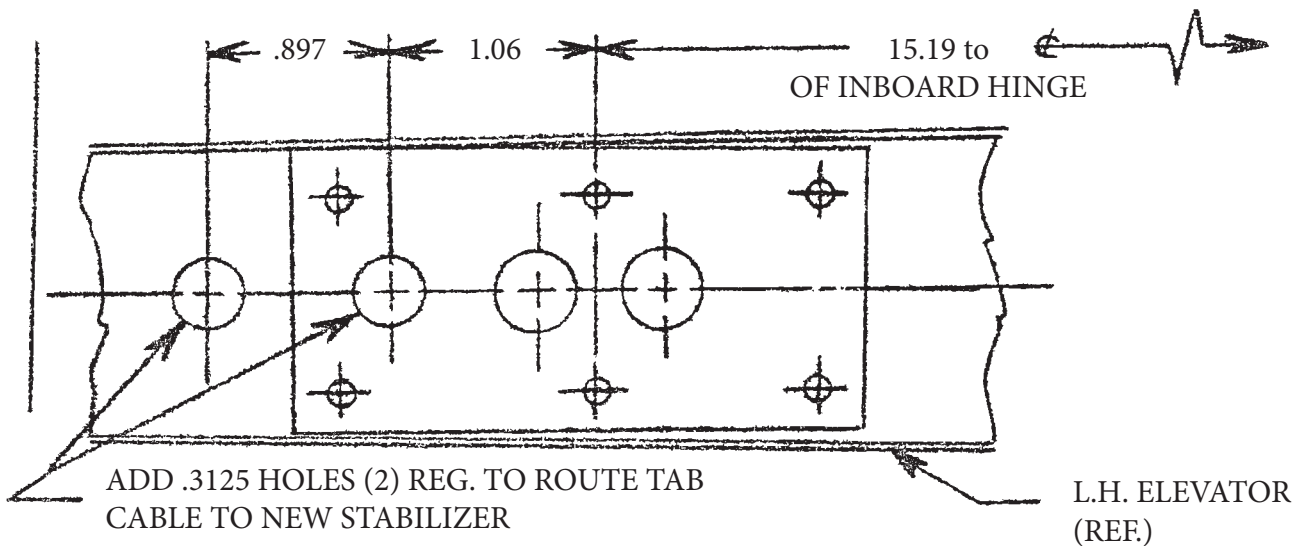
FIGURE II---OLD ELEVATOR USED WITH NEW STABILIZER. SHIPS MADE SINCE SERIAL NO. 5075 (SQUARE TIP TYPE)
