SILVAIRE AIRCRAFT CO.

SERVICE BULLETIN #3

SILVAIRE AIRCRAFT COMPANY  
SERVICE BULLETIN #3  
October 19, 1959

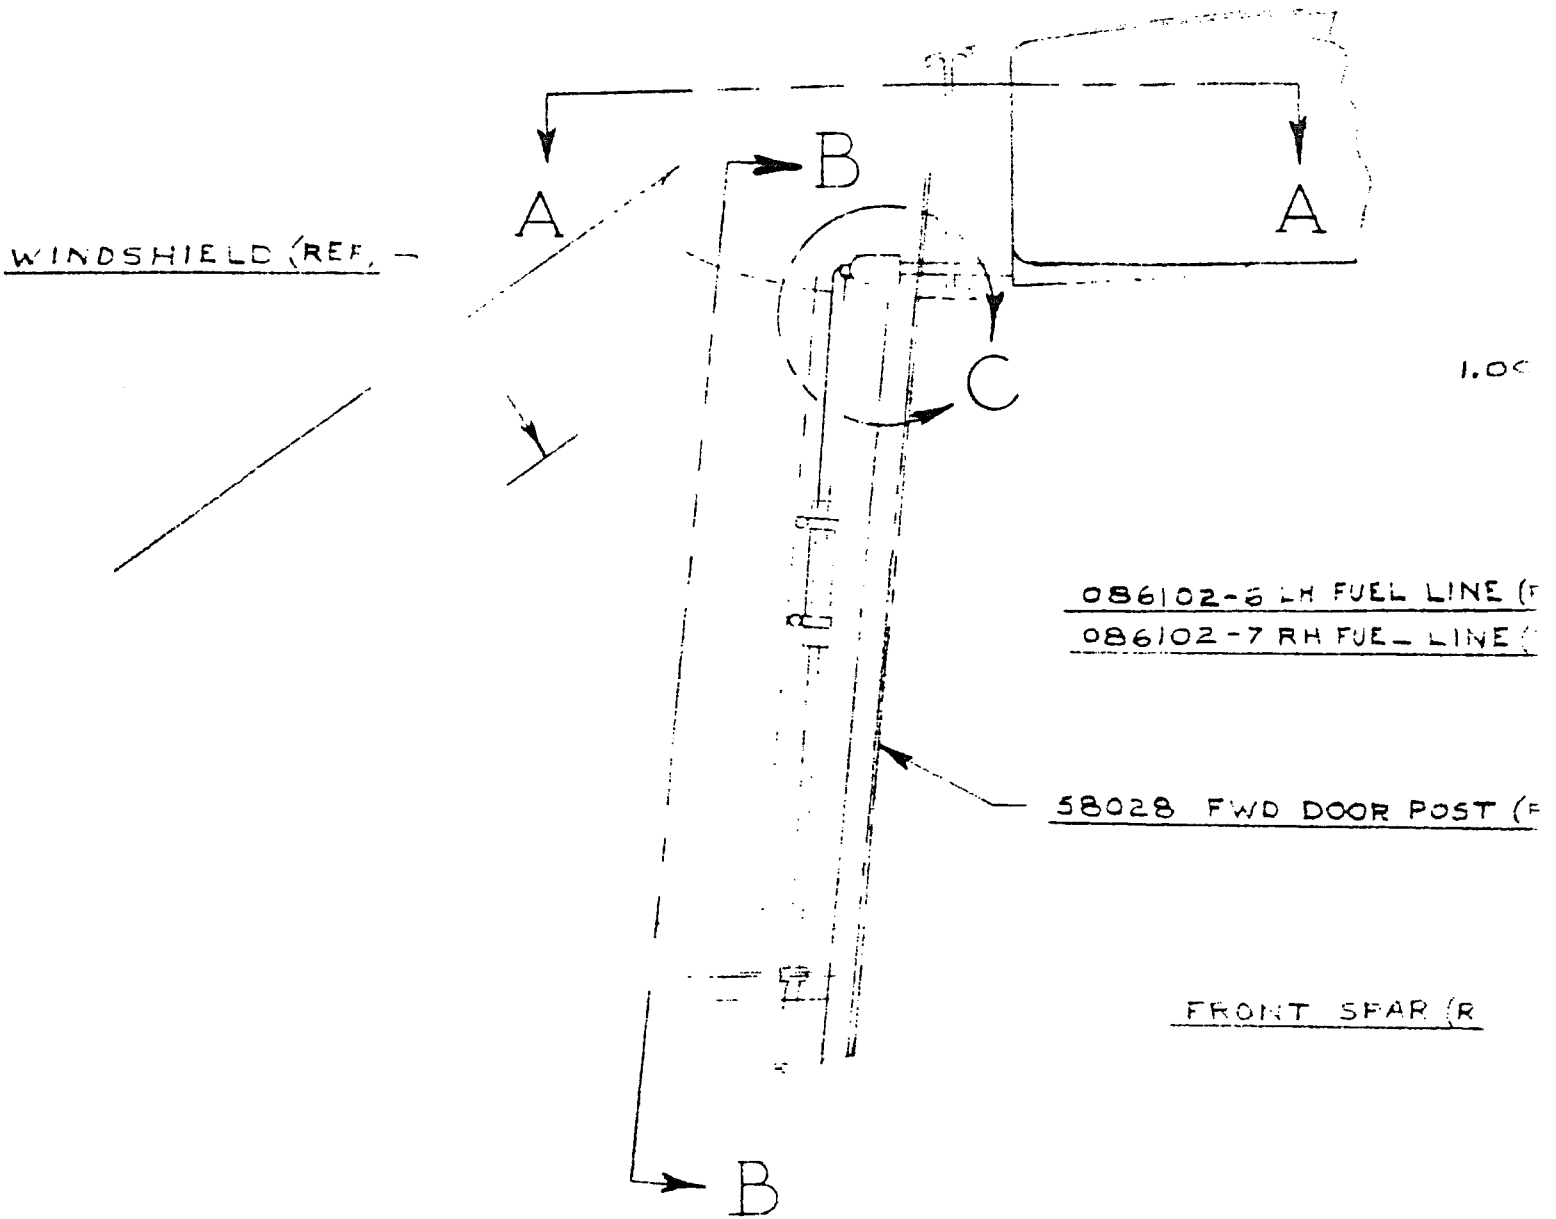
We have received reports of aileron cable pulleys rubbing on the fuel line in the area of the wing root leading edge and the upper end of the forward door post on the model 8F Luscombe. For the purpose of correcting this condition we recommend the following repair.

1. THE CLEARANCE BETWEEN THE AILERON FULLEY OR CABLE AND THE FUEL LINE SHALL NOT BE LESS THAN .06

1. Remove 086102-6 L.H. and -7 R.H. fuel lines.
2. Re-form the removed tubes as shown on the attached sketch. Care should be taken to properly support the tubes during this operation.

3. Remove .20 inch from the lower end of the tubes.
4. Inspect the tubes for any damage resulting from the rework and if the condition of the tubes is unsatisfactory, replace with new tubes formed as shown on the attached sketch.

5. Using a rotary file trim the fuselage wing root leading edge area as shown on the attached sketch. Be careful not to trim below the .25 inch "along fairing contour" dimension.

6. Index the fuel line elbow located in the wing root leading edge at 1.5 degrees down in relation to the spar. (see attached sketch.)
7. Re-install the tubes being careful to index the clamps on the connecting hose such that they do not interfere with the aileron cable.

8. Inspect the completed installation to be certain that the clearance between the cable pulley and the tube is at least .06 inch.

INDEX CLAIM THAT THEY DO NOT INTERFERE WITH AILERON CONTROL
