Rev. Date: 2-18-46

SUBJECT: Reinforcement of Stabilizer Yokes

MODELS AFFECTED: E2 and F2 Cubs

SERVICE BULLETIN NO. 8

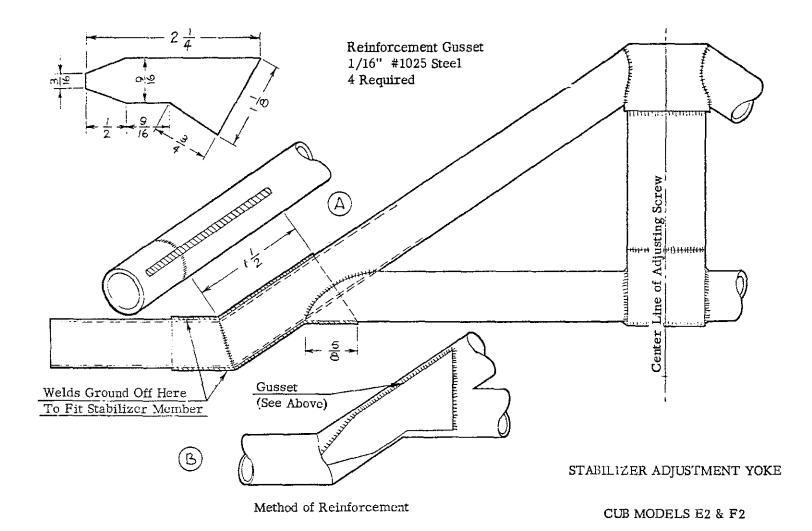
It will be seen, upon examination of the yoke at the joint located just outside the fuselage, that there is a welded seam lengthwise of the tubing on both top and bottom. These seams indicate where an internal gusset, as shown at "A" in the sketch, has been inserted in slots in the tubing and welded in place at these slots.

The dimensions of 1-1/2'' on top and 5/8'' on the bottom, as shown in the sketch, indicate the correct distance which the gusset should extend inward. If, when measured in the exact manner as indicated, these seams are found to be shorter than the dimensions given, it will be necessary to add an external reinforcement.

The method of reinforcement as shown at "B" on the drawing will be satisfactory. Four gussets of the form indicated should be made and welded in place, one on the front and one on the back of each joint.
