SERVICE

BULLETIN

NUMBER 9

SUBJECT: Tail Surface Bracing

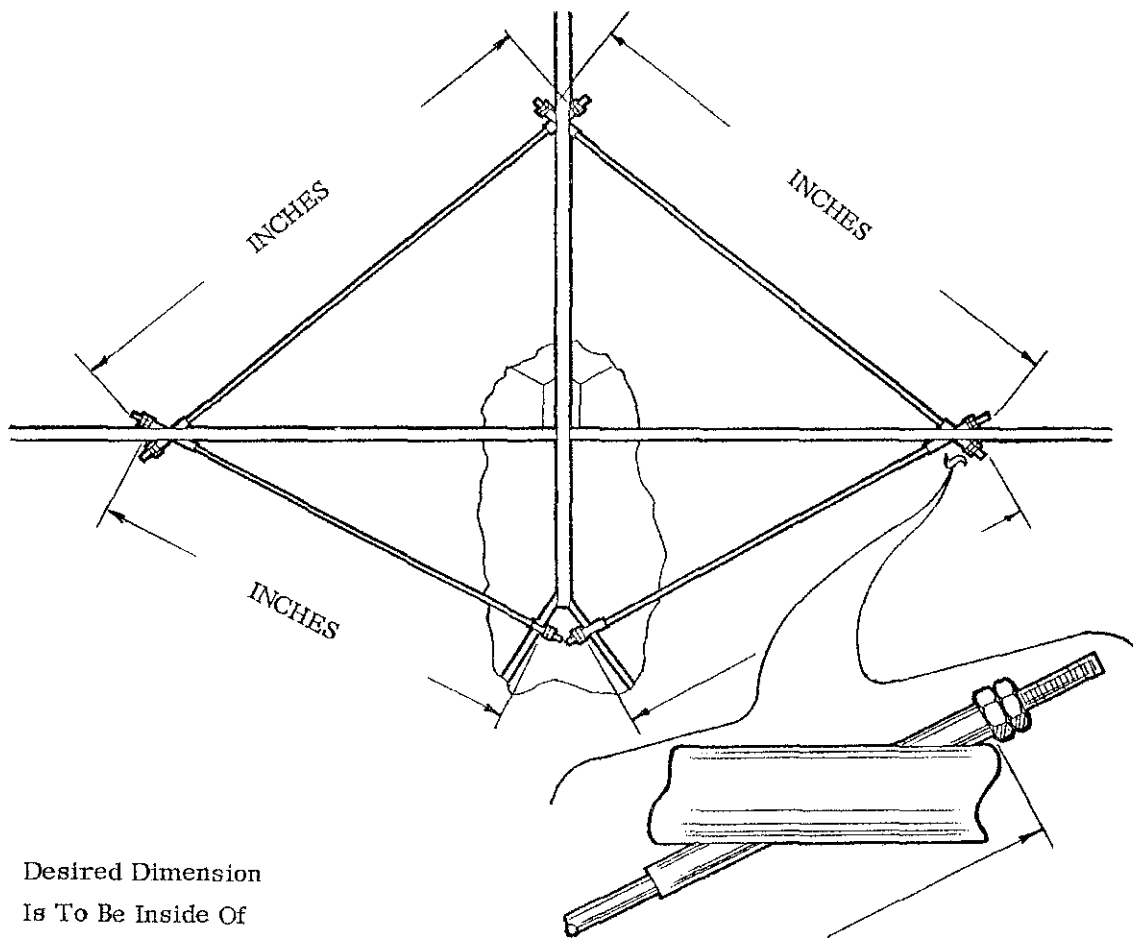
Note: Desired Dimension
Is To Be Inside Of
First Nut As Shown At
Right

"Cubs" of Serial No. 1500 and up have this same size wire, but the end fittings are of a different design, making the bracing system more flexible and better able to absorb vibration. In order to accomplish the same purpose where the older type of fitting has been used, which carries the wires clear through the fin and stabilizer spars in bushing tubes, it will be necessary to replace the solid tie rods with a standard cable.

To facilitate this replacement in the field, fittings for the stranded cable are being made up at the factory such that the new flexible wires may be readily installed in the same fittings as used for the solid wires.
