**SERVICE**

NUMBER 83

**SUBJECT:** Tailskid Spring Attachment Reinforcement

**MODELS AFFECTED:** E2 and J2

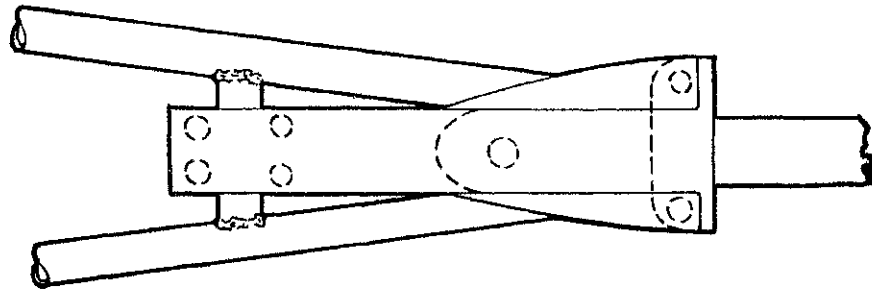
We have received a number of reports of failure of the tailspring attachment on the subject model airplanes, and at the suggestion of the Civil Aeronautics Administration, we have developed a reinforcing unit, part numbers 30882 and 30871, which may be bolted to the tailspring and fuselage structure. (See Sketch).

If your airplane is subject to hard landings, incident to student training, or if you are operating from a rough field, we recommend that this reinforcement be installed to prevent any possible failure of the tailspring attachment.

These parts may be obtained through your local dealer or distributor and, when installed, should be covered by an appropriate entry in the aircraft log book.
