SERVICE LETTER

No. 207

Piper Aircraft Corporation

SUBJECT: Oil Quick Drain Valve Assembly, Part Number 12956-04

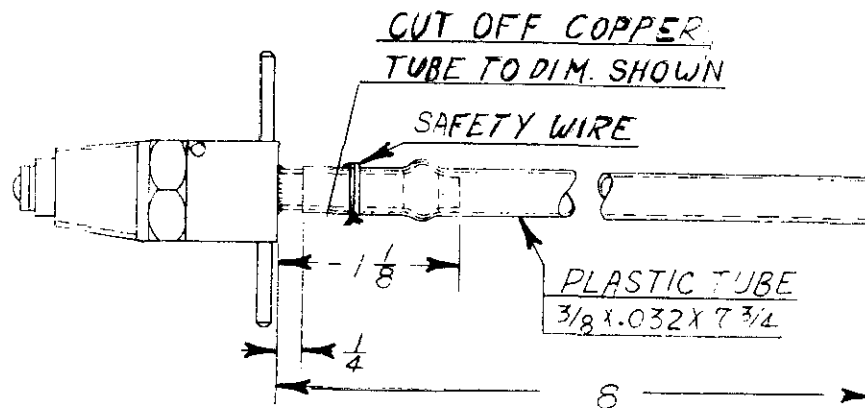
It has been brought to our attention that vibration has caused the quick oil drain valve to break at the rubber washer seal and also at the point where the copper drain tube is soldered.

To eliminate this condition it is recommended that the valve be modified in accordance with the sketch shown below. The plastic tube may be obtained from the Service Department of the Piper Aircraft Corporation on a No Charge basis. This plastic tube will be furnished on a No Charge basis until June 1, 1954.
