VSP-30
May 20, 1981

VENDOR SERVICE PUBLICATION

Subject: Bendix Service Bulletins 599A, 609A, 610,
613, 614

SERVICE BULLETIN NO. 599A
(Supersedes Service Bulletin No. 599)
Engineering Aspects are
FAA Approved

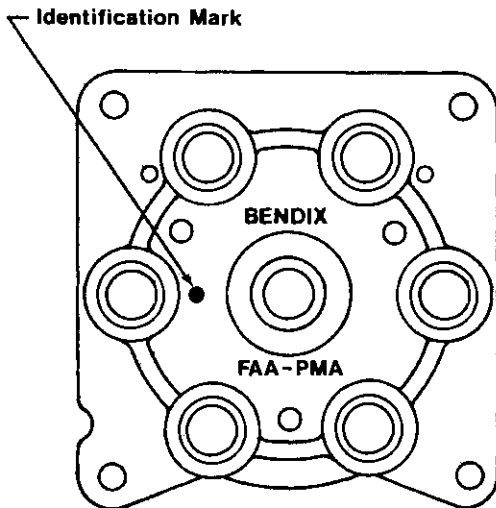
Figure 1. Location of Identification Mark

The new "Gripper Bushing" will eliminate the possibility of the bushing becoming loose. The "Gripper Bushing" block can be identified by a circular shaped mark 0.188 inch \pm 0.031 inch in diameter raised 0.010 inch to 0.030 inch above the surface of the block. This mark is located on the tower side of the block, as indicated in figure 1.
