# SERVICE

NUMBER 42

# BULLETIN

**SUBJECT:** Elevator Bungee Installation

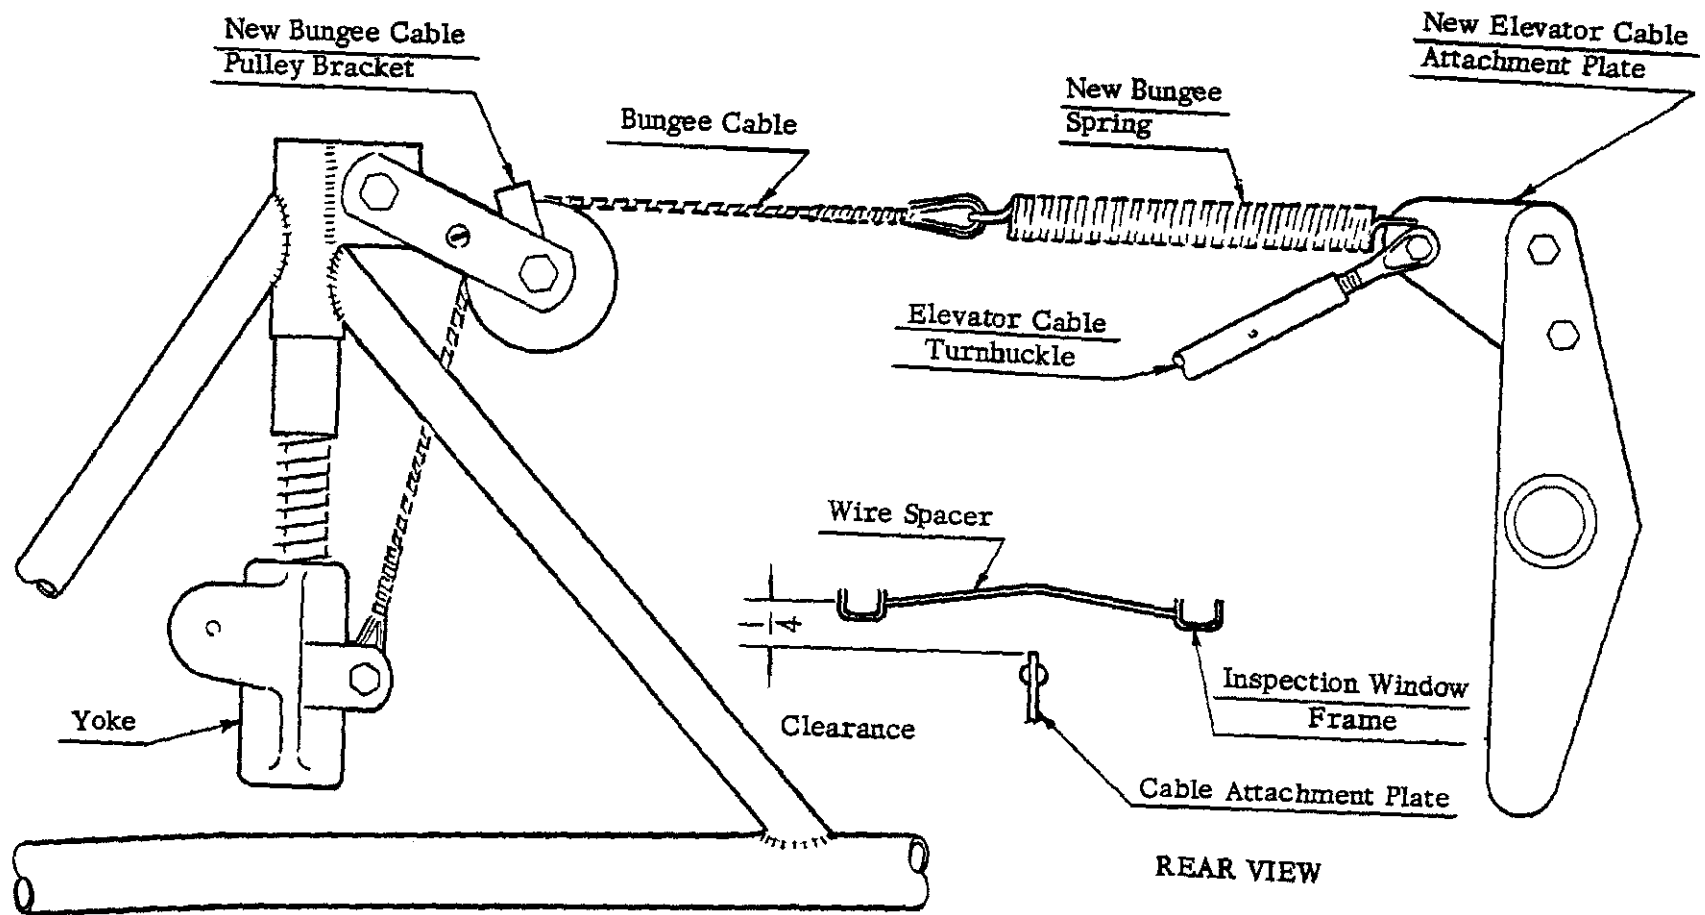
NEW BUNGEE INSTALLATION

2. From the accompanying sketch it will be noted that the revised installation is similar to the original one with the exception of the above mentioned parts and the fact that the spring now attaches directly to a small hole in the elevator cable attachment plate. The small plate, washer and No. 4 screw and nut, that were used to attach the original spring, may be discarded. In dis-assembling the installation, it will not be necessary to disconnect the forward end of the Bungee cable from the stabilizer yoke and in reassembling the installation, the new spring and elevator cable link should be attached to the Bungee cable, then the new pulley bracket and pulley should be installed. The elevator cable plate should then be bolted between the elevator horns and lastly the elevator cable turnbuckle attached to this plate, making certain the turnbuckle is free to swivel.

1. The Bungee cable pulley bracket, elevator cable to horn attachment plate and Bungee spring must be replaced by the parts accompanying this bulletin.

In the fuselage structure, directly above the elevator horn, there is a wire spacer between the inspection window channels. This should be bent up in the center, if necessary, to prevent interference with the enlarged cable attachment plate. A 1/4" clearance at this point, when the elevator horn is in the most critical position, is considered satisfactory.
