SERVICE

NUMBER 43

SUBJECT: Stabilizer Link Tube and Rear Support Bearing Bracket

MODELS AFFECTED: J3, Serial Nos. 2325, 2327, 2339, 2340, 2342, 2344, 2345, 2347, 2349, 2351, 2355 and up to 8018.

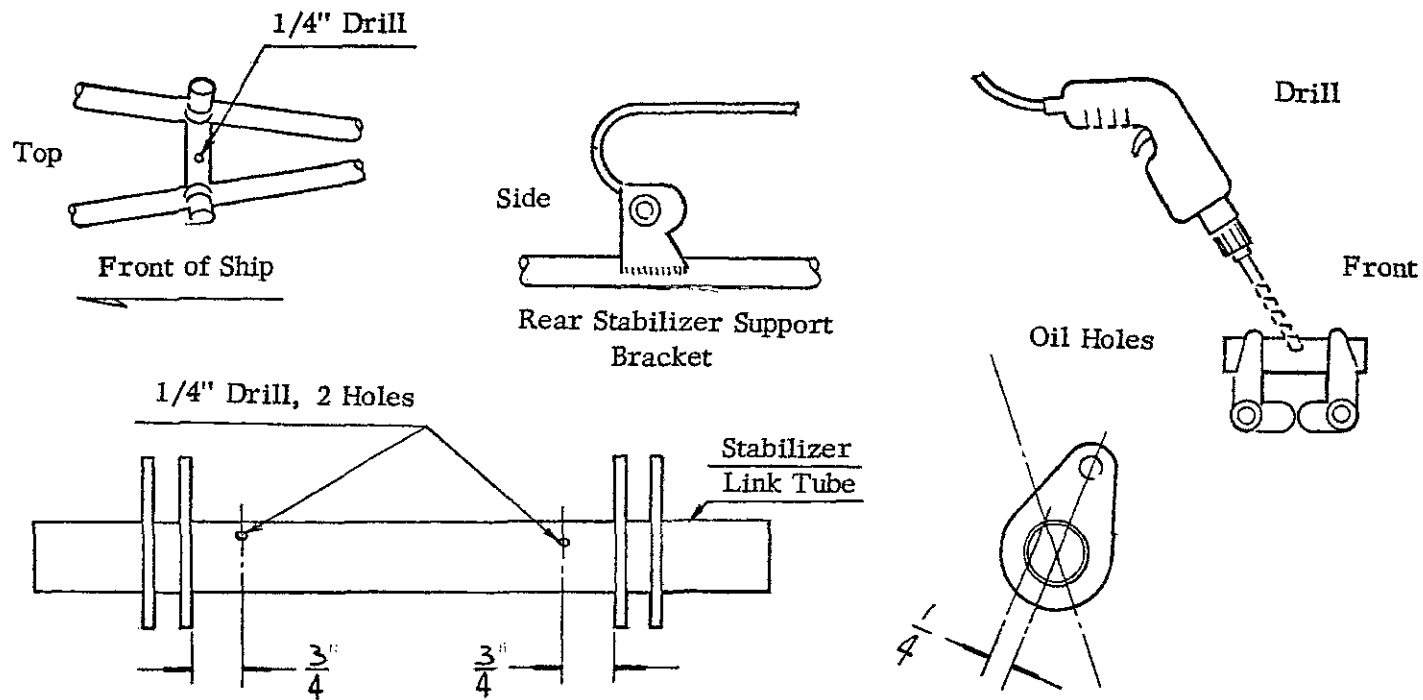
Instructions for Drilling Oil Holes

We have received a number of reports of binding in the stabilizer rear support bearing and, as the link tube at the adjustment yoke is of similar construction, there is a possibility that the same difficulty may occur there.

3. Defective parts should be replaced.
4. Before reassembling the parts, a 1/4" oil hole should be drilled in the top center of the stabilizer rear support bearing tube and also 3/4" inboard of each attachment lug on the link tube as shown on the attached sketch unless such holes are already present.

If an extension drill is not available to drill the oil hole in the stabilizer rear support bracket, a $\frac{3}{16}$ " hole may be drilled at an angle, as shown and slightly to the rear of the top center if necessary.

An extension drill may be made by brazing a $\frac{1}{4}$ " drill to a length of $\frac{1}{4}$ " cold roll steel rod.
