BULLETIN

NUMBER 45

SUBJECT: Control System Interference

MODELS AFFECTED: J3

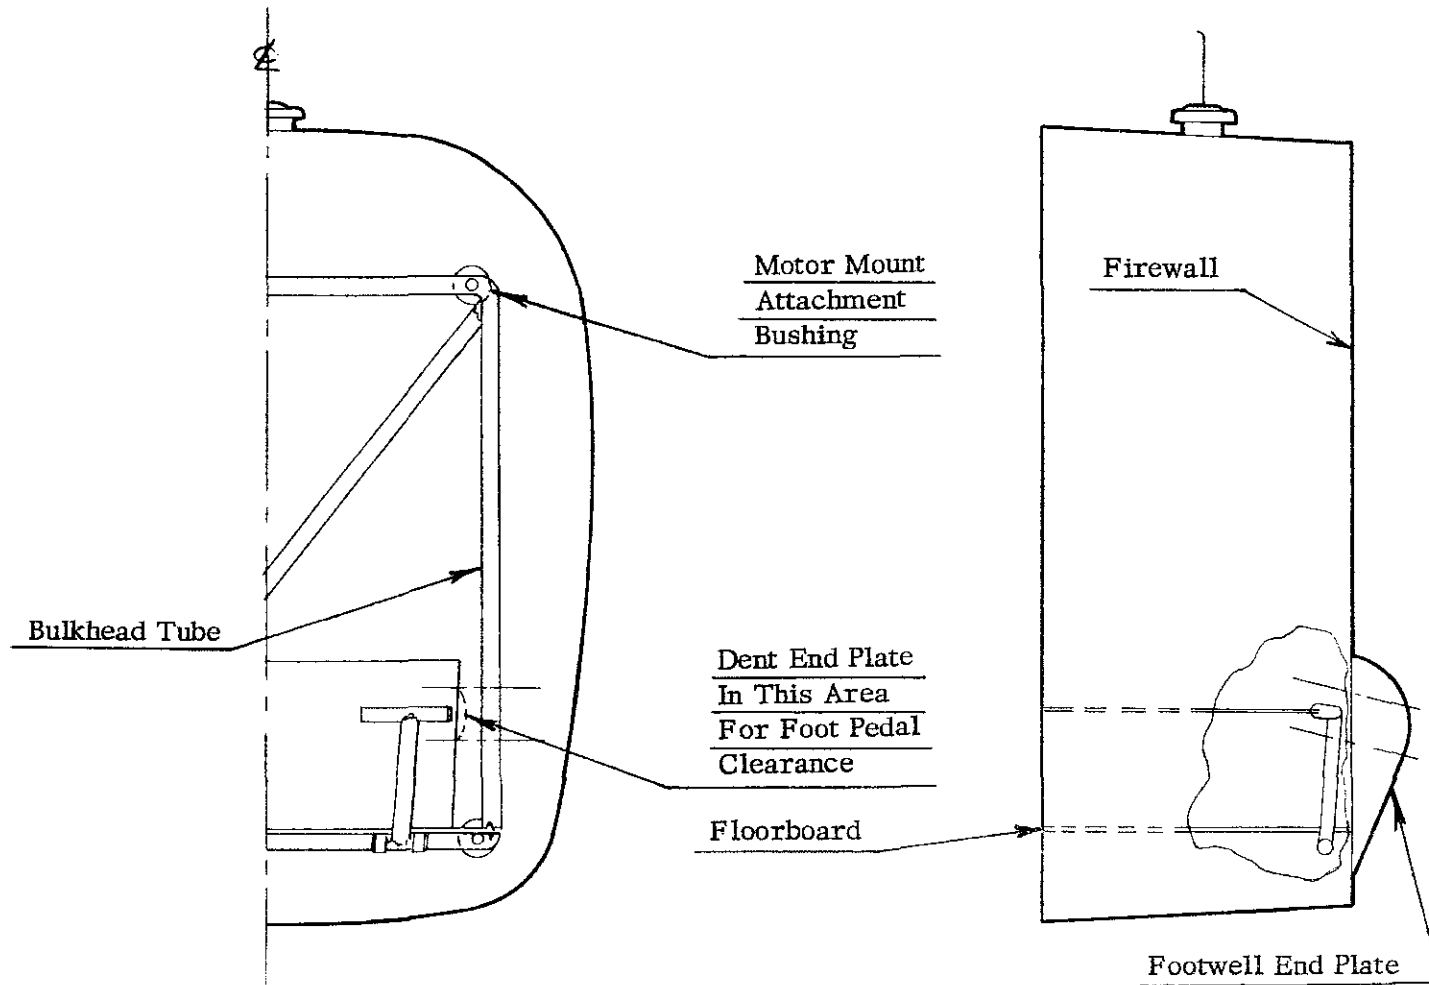
We have received reports of interference of the front rudder pedals with the fire-wall footwells. There is a possibility that the bolt attaching the cable to this pedal has been installed with the nut on the outboard side of the pedal lug. If this condition exists and if reversing the bolt position does not give a minimum of 1/4" clearance, it will be necessary to rework the footwell as shown in the attached sketch to obtain the minimum clearance.

Note: Use Wooden or Non-Metal Mallet
Use Same Procedure On Left Side

CAUTION: DO NOT DENT BULKHEAD TUBES
