# SERVICE

NUMBER 72

**SUBJECT:** Rudder Pedal and Floorboard Attachment Lugs

**MODELS AFFECTED:** J3 and J5 Series

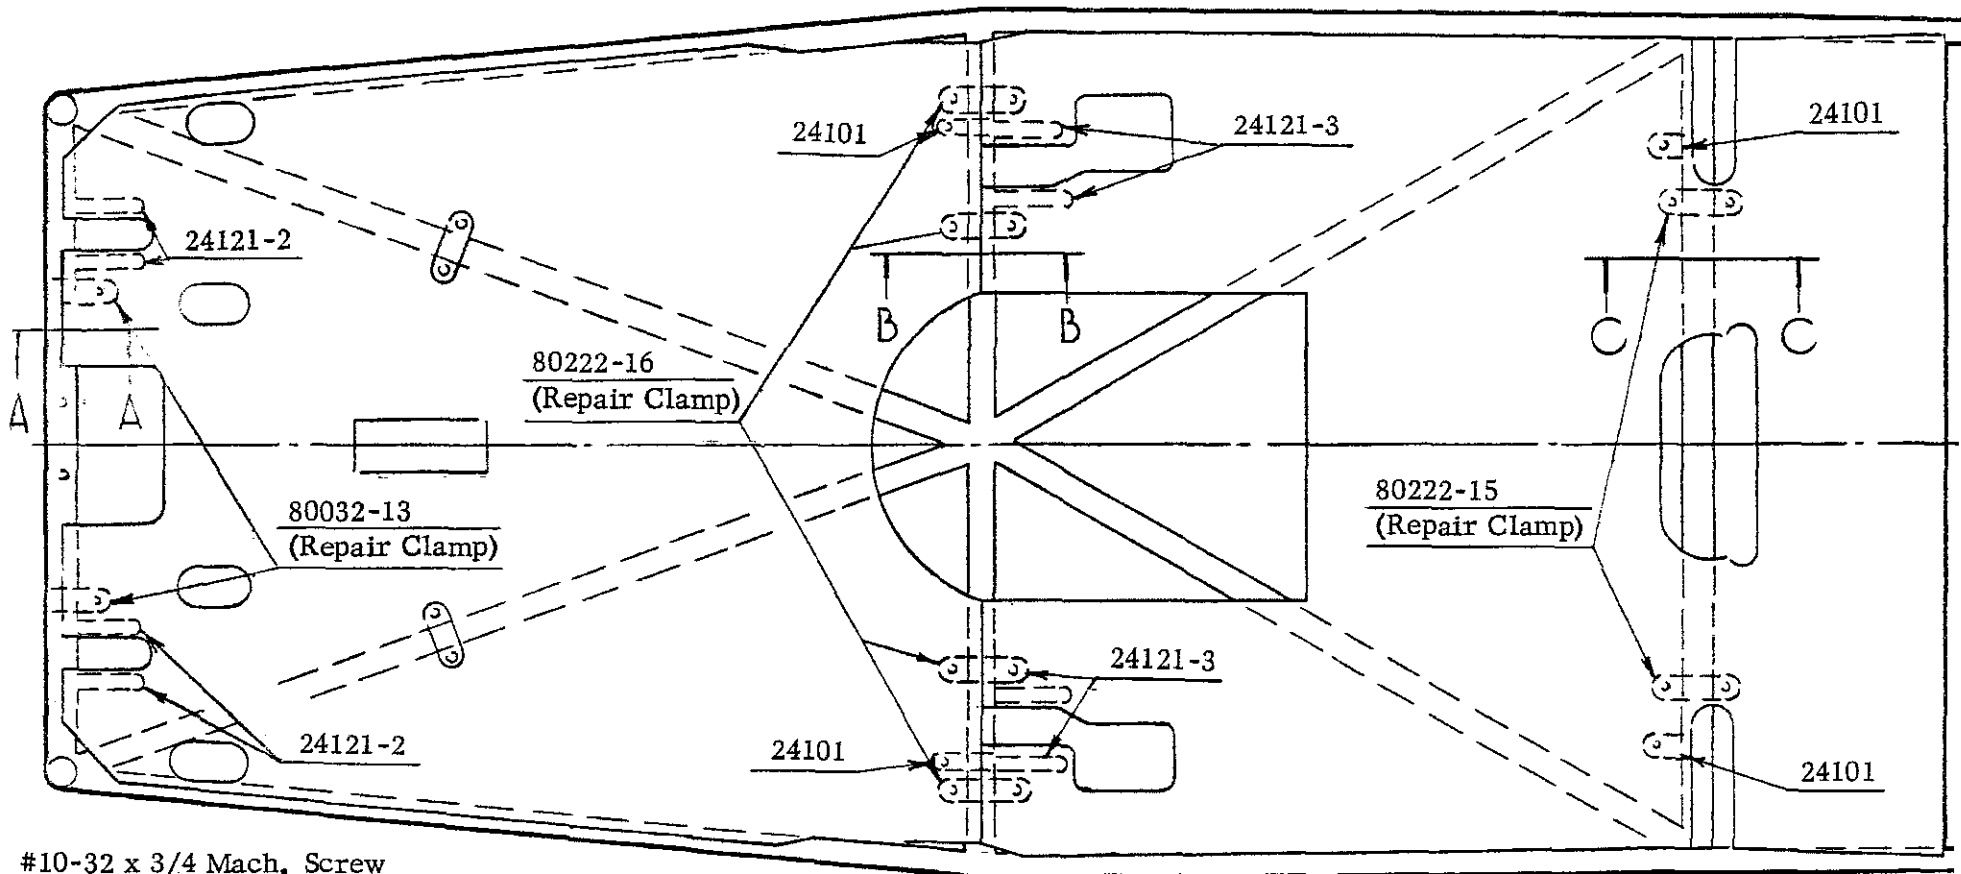
FLOORBOARD FITTING REPAIR

A number of reports have recently been received regarding failure of the floorboard and rudder pedal lug attachment to the tubular structure. This is apparently due to continued flexing of these parts during operation. As it may be possible to foul the controls as a result of such failures, we recommend that an immediate check be made to determine whether or not these fittings are intact on your airplane.

In the event that such failures are discovered, a temporary repair may be effected by attaching the floorboard with a clamp fastened about the tubular structure immediately adjacent to the failed part. (See attached sketches.) SAE No. 1025 steel strip .045" thick by 3/4" wide is recommended for such clamps. The original fittings should then be re-welded or replaced when convenient; in which case the repair clamps may be reinstalled for additional strength.

#10-32 x 3/4 Mach. Screw  
 80122-11  
 Plain Nut 14 Req'd.
