Service Bulletin #108

October 20, 1948

SUBJECT: MODEL PA-11 FRONT AND REAR SEATS

Affected Airplanes: Front Seat: Serial Nos. 11-1 to 11-473 incl.,
11-475 to 11-477 incl., 11-482 and 11-485,
11-1354 to 11-1678 incl.

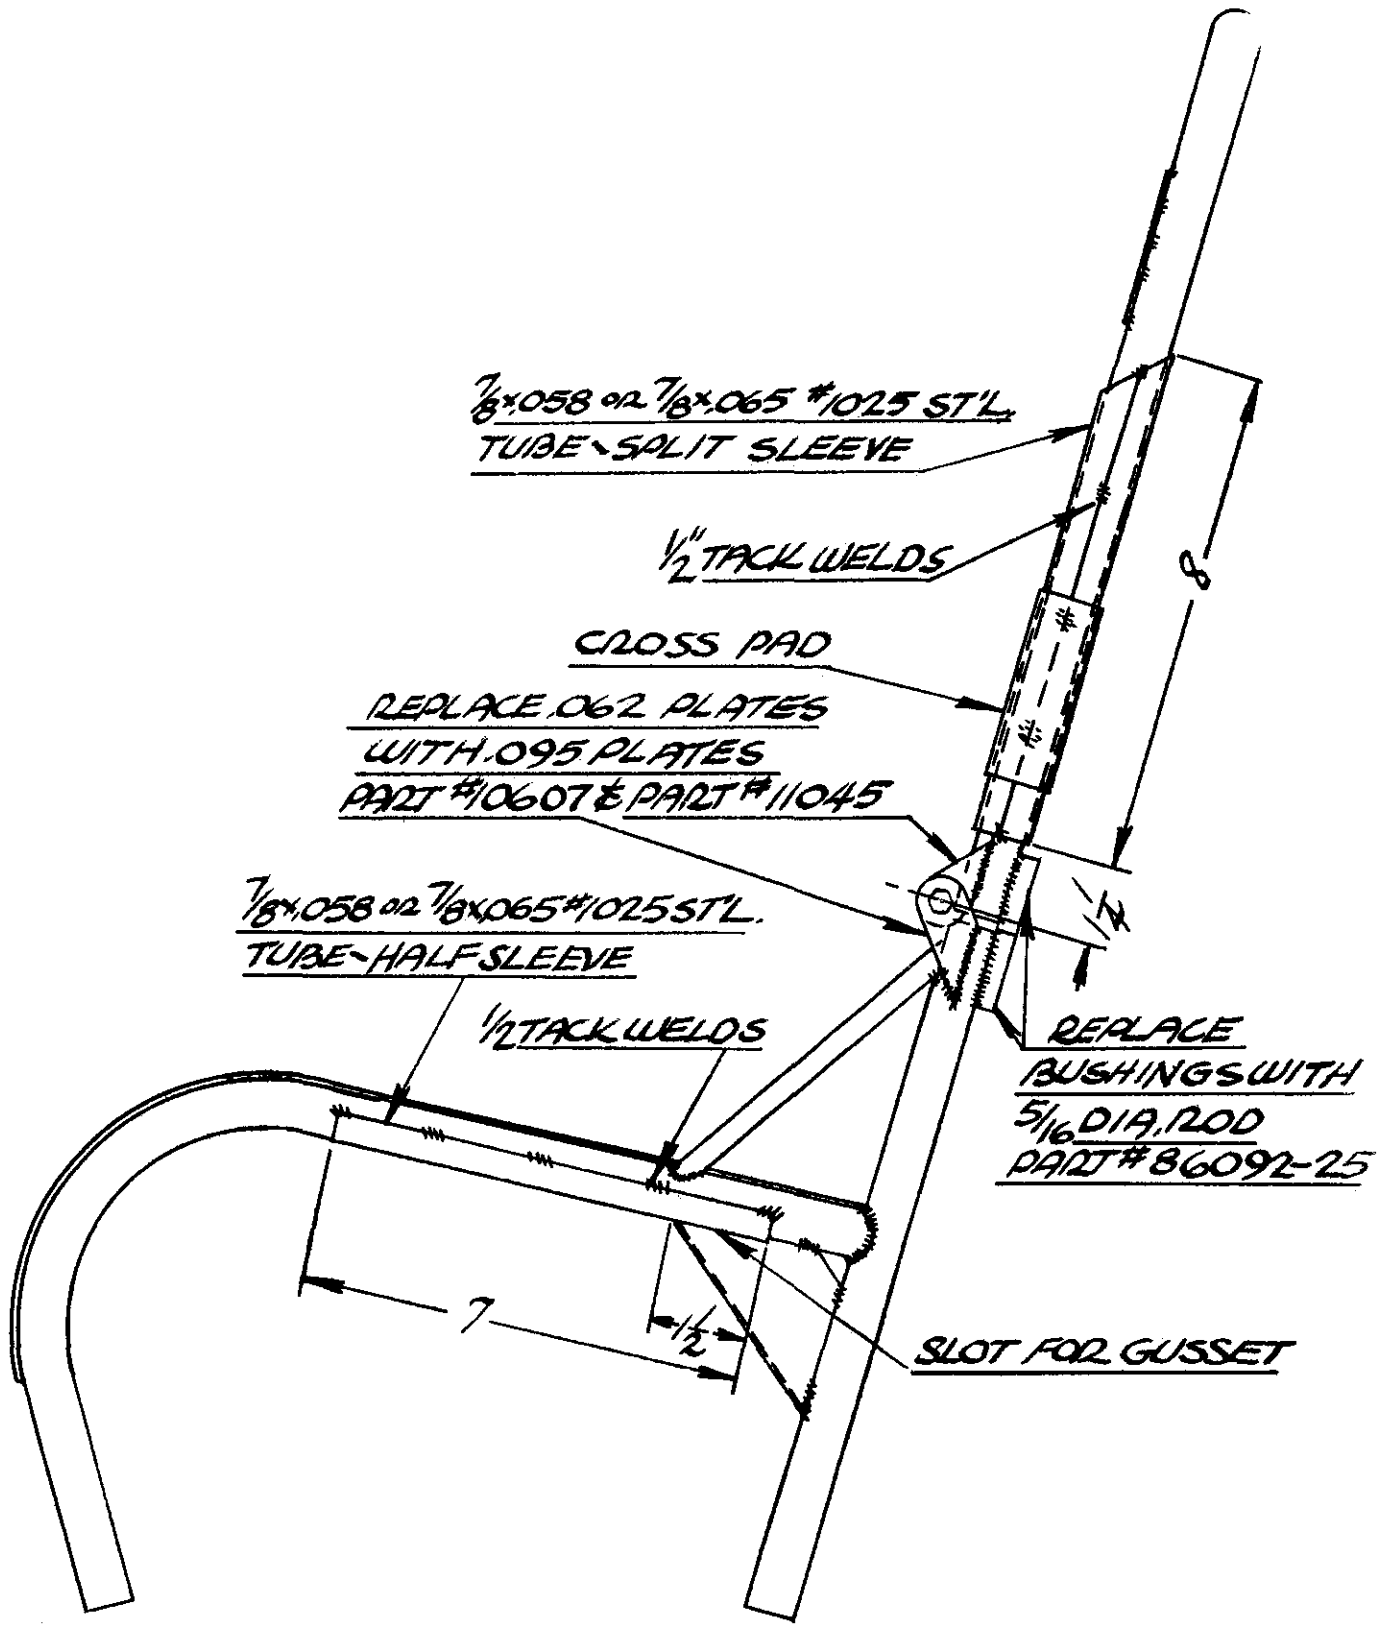
The front seat has been bent backward resulting in bending of the seat side rail and back tubes, the crushing of the stop tubes at the hinges and the stretching of the hinge plate. In order to preclude the possibility of additional failures, it is recommended that the airplane be inspected and if such deformation is found, the following repairs may be made as needed or a new seat installed.

1. Side rail tube reinforcement

Add a half sleeve to underside of tube as shown on sketch.

2. Seat back tube reinforcement

Chip off lower sheet metal cross pad. Add split sleeve as shown on sketch and replace cross pad.

3. Hinge Revision

Replace present .062 hinge plates with .095 plates.

4. Stop Revision

Replace tube with cold rolled rod.

7/8 x .058 or 7/8 x .065 #1025 STL.
TUBE - SPLIT SLEEVE

REPLACE .062 PLATES
WITH .095 PLATES
PART #10607 & PART #11045

7/8 x .058 or 7/8 x .065 #1025 STL.
TUBE - HALF SLEEVE

REPLACE
BUSHINGS WITH
5/16 DIA. ROD
PART #86092-25
